**NATIONAL REGISTER OF HISTORIC PLACES  
REGISTRATION FORM**

historic name Chaffee-Moloney Houses

street & number 194 and 196-98 Columbian Avenue

**Chaffee-Moloney Houses  
Rutland, Rutland County, Vermont**

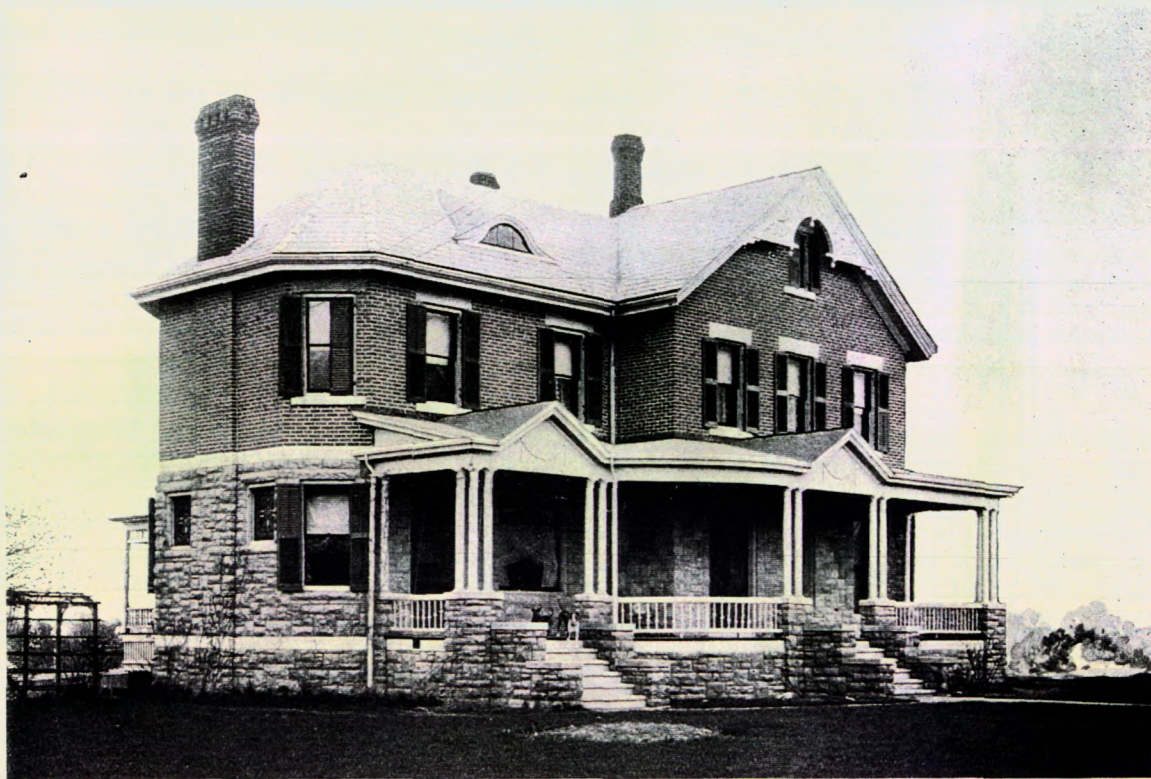
Chaffee-Moloney House #1  
194 Columbian Avenue  
Rutland, Rutland County, Vermont

RESIDENCE OF THOMAS W. MALONEY.

Most of the exterior features of the house are original. The 1900 photograph of the house reveals that the house is now missing features including a chimney at the juncture of the cross gable roof, a Carpenter-Gothic bargeboard in the front gable, garlands on the porch gables, and stained glass windows in the fixed windows flanking the chimney at the side ell. This photo also reveals that the original porch railings were low, simple railings with narrow, turned balusters, and that the house originally had louvered shutters.
