Titan II ICBM Launch Complex 374-7 Site
Name of Property

Van Buren County, Arkansas
County and State

**NATIONAL REGISTER OF HISTORIC PLACES
REGISTRATION FORM**

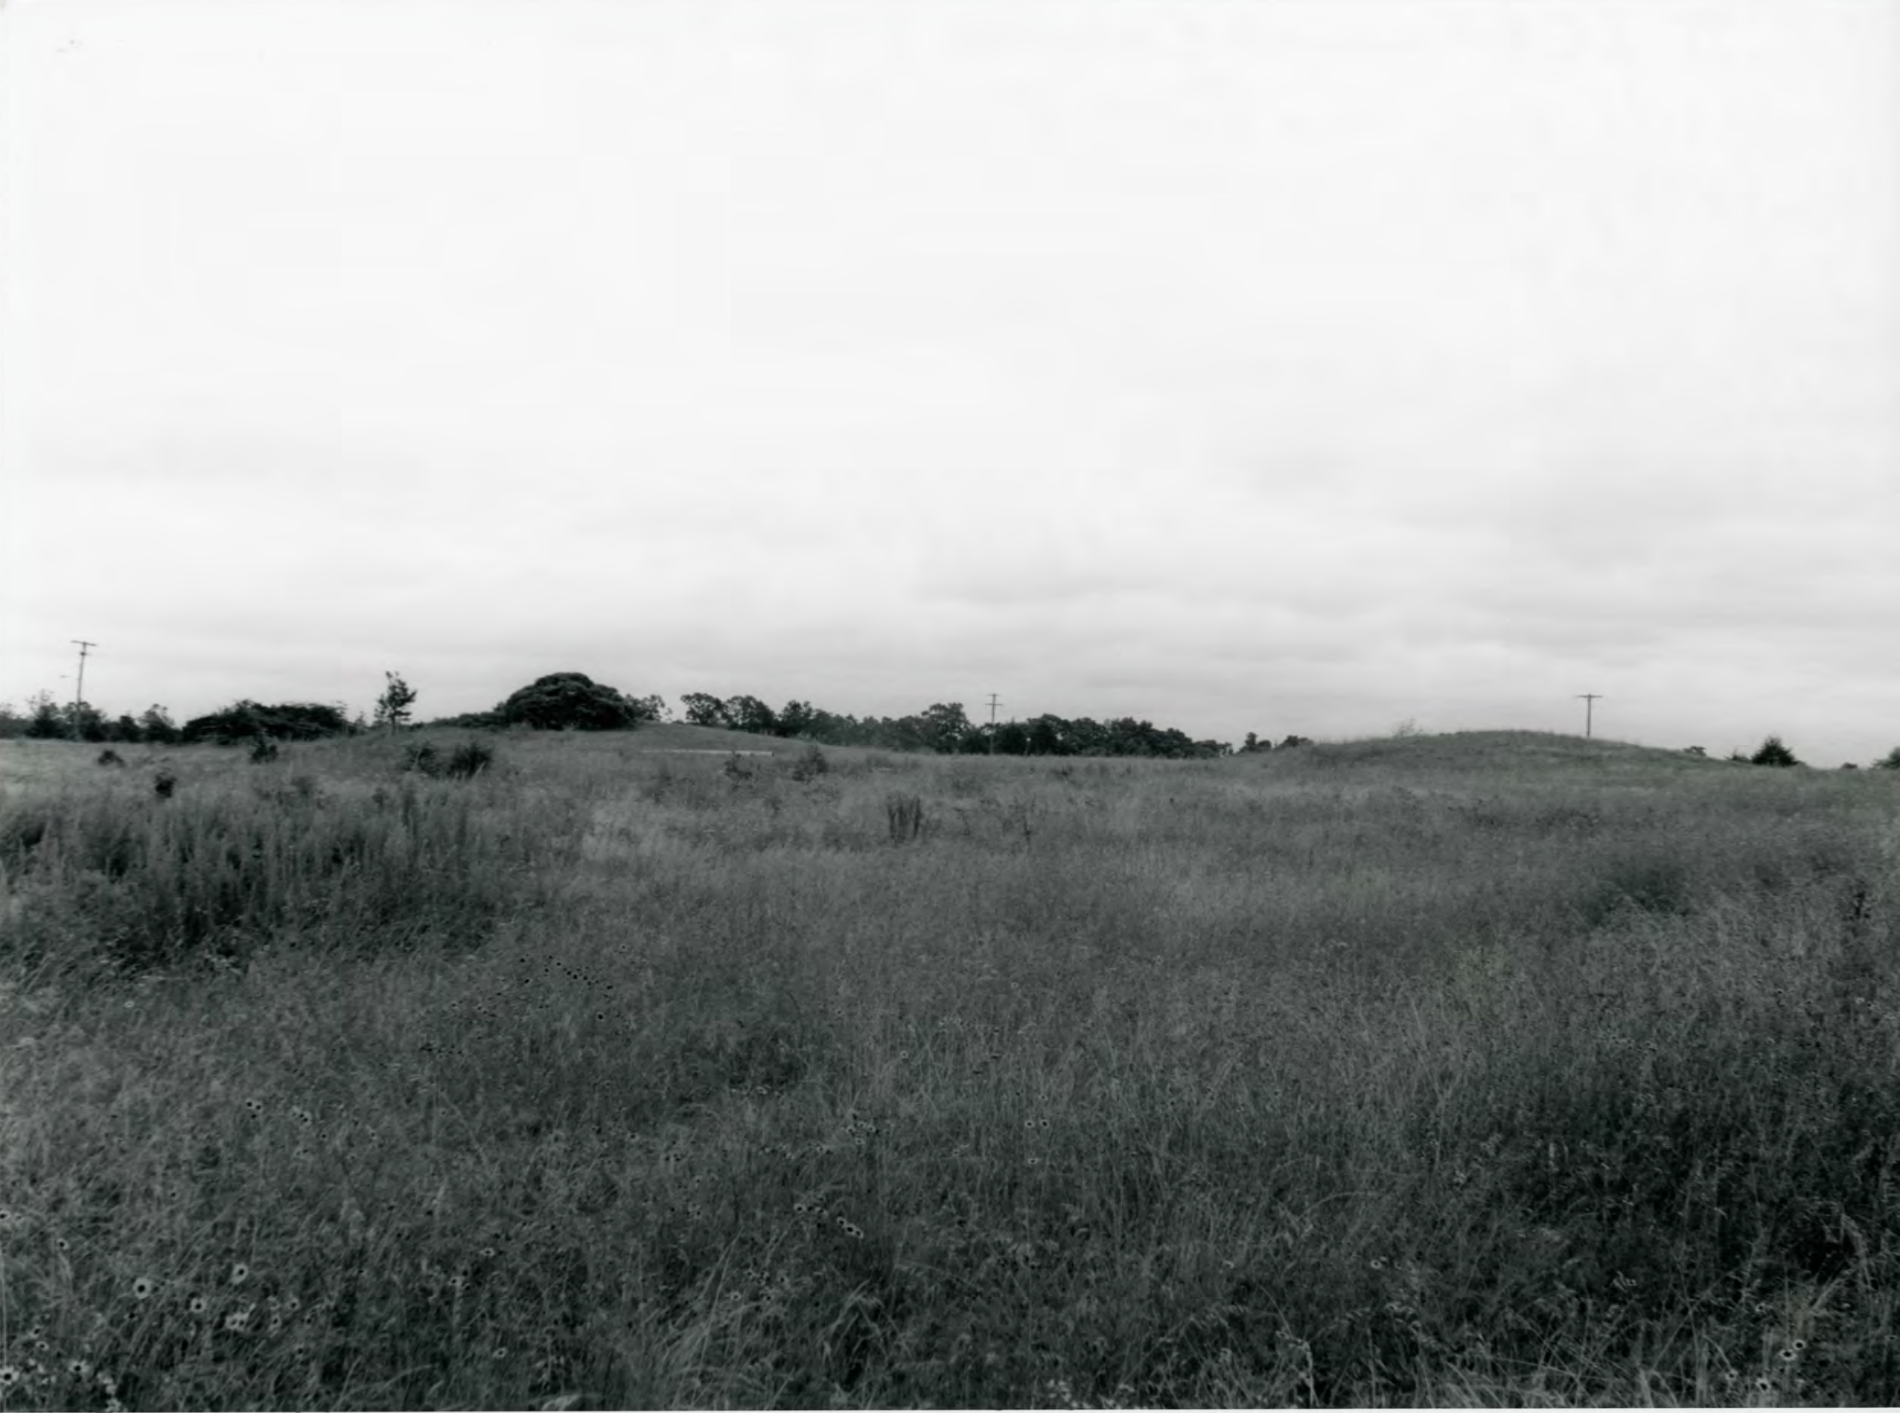
374-7 site overview with command center mound at right,
launch duct mound at left. View from NW

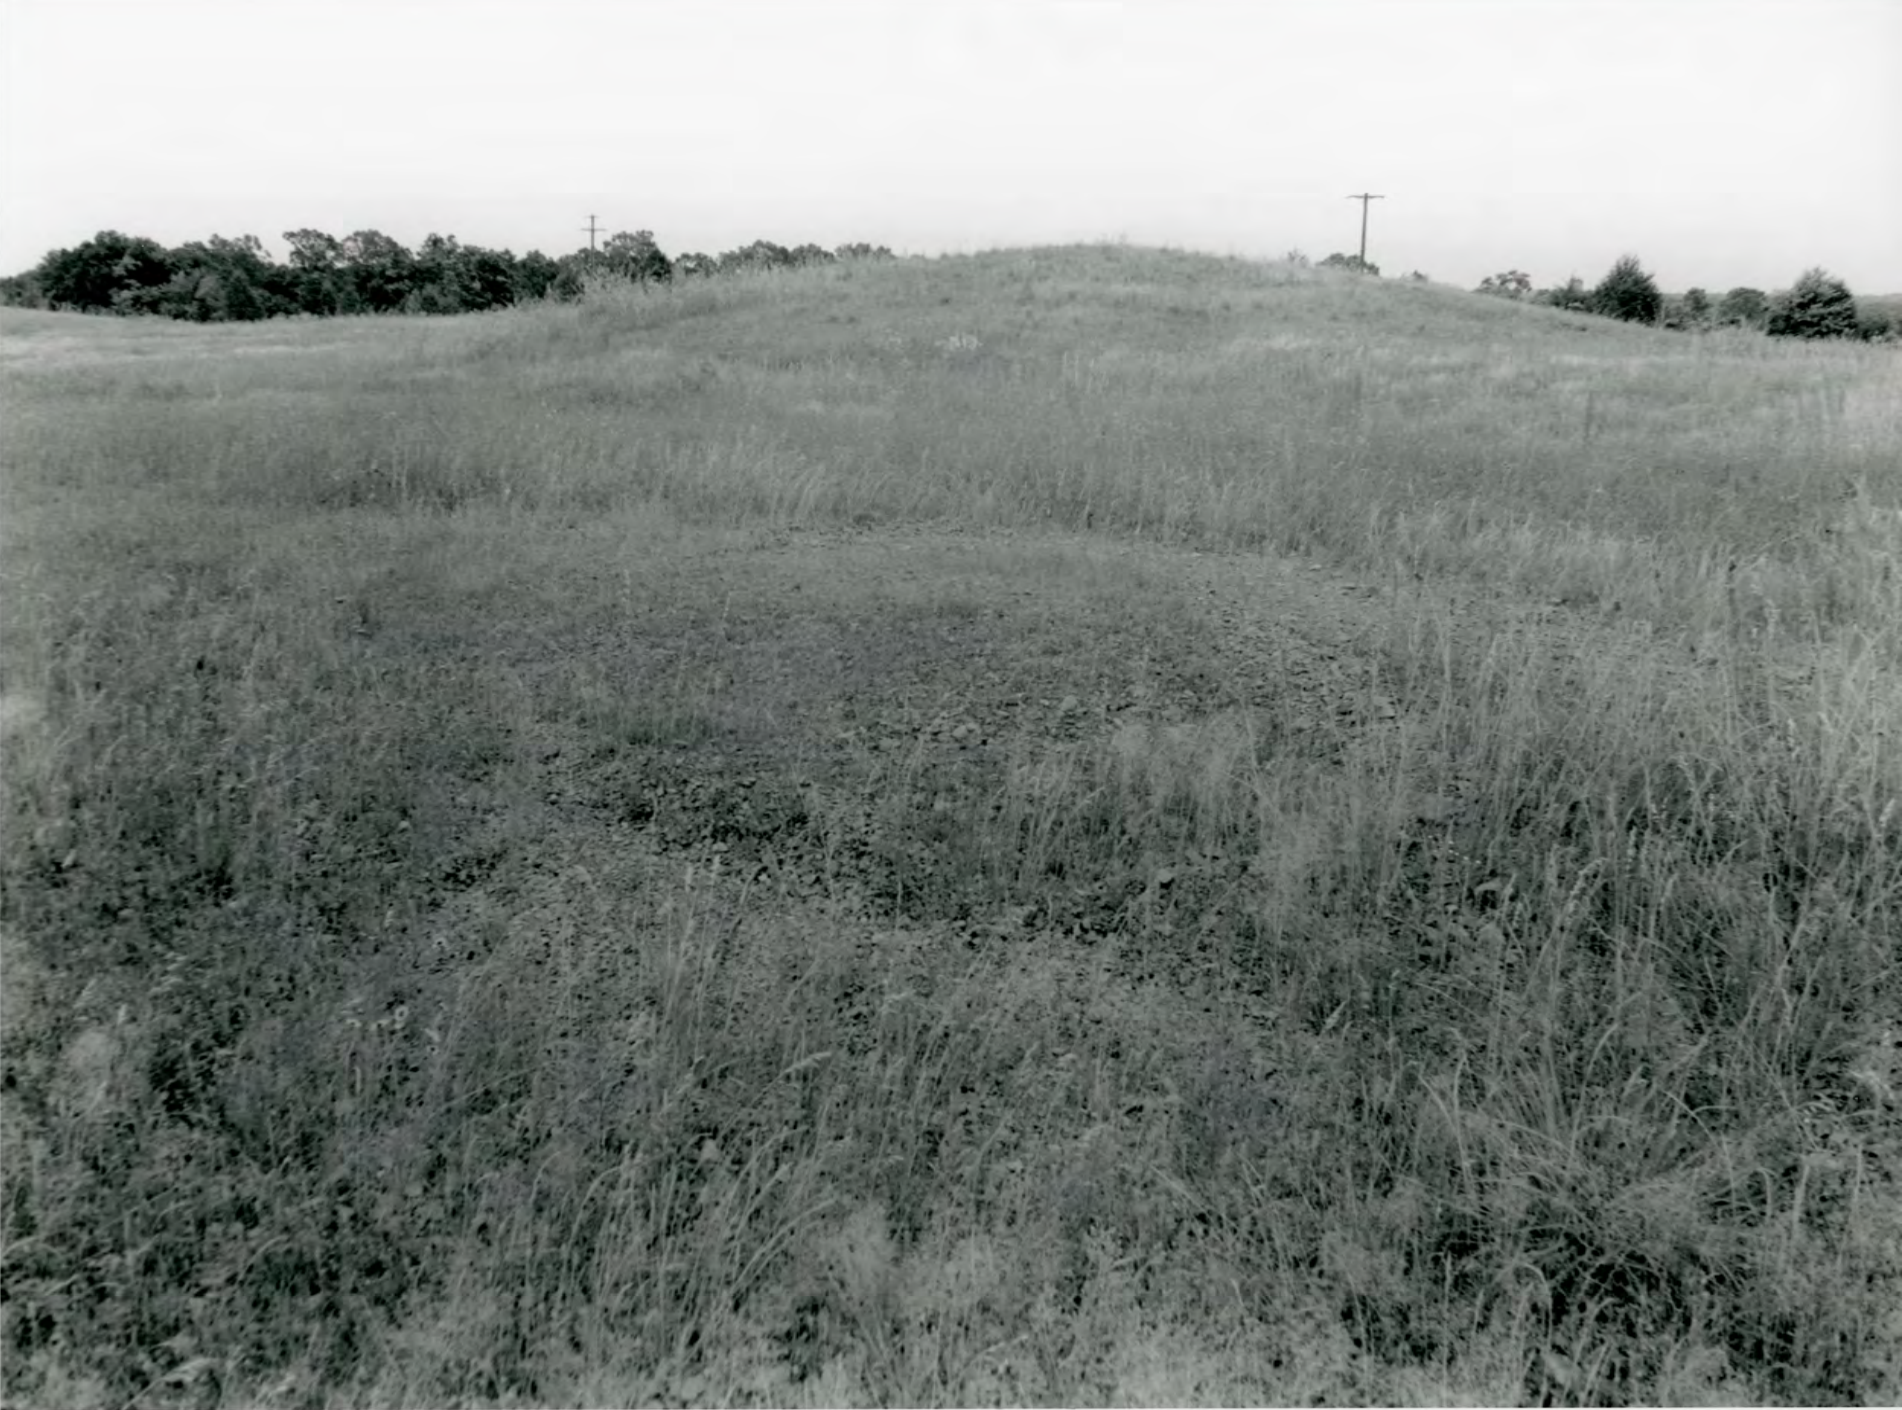
Launch duct mound, view from west

- 1) A large earthen mound toward the east-center area of the site and slightly north of the end of the original access road, the bed of which remains clearly visible. This was the location of the missile launch duct and its associated sliding door.

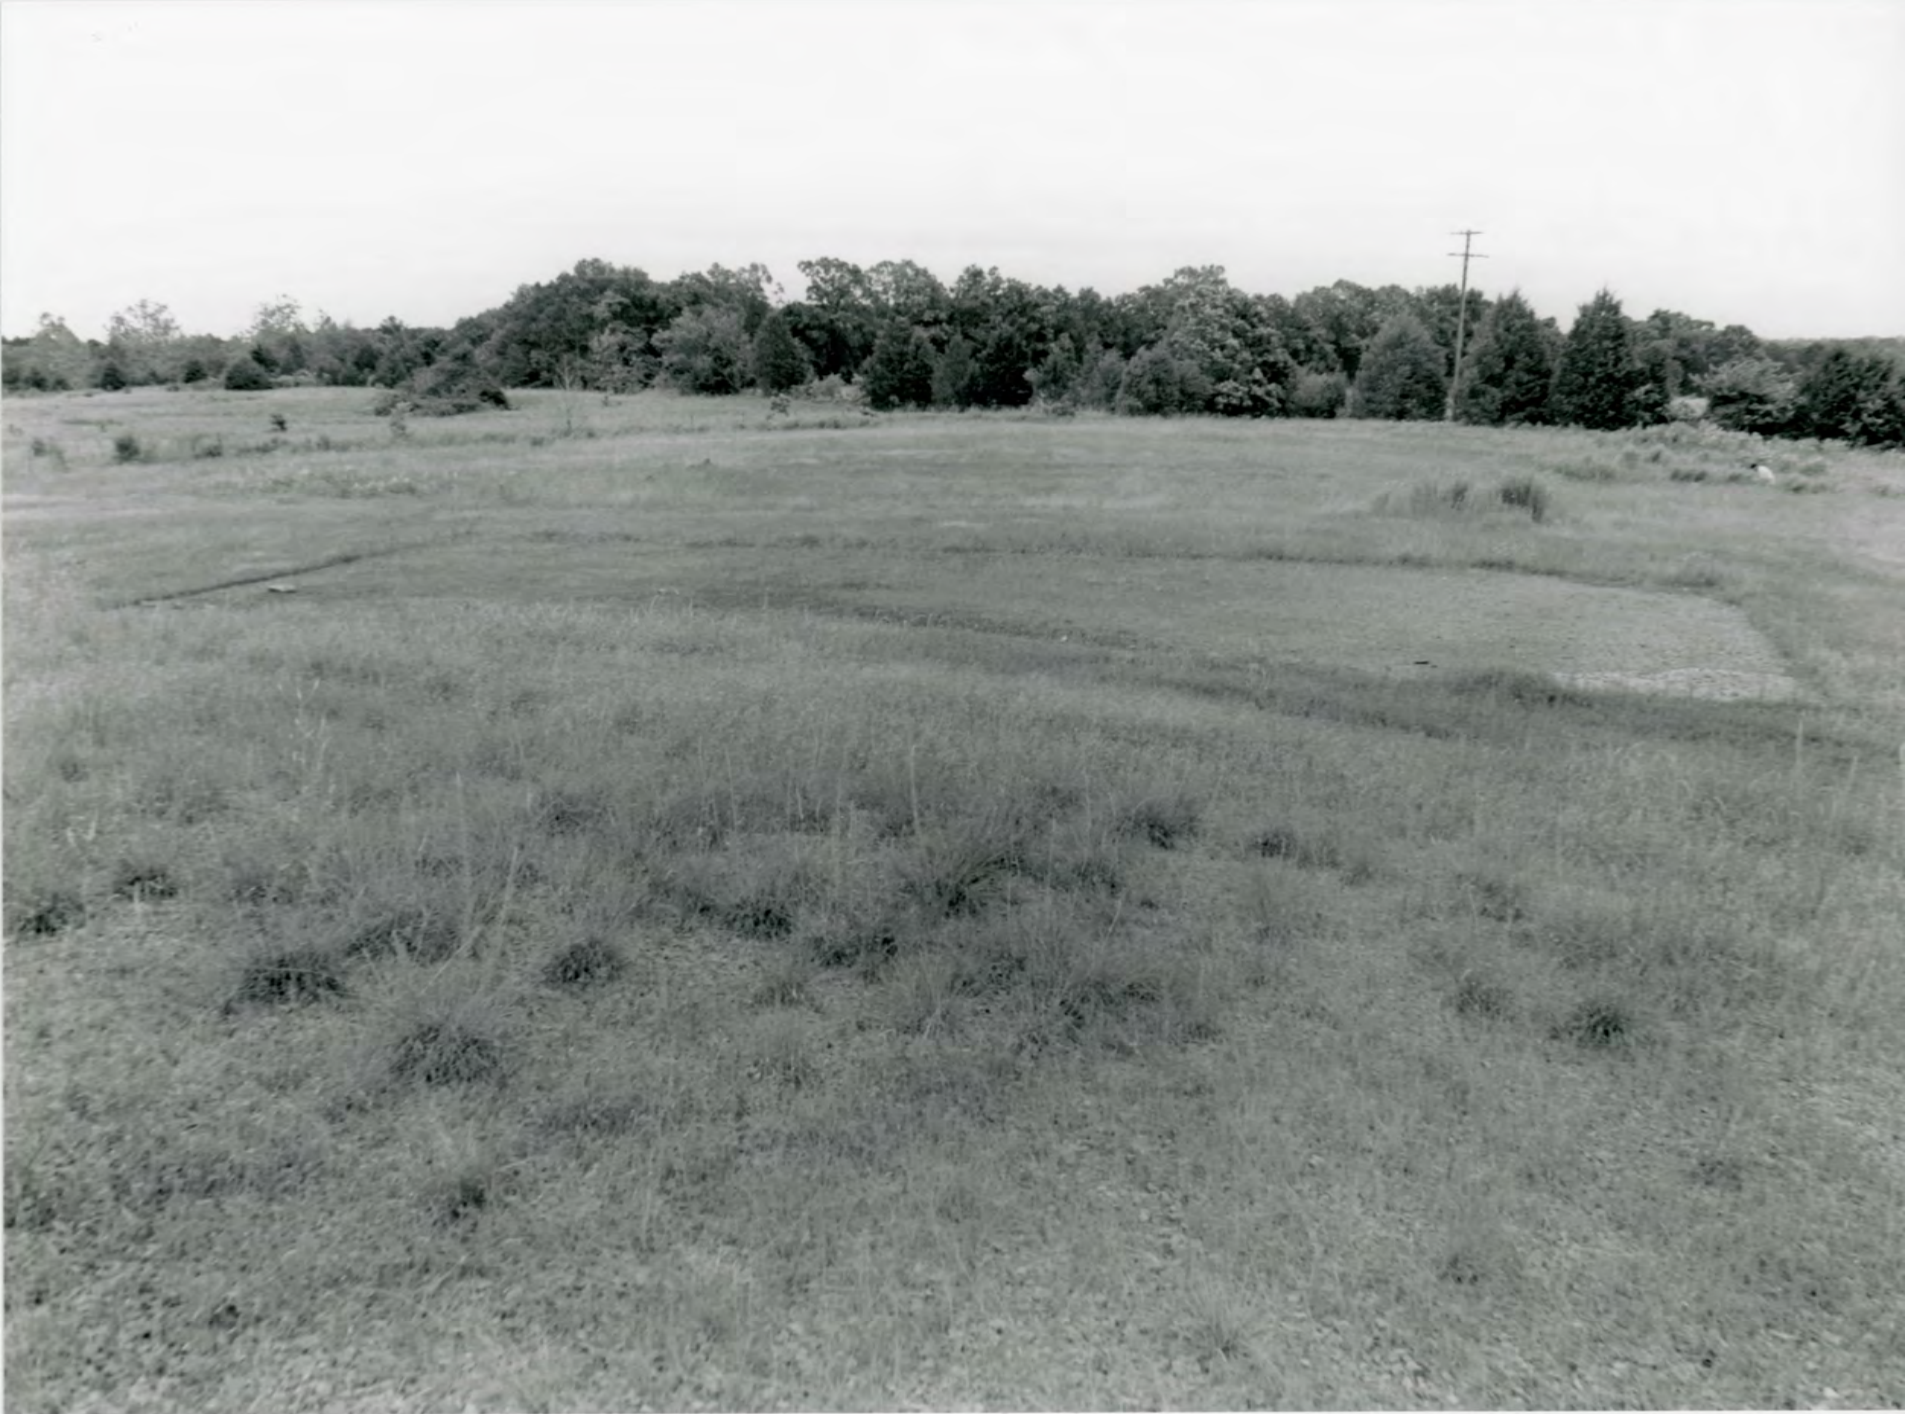
Titan II Launch Complex 374-7 Site
Southside vic., Southside vic., Van Buren Co, AR
Photo by Ken Grunewald
June 1998
Negative on file at AHPP
Oxidizer hardstand, view from north

- 2) Hardened concrete pads to the northwest and southeast of the silo mound that would have served, respectively, as fuel- and oxidizer-servicing trailer stations.

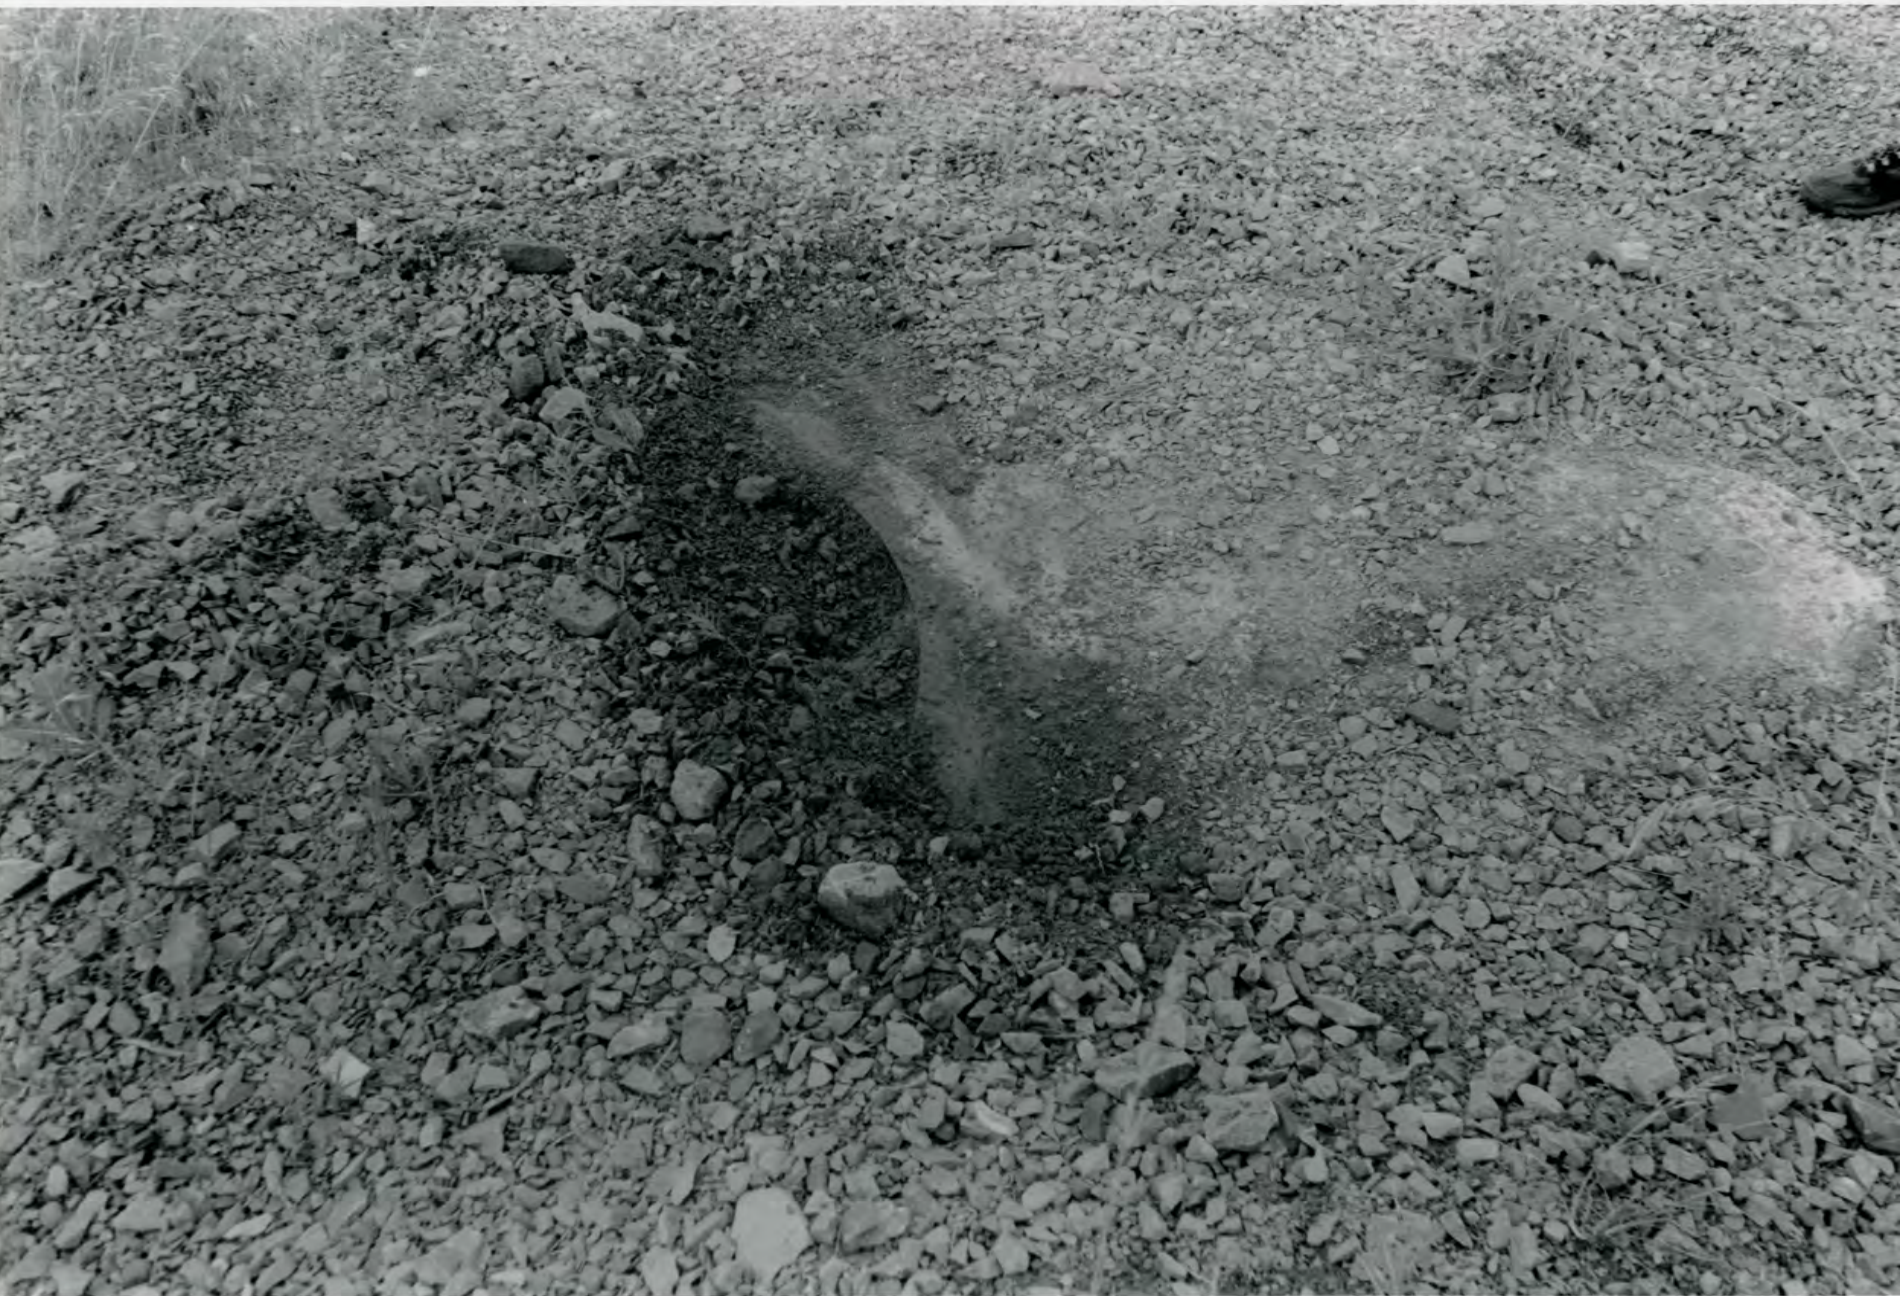
Air intake vent for control center, detail

- 5) A concrete pad due west of that mound that served as the control center's air intake shaft.
- 6) A square concrete structure north of the air intake shaft that served as the base for a fixed, aboveground communications antenna.

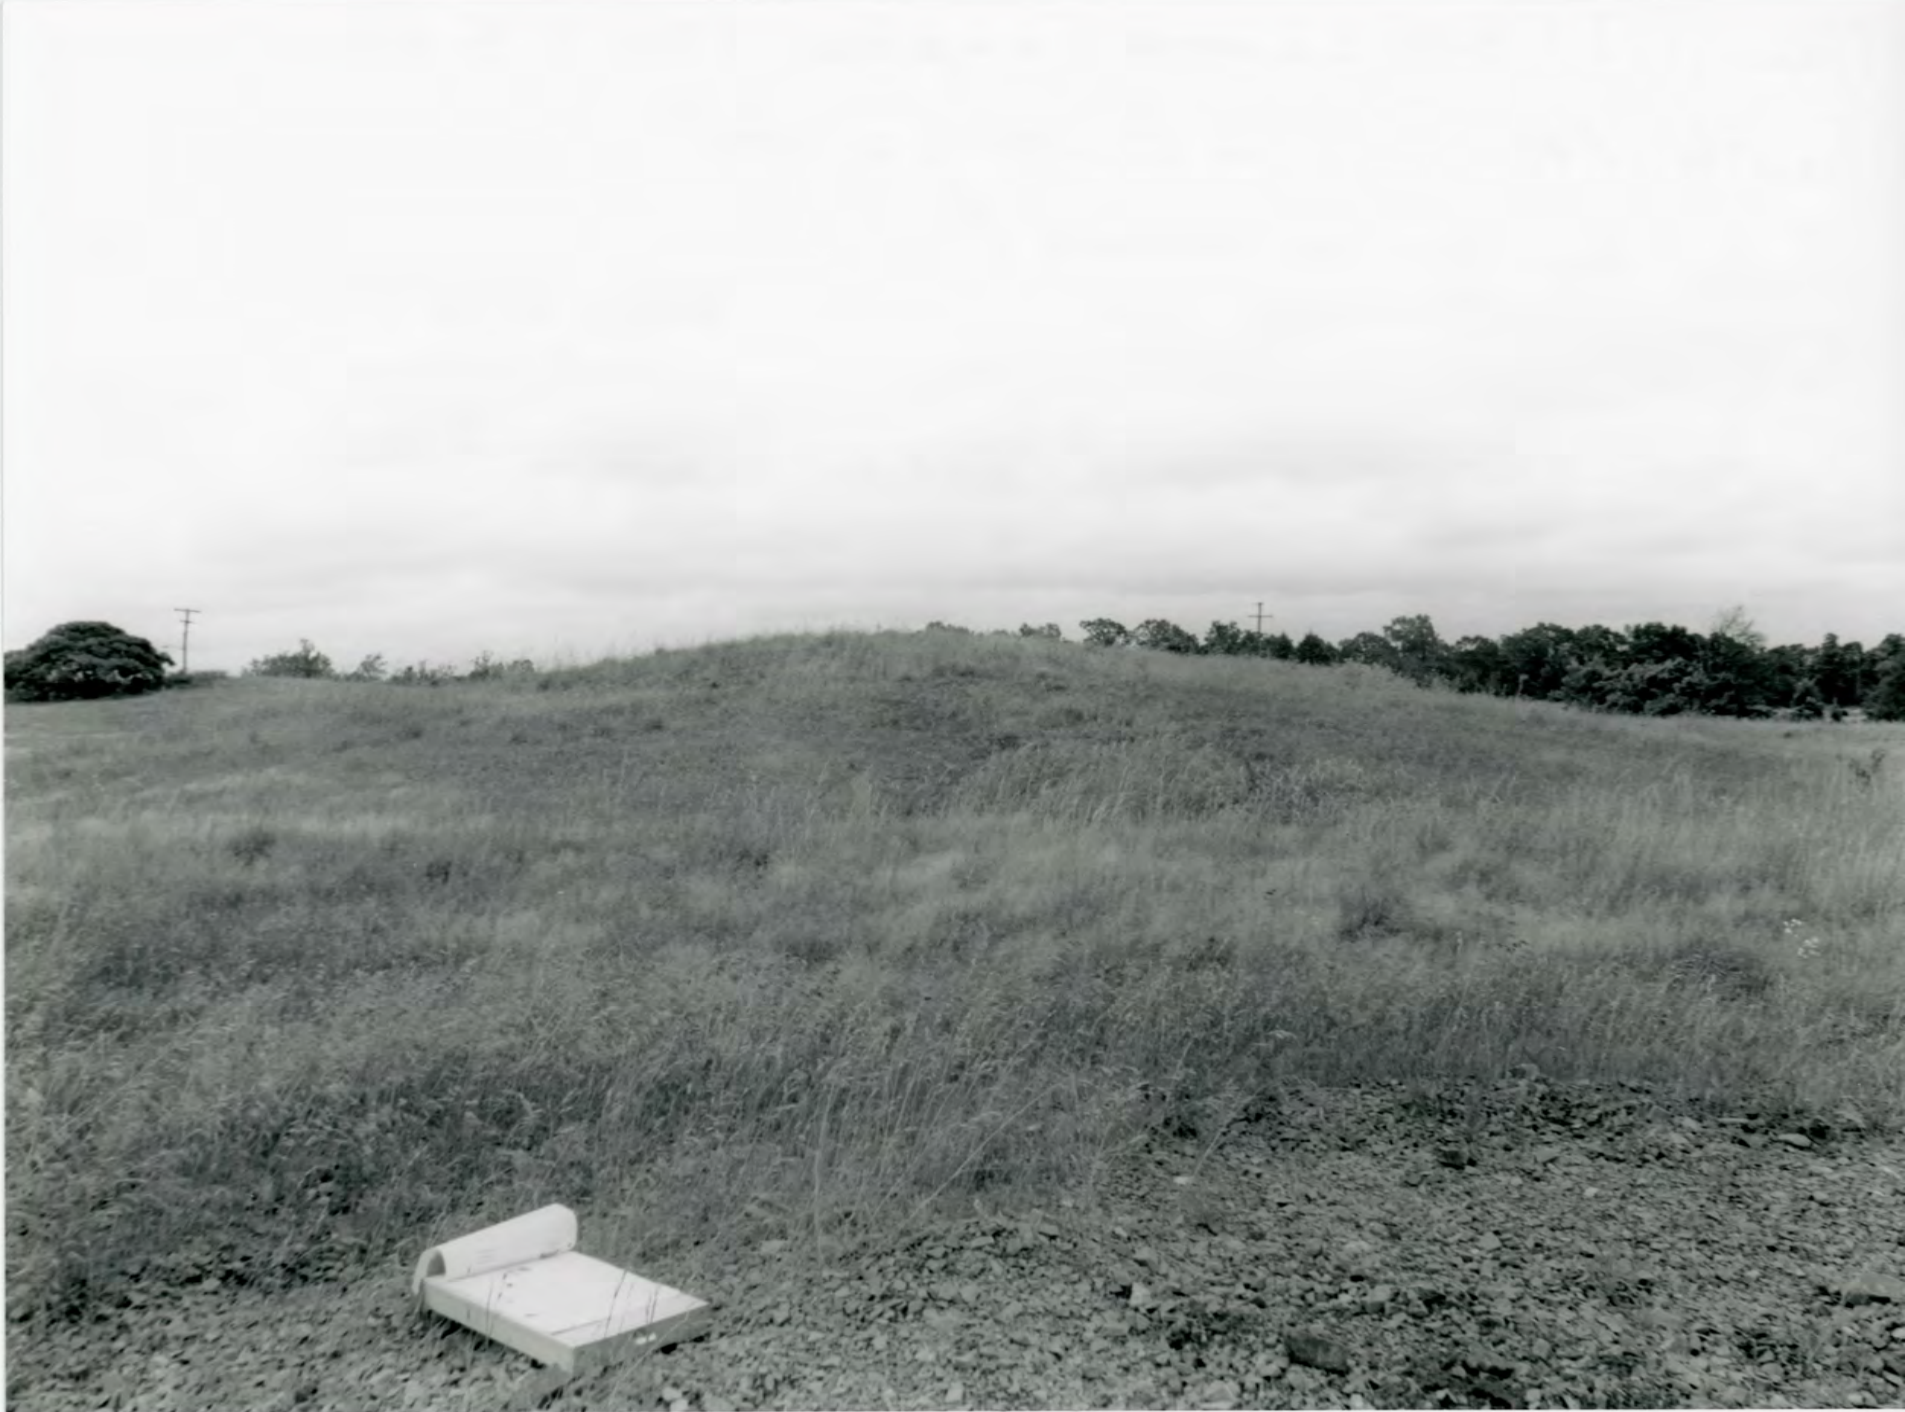
Control center mound, view from west

- 3) A pair of concrete communications antenna pads due east of the silo mound.
- 4) A smaller earthen mound southwest of the silo mound that shows the site of the complex control center/access portal.

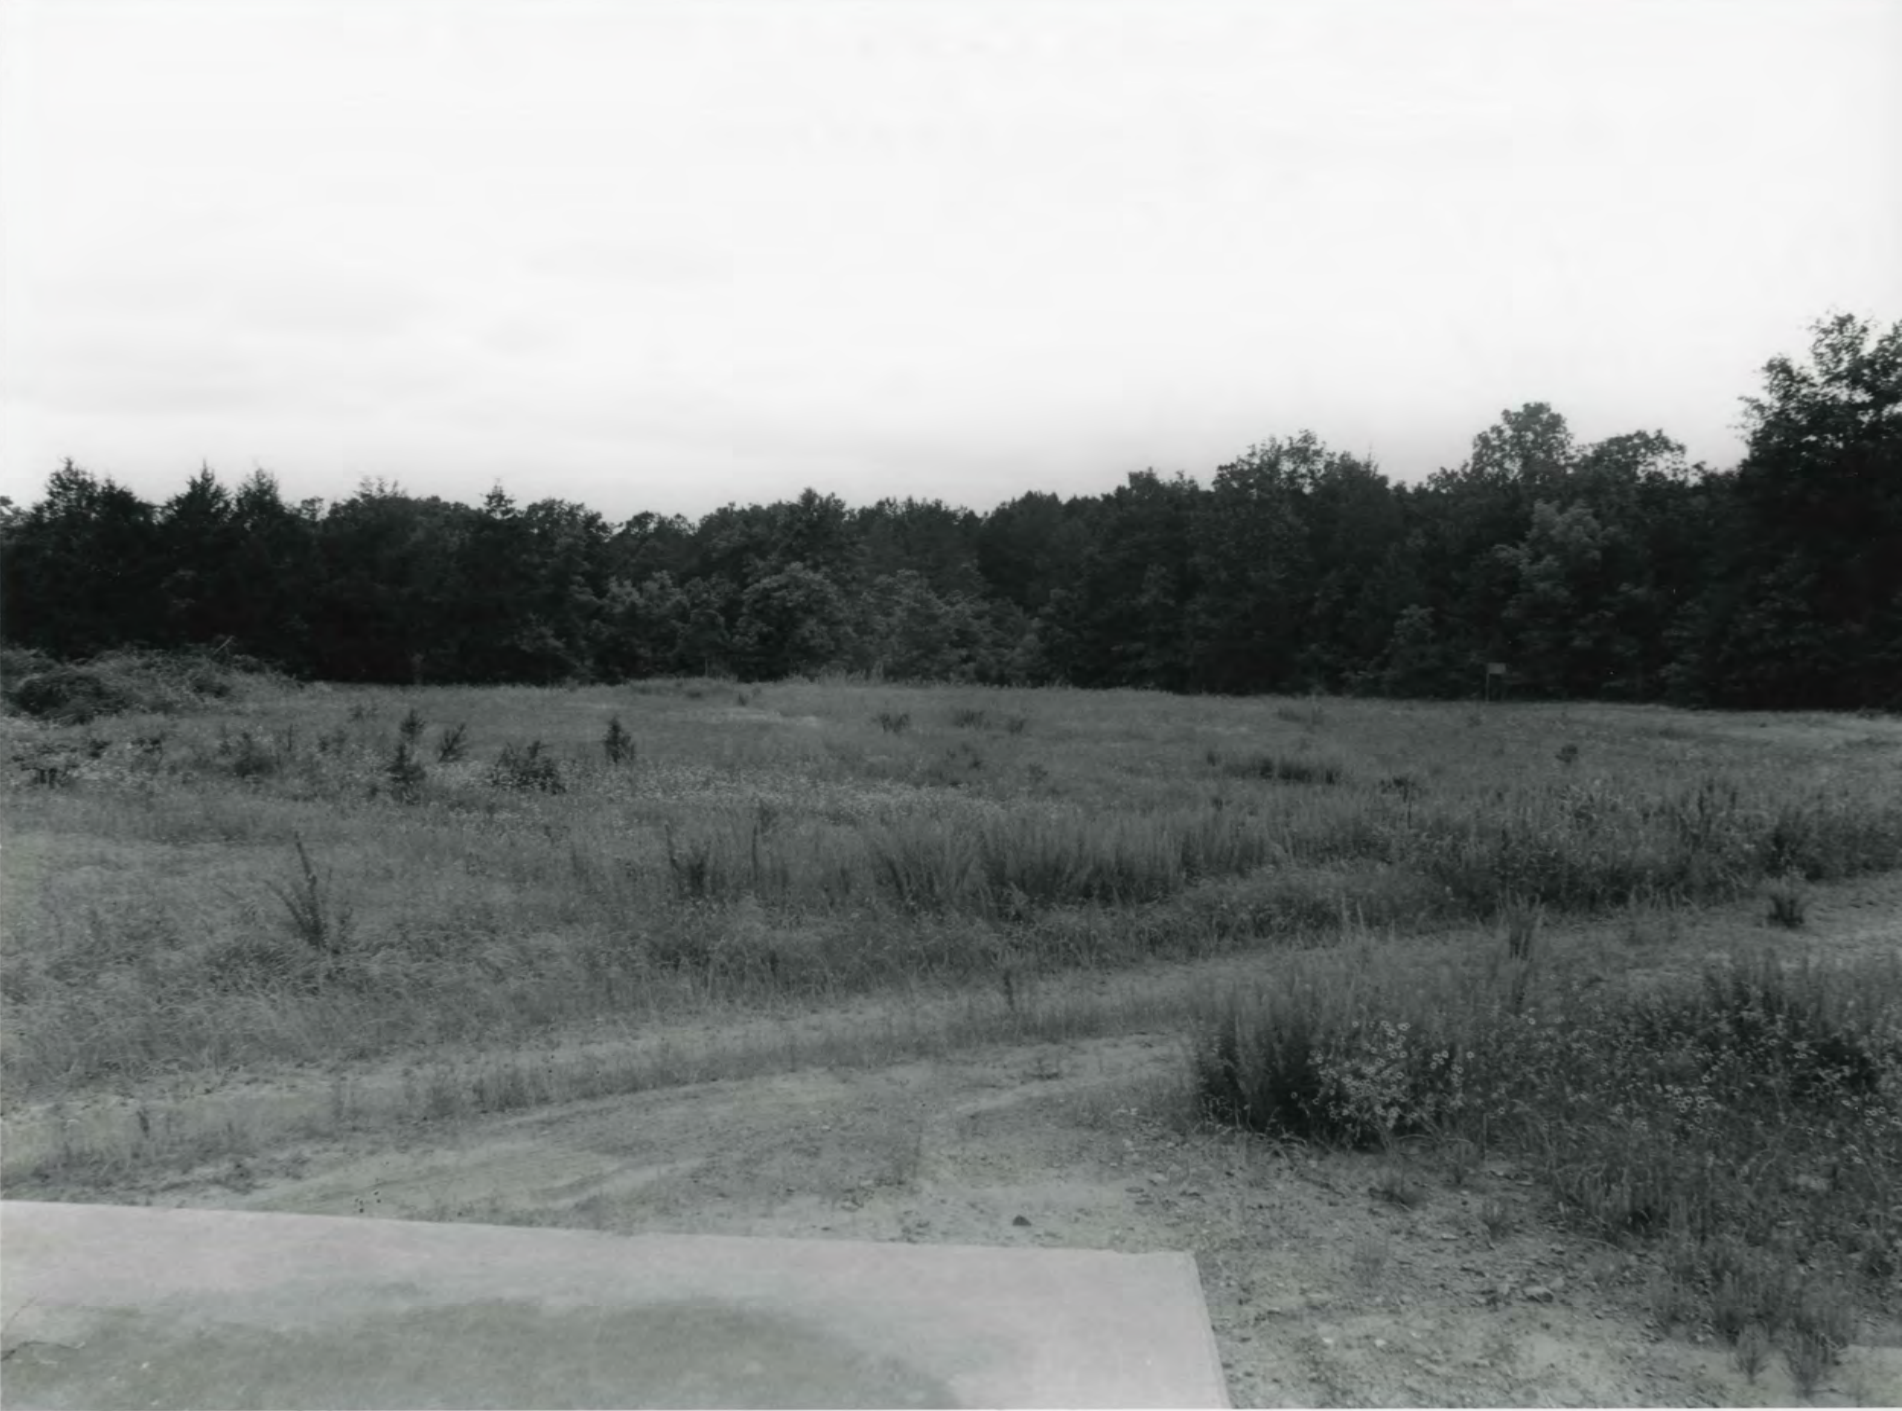
June 1998
Negative on file at AHP
HF antenna site, view from South

- 8) A square concrete pad north of the above that served as the base for a fixed, aboveground communications antenna.
- 9) A large, rectangular depression lying to the west of site features 6 and 8 that remains fenced and marked with government warning signs; this was the site of the complex's above-ground UHF antenna.

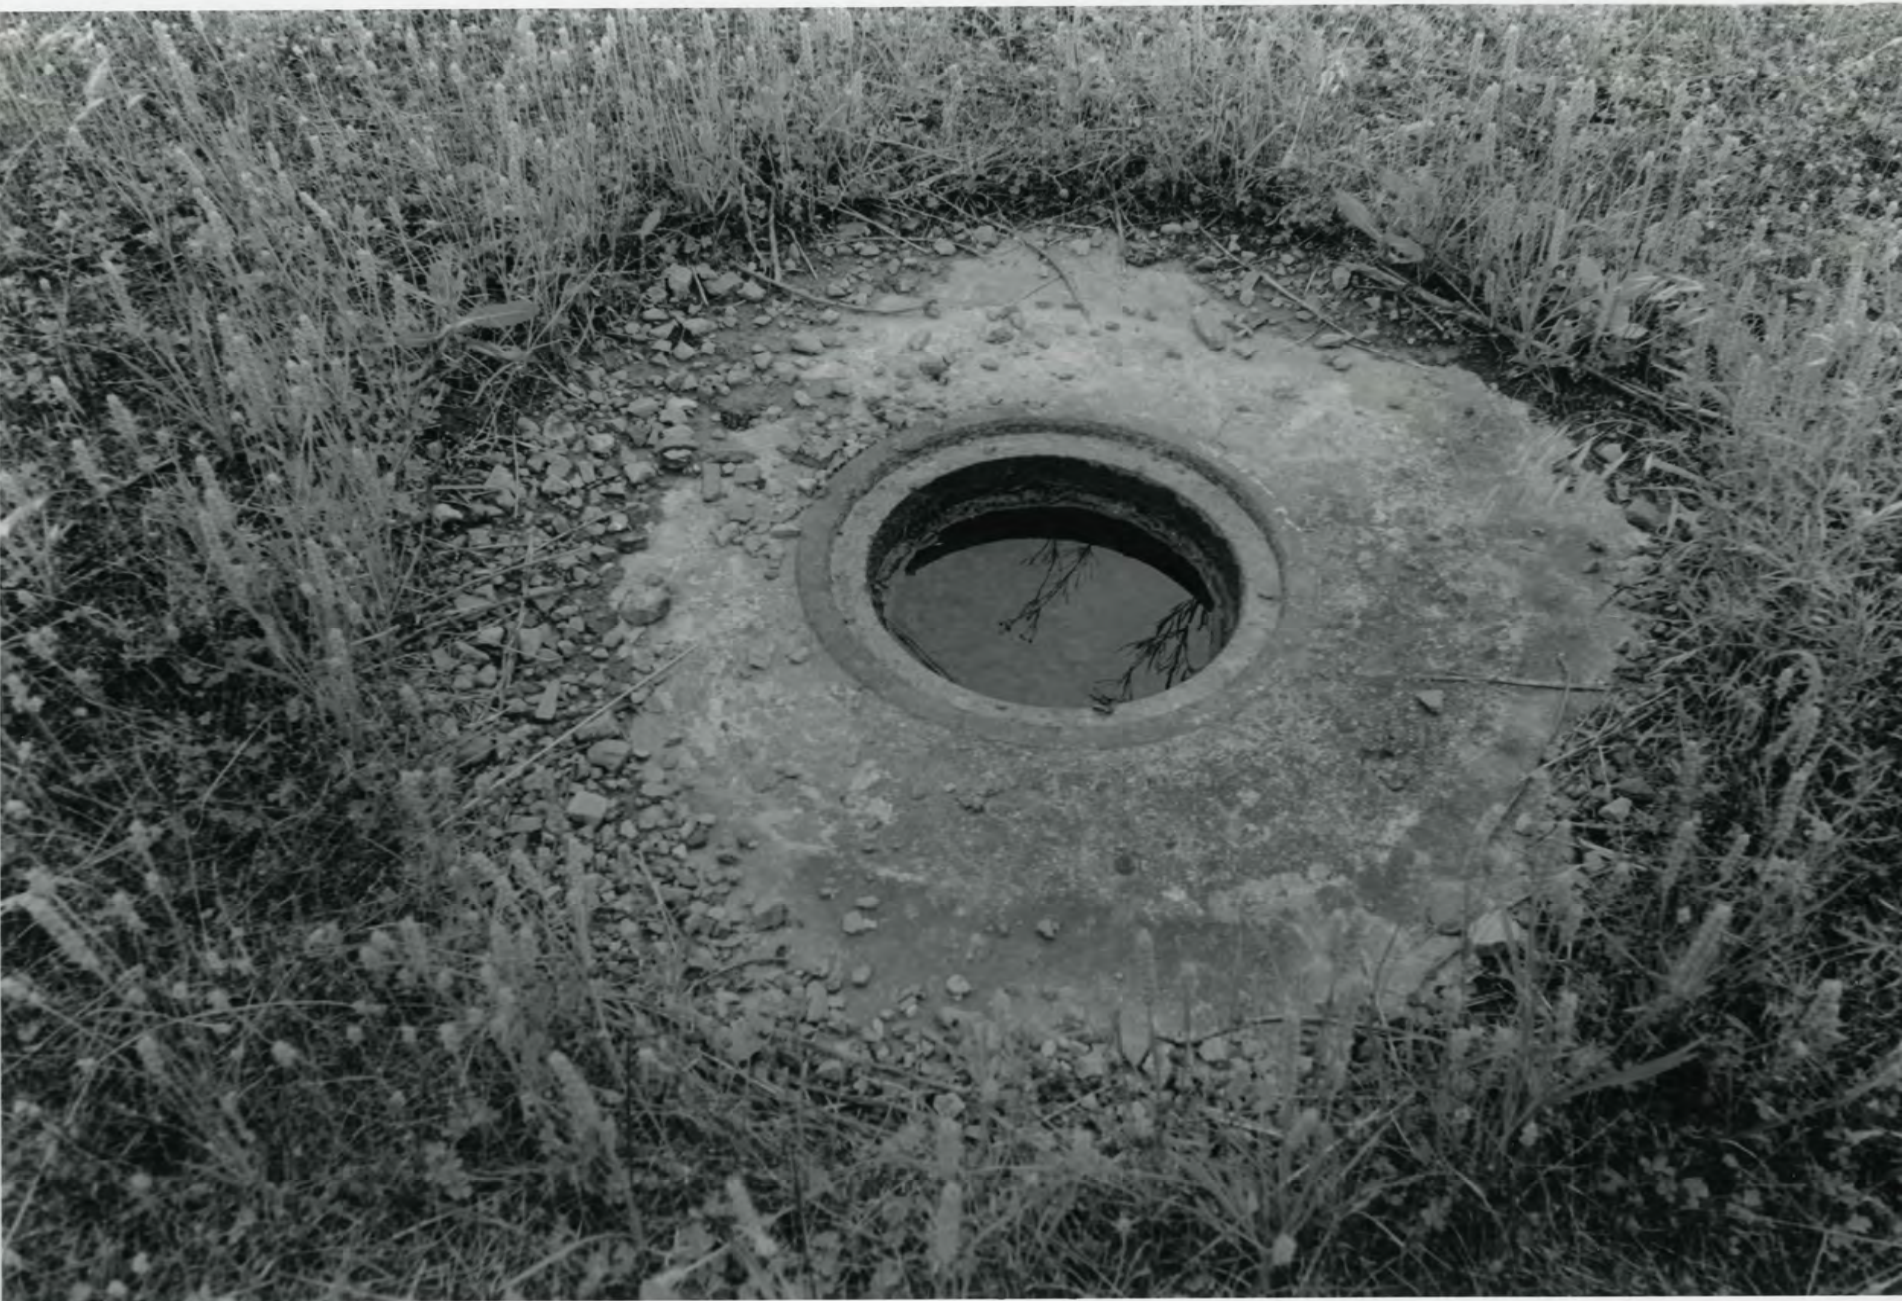
Hard antenna stand detail

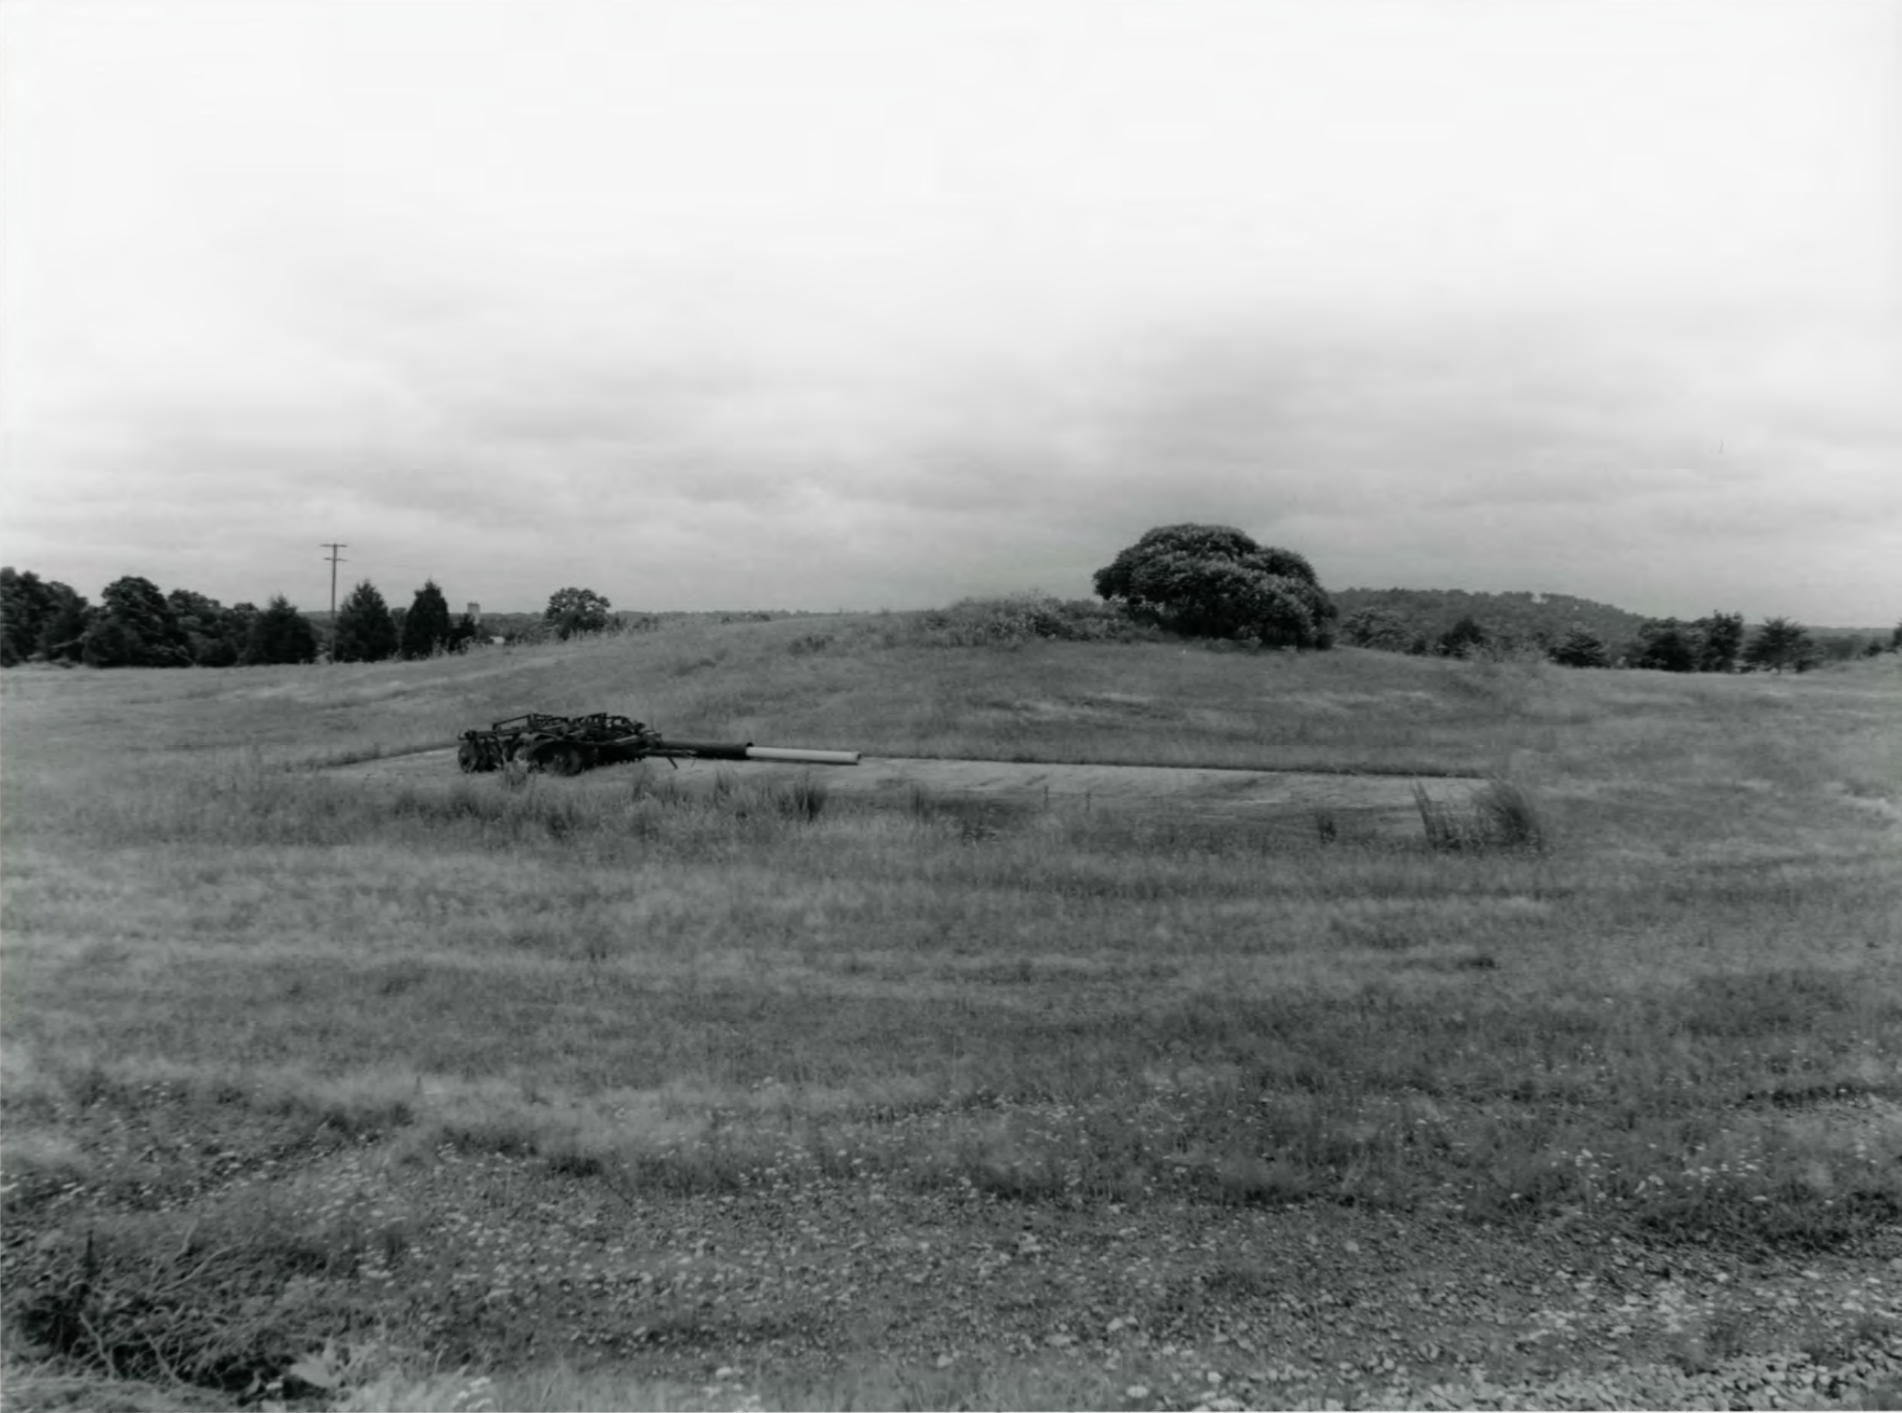
Fuel hand stand with launch duct mound behind it,
view from north
