Titan II ICBM Launch Complex 374-7 Site
Name of Property

Van Buren County, Arkansas
County and State

**NATIONAL REGISTER OF HISTORIC PLACES
REGISTRATION FORM**

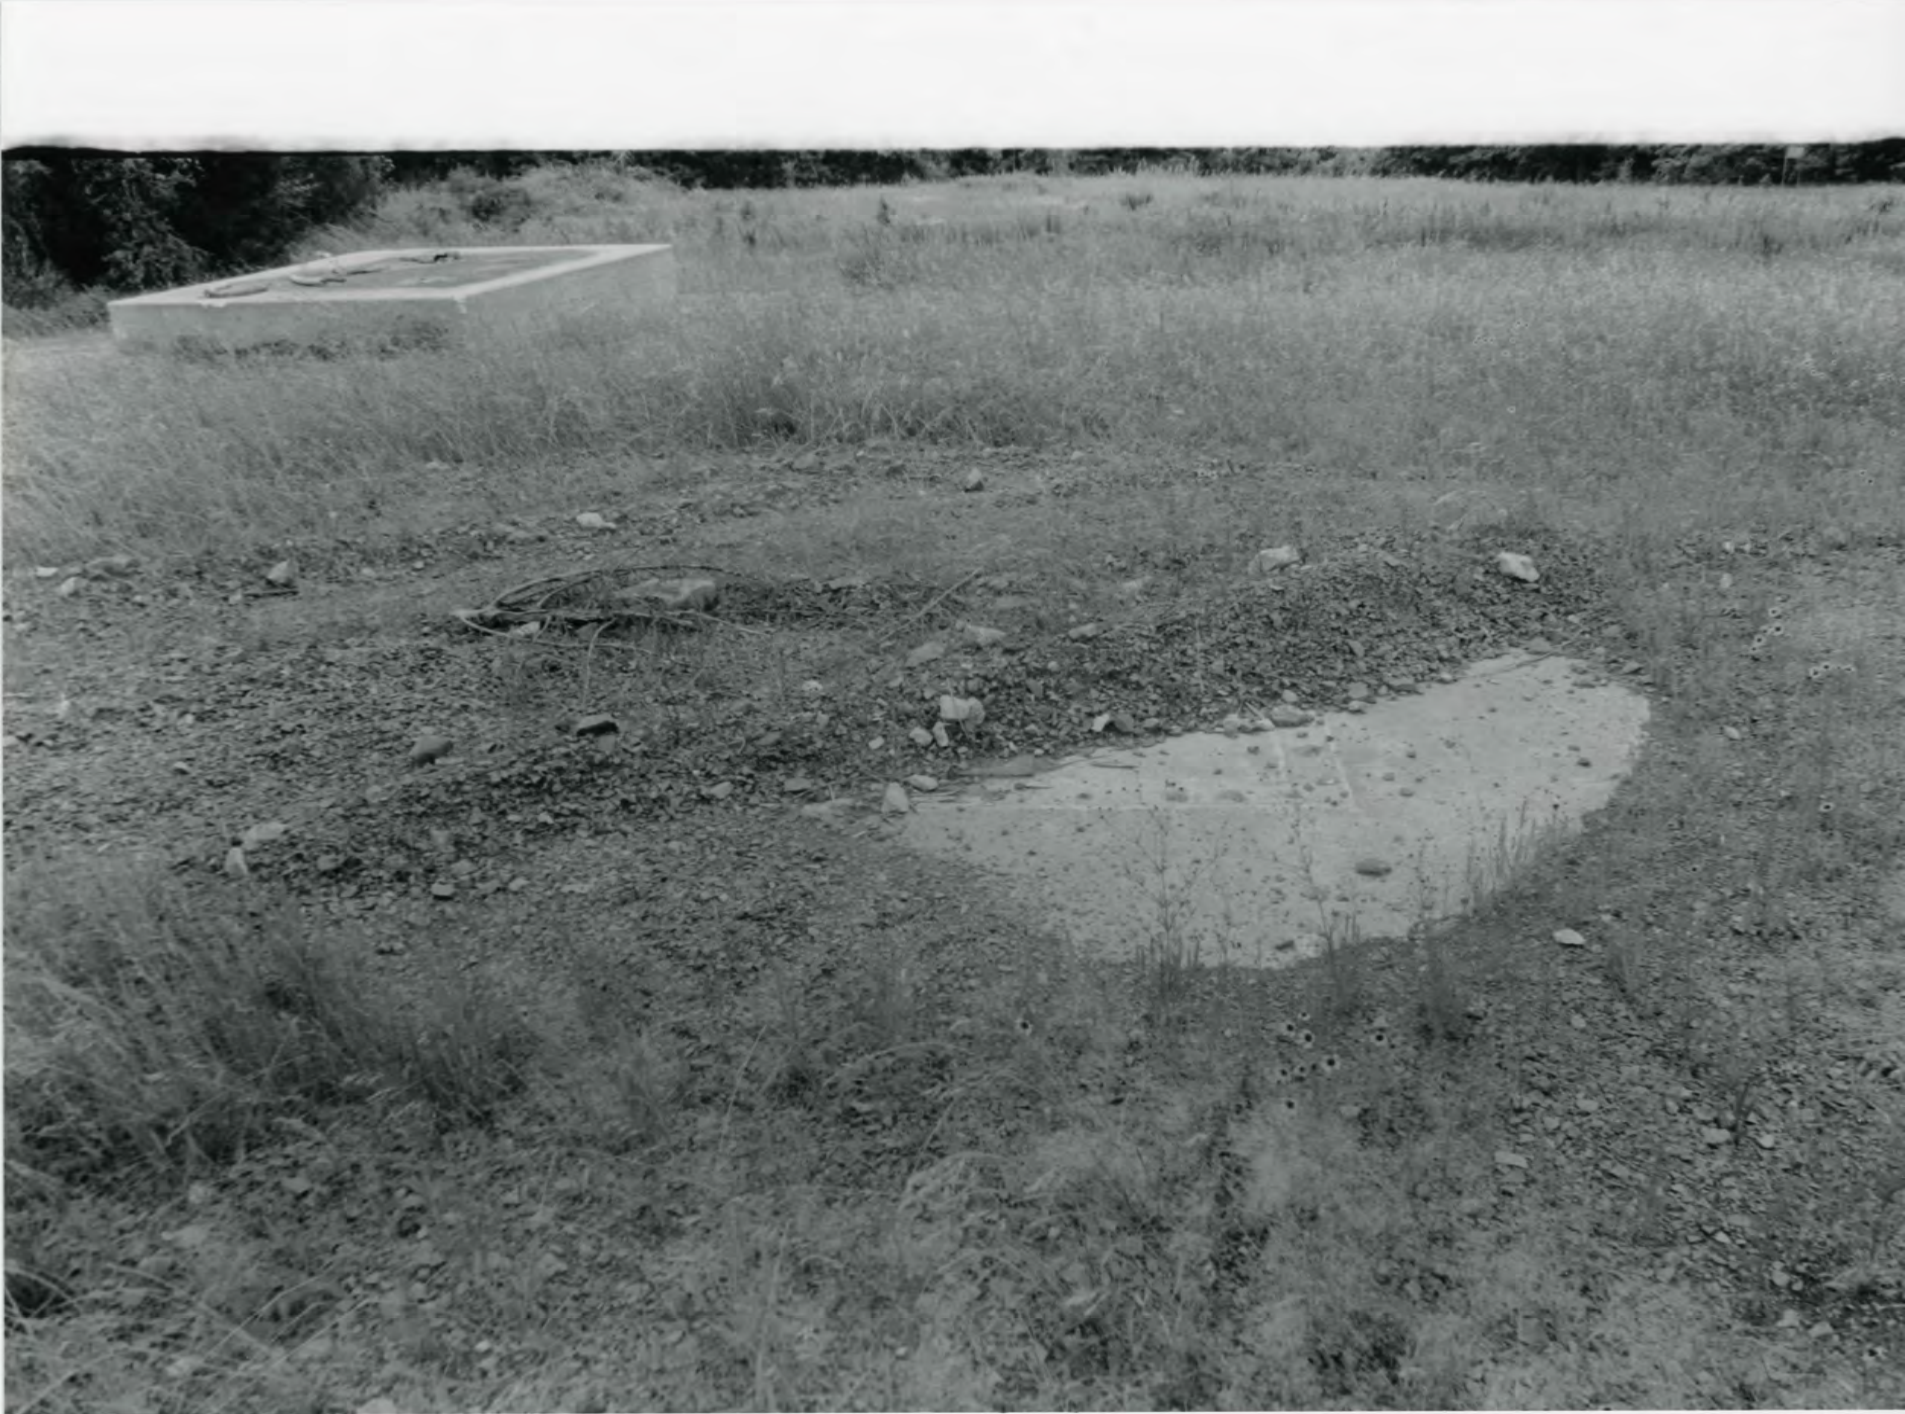
Hard antenna stand in foreground, soft antenna stand
beyond it, view from east

- 7) A pair of circular, hardened concrete pads east of the above-mentioned antenna pads that served as the bases for belowground, extendable communications antennas.
