Entrance Road  
Report to Howard W. Baker  
from Resident Landscape Architect S. Serrano  
ECW/CCC Activities -  
Oct. 1, 1935 to Oct. 1, 1936

Report to Howard W. Baker,  
District Landscape Architect  
on Devils Tower National Monument  
ECW 6th and 7th Period Activities  
by S. Serrano (1936)

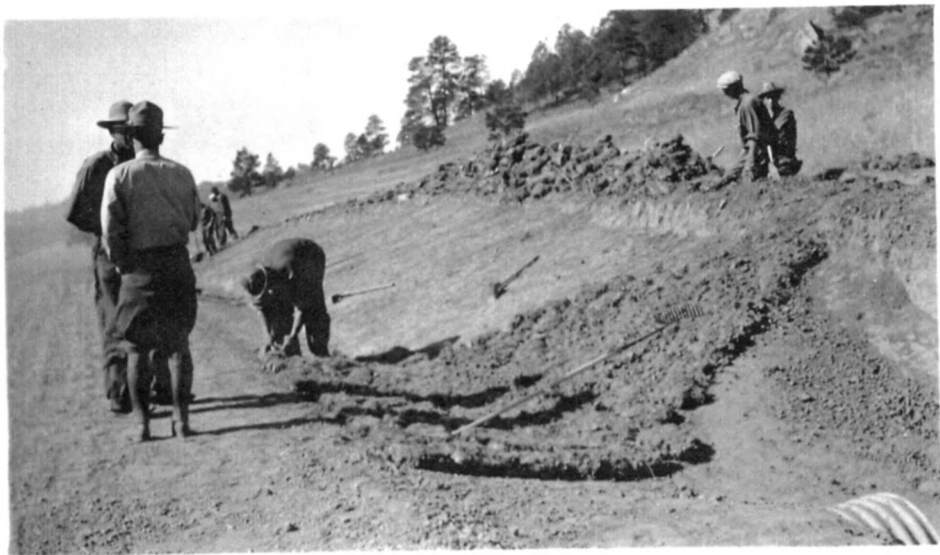
"Resodding ditch line and cut slope after flattening and rounding along entrance highway."

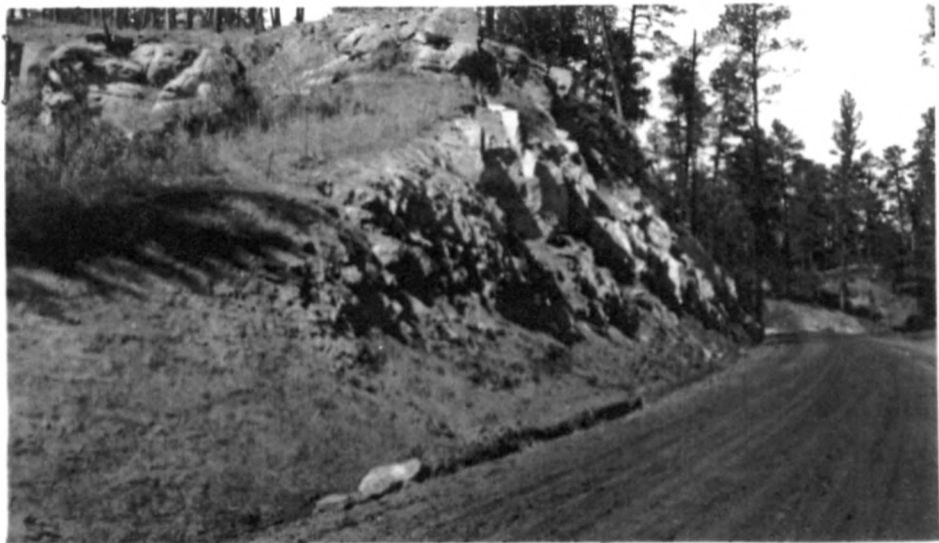
"Showing manner in which rock cut slopes left in rough state."

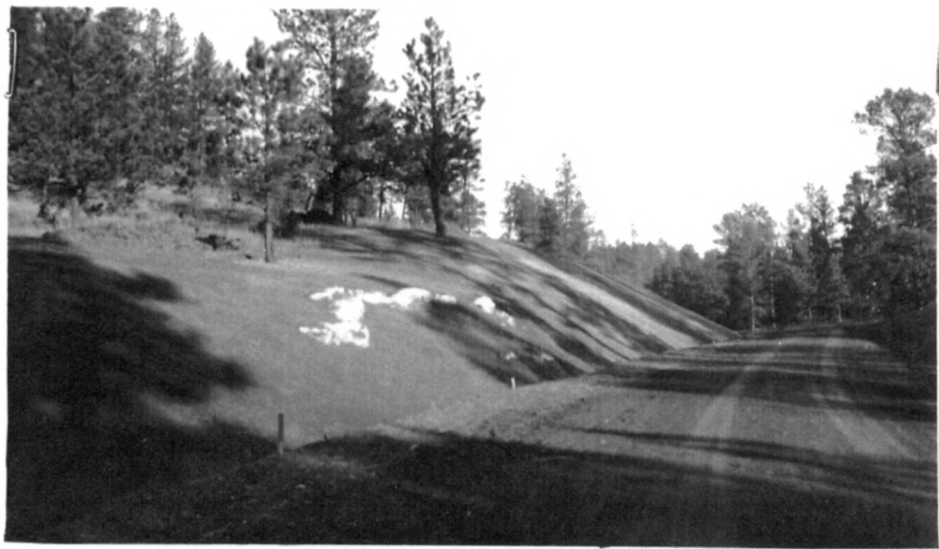
"Showing cut slope after flattening and rounding."

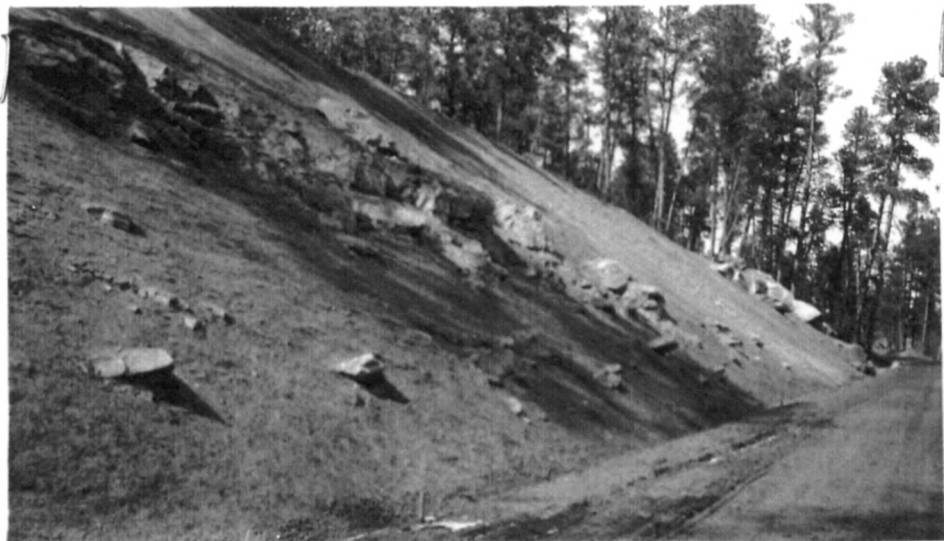
"Cut slope after flattening and rounding. Note all existing rocks strongly imbedded, not disturbed."

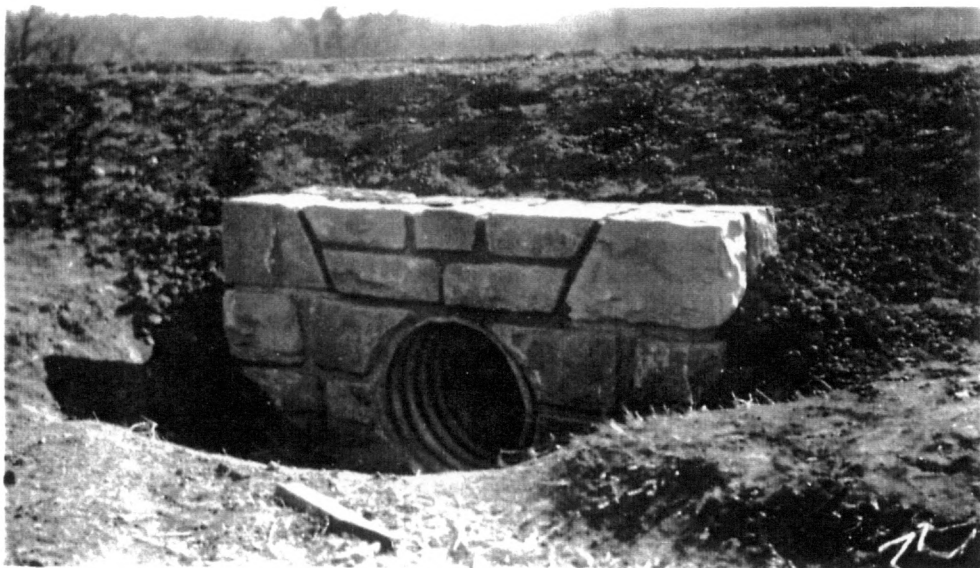
"Showing headwall typical of  
those constructed along entrance highway"
