NATIONAL REGISTER OF HISTORIC PLACES REGISTRATION FORM

historic name: **Olsson, Don E., House and Garage**
other name/site number: **Olsson-Rohr-Winchell House; 503 4th Avenue, SW**

street & number: **503 4th Avenue, SW** not for publication: n/a
city/town: **Ronan** vicinity: n/a
state: **Montana** code: **MT** county: **Lake** code: **047** zip code: **59864-2918**

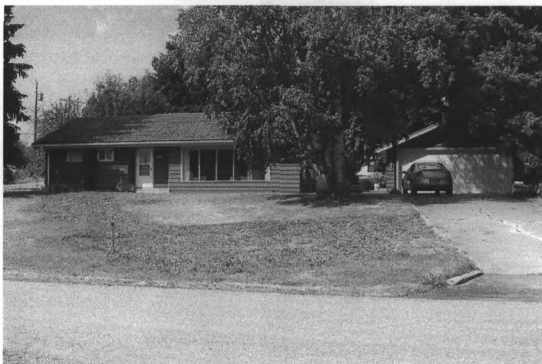
1. East façade house and garage looking west.

East (front) Elevation

The façade is characterized by an inset entrance stoop one step above the walkway. The south wall of the entrance is perpendicular to the walk and the north wall is diagonal to give full visual acknowledgement of the entrance from the driveway. Between the entrance feature and the northeast corner are five large vertical Thermo-pane windows within wooden mullions. The windows, which light the living room, extend from nearly floor level to the eave soffit. South of the entrance feature is a band of ribbon windows with two openings with fixed lights and one opening with sliding sash that typically replaced an awning style window. It is believed that the sliders were installed sometime after 1978. Typically, the windows openings have flat board trim with a one-by-one fillet on the outside edges. A drip cap is located above each. The sills are plain without aprons and receive the trim of the jambs.

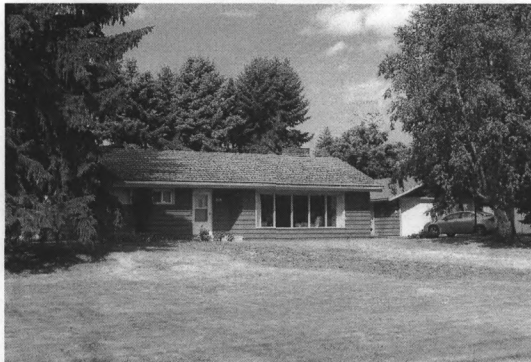
2. East façade of house and garage looking northwest.

Located approximately twelve feet from the house is the gabled roof, two-car garage designed to match the architecture of the house. A modern 32-panel overhead double garage door, extends partially into the east gable end. A doorway, with a solid core, flush panel door, is located near the east corner on the south elevation. There are no openings on the west gable end and the north elevation.

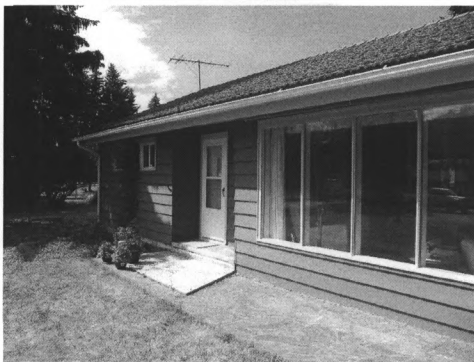
3. Detail of east façade of house looking southwest.

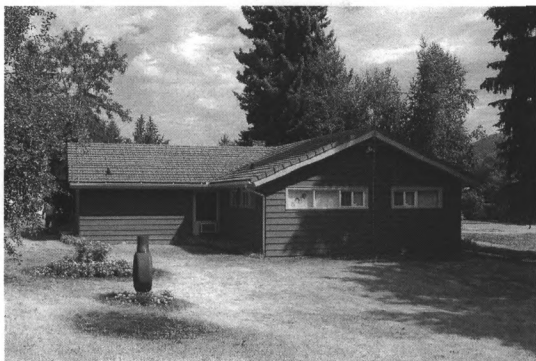
4. South elevation of house looking north.

The south elevation has two ribbon window openings of similar design. The eastern ribbon has two openings, one with fixed sash and one with sliding sash. The western ribbon has three openings with two fixed sash and one slider opening. The cedar siding extends into the gable end to a metal louver set into the apex.

At the south elevation of the rear wing, there is one large opening set into the cedar siding near the west wall. This window, which lights the dining room and was installed in 1954, has a large fixed sash in the upper section and a narrow bottom section presently infilled with an air conditioner. Originally, the bottom opening had an awning style sash.

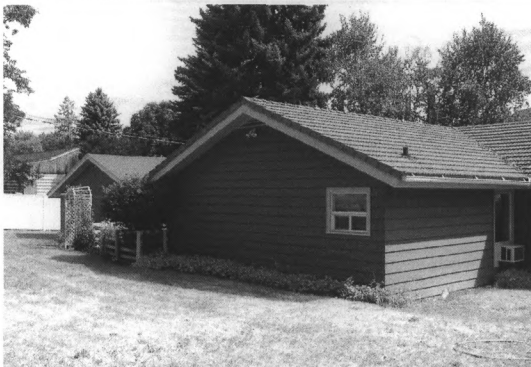
5. West wing looking northeast.

The eaves of the south elevation of the wing merge into the eaves of the west elevation of the original house that has two sets of ribbon style windows set into the siding. The south has two openings, one with fixed sash and one with sliding sash. The other is a sliding sash lighting the original bathroom.

At the west gable end of the wing, there is a single opening near the south corner that lights the master bathroom. It has a fixed upper light and a sliding sash in the lower light that replaced an awning style window. Similar to the south gable, the cedar siding extends to a louvered vent set into the apex.

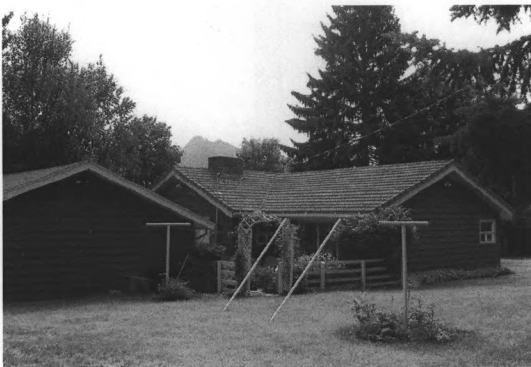
6. West elevation of garage, and west and north elevations of house looking southeast

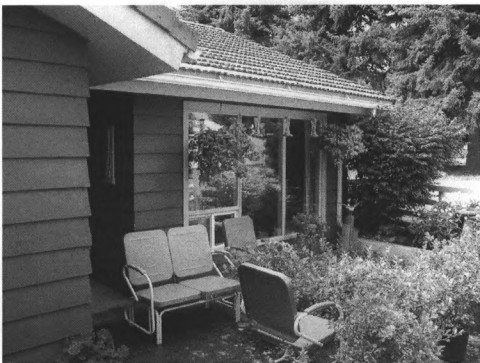
7. North elevation of west wing looking southwest.

The north elevation of the wing has three large vertical Thermo-pane windows that extend from nearly floor level to the soffits of the eave and light the master bedroom. The eastern window has a slider set into a lower opening that replaced an awning style window. Set back into a reveal is a doorway providing access directly to the dining room; a modern glazed door is in the opening.

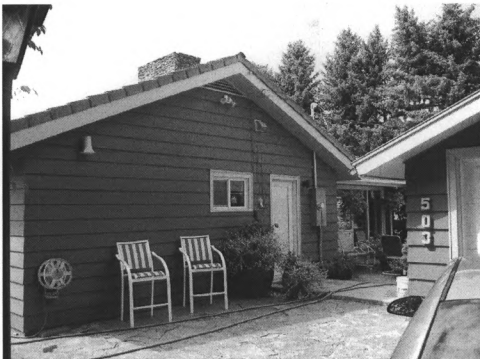
8. North elevation of house and west wing looking southeast.

At the north gable end elevation of the original house, there is a doorway near the west corner with a modern glazed door. Adjacent to it is a sliding window lighting the basement stairway. Like the opposite south gable end, the cedar siding extends to a metal louver set into the apex.

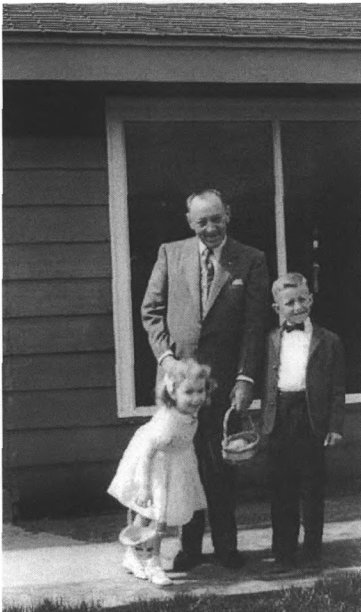
11. Close up of front of house (1954) looking west.

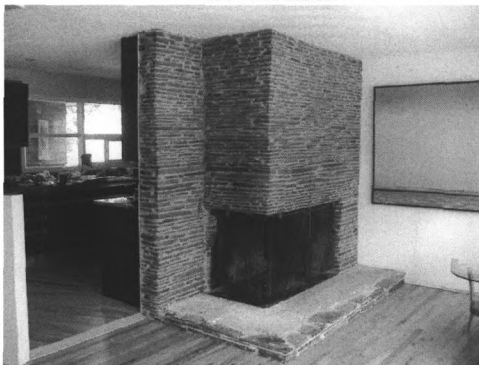
12. Living room fireplace looking northwest.

The Olsson House originally was built as a two-bedroom, one-bath residence with an open living room, kitchen, and small dining area. Original owner Don E. Olsson reported that there also was a small office near the bathroom in what is now the dining room. Below the original house is a basement containing a recreation room and laundry, furnace and storage rooms. The wing addition, that included enlarging the dining room by nearly one-third and adding a master bedroom suite with a three-quarter master bathroom, was built on a concrete slab. As a custom built house there are built-in wardrobes flanking drawers in each of the two original south bedrooms. Of similar construction is a built-in buffet in the south wall of the dining room that has cupboards surrounding open shelves. Opening from the dining room is the master bedroom suite. Separating the living room, which opens to the entrance vestibule and coat closet, from the dining room is an offset right-angled half partition set with four-by-four columns extending to the ceiling. The most distinctive feature of the house is the living room fireplace set into the northwest corner of the room. Constructed of carefully laid ledge stone in random horizontal courses, it has a shallow raised hearth and the firebox is open on two sides, which face into the room. The chimney stack extends from the hearth to the ceiling as a solid mass above and to the north of the firebox and is anchored with a ledge stone wing wall that extends south from the hearth to the ceiling.

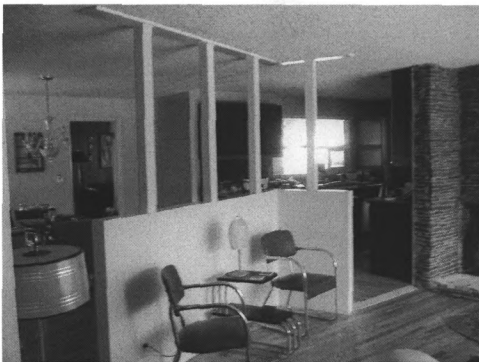
13. Partition between living room and dining room looking northwest.

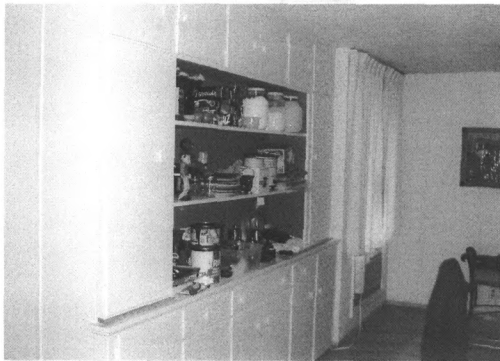
14. Close up of built-in cabinets and shelving looking southwest.

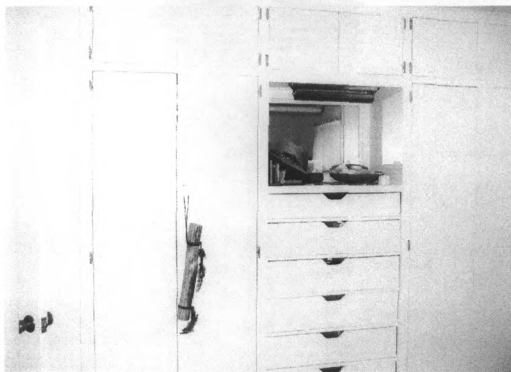
16. Close up of built-in cabinets and shelving in southeast bedroom looking north.

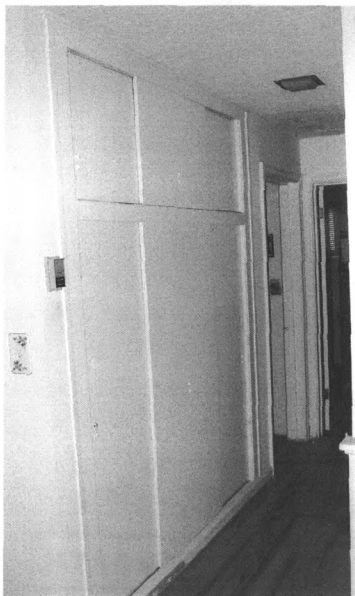
17. Close up of built-in cabinets and shelving in hallway, taken from living room looking south.
