National Register of Historic Places Registration Form

historic name Capilla de San Isidro

other names/site number Chapel of St. Isadore, 5CT.195

Culebra River Villages of Costilla County, Colorado
MPS

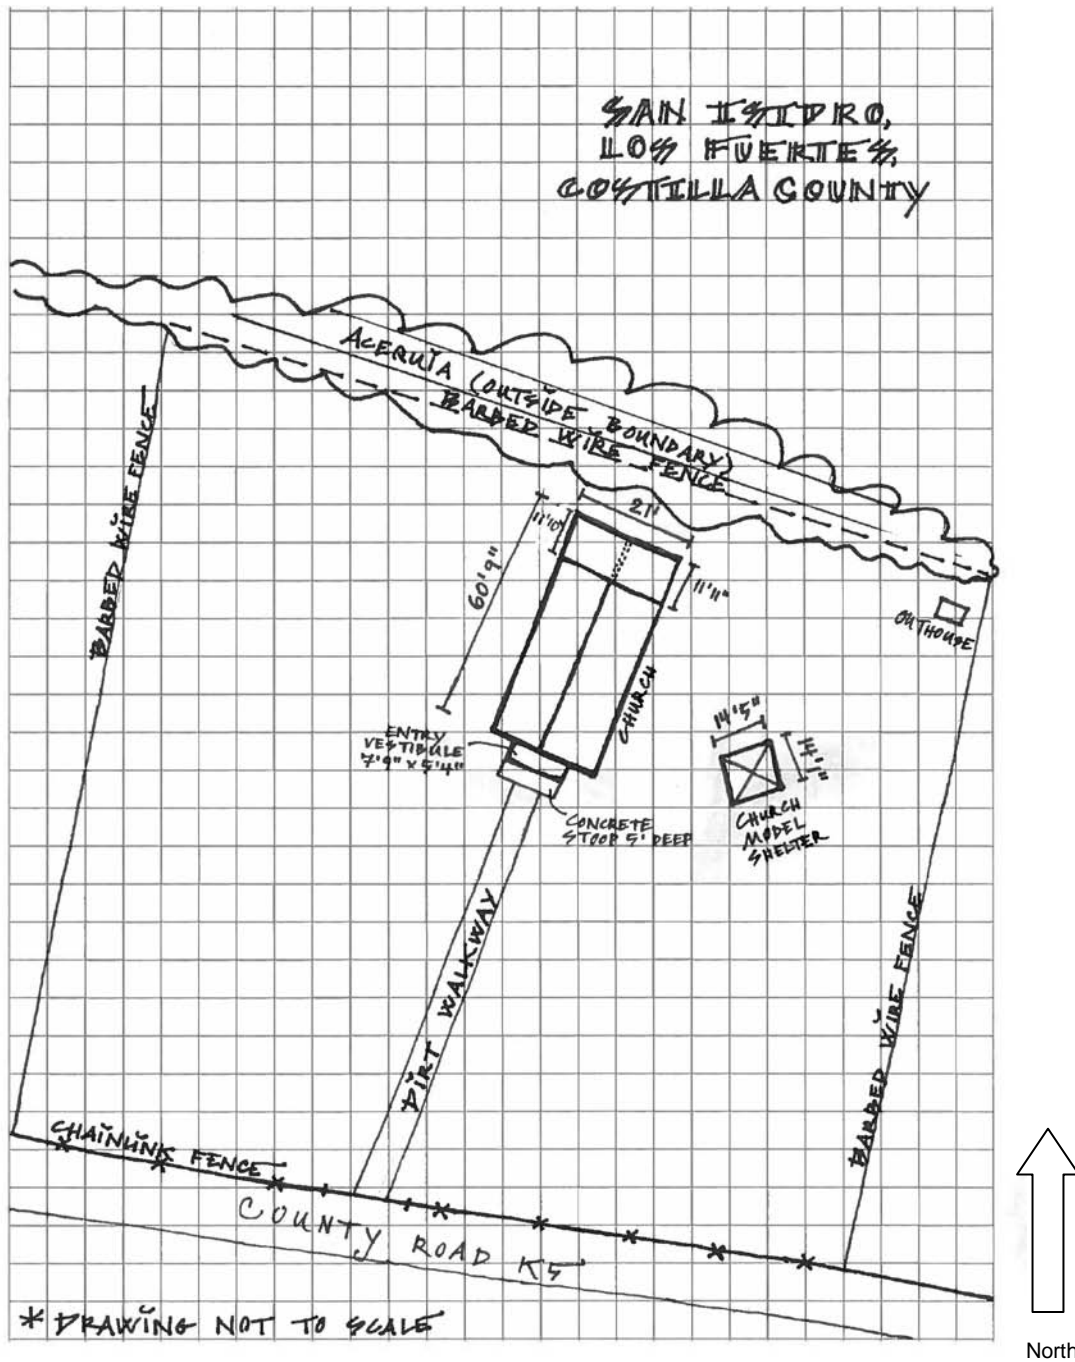
Sketch Map

The one-acre property is bounded by Road K5 on the south, pasture and the community *acequia* on the north, and a rural residence with pasture on the west. The circa-1894 church is a modest 1000 square-foot, one-story rectangular Territorial Adobe building with a front gable cedar shingle roof and a wood belfry above the entry vestibule. The churchyard is a large open lot with no plantings, but outside the property boundary mature trees line the *acequia* to the north across the fence. A WPA-era outhouse is located at the rear (northeast) corner of the property. A wide dirt walkway leads from the roadway on the south to the church. To the northeast, an open shelter houses the model church used in Holy Week observances. The Capilla de San Isidro is located at the eastern extremity of the linear village of Los Fuertes in the San Luis Valley.

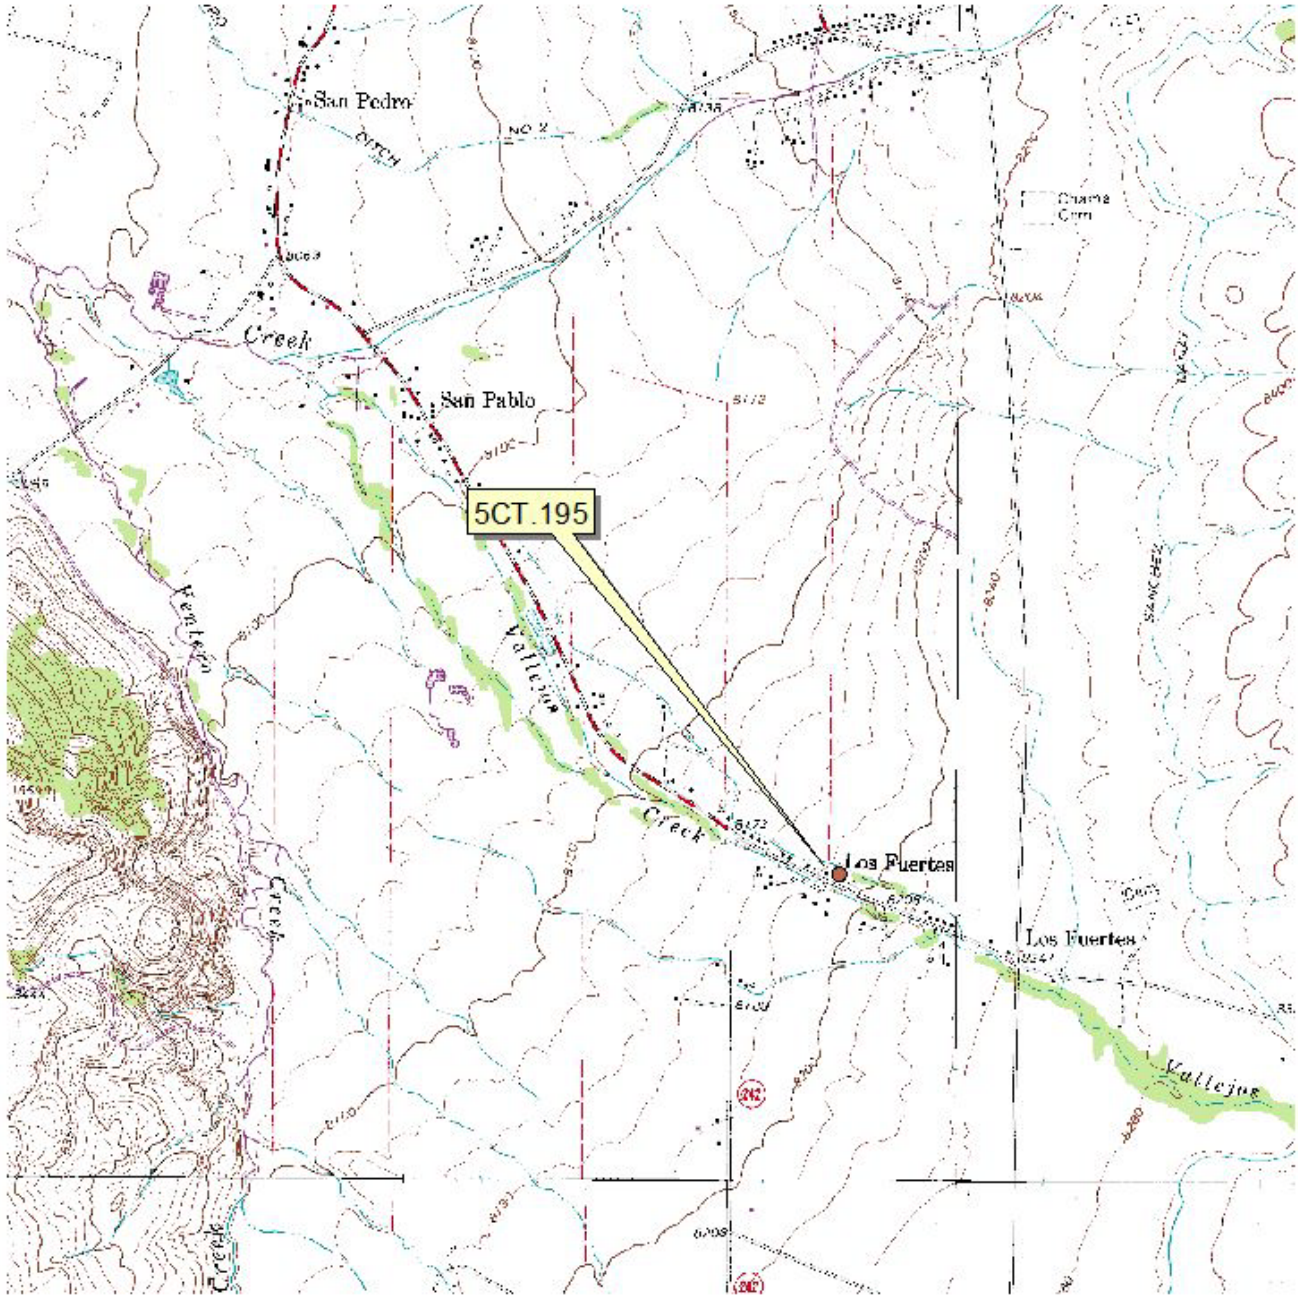
USGS TOPOGRAPHIC MAP, 7.5 Minute Series, San Luis Quadrangle
T 2N, R71W, NW ¼, Section 17
UTM 13; 466225mE; 4109892mN
Elevation 8190'

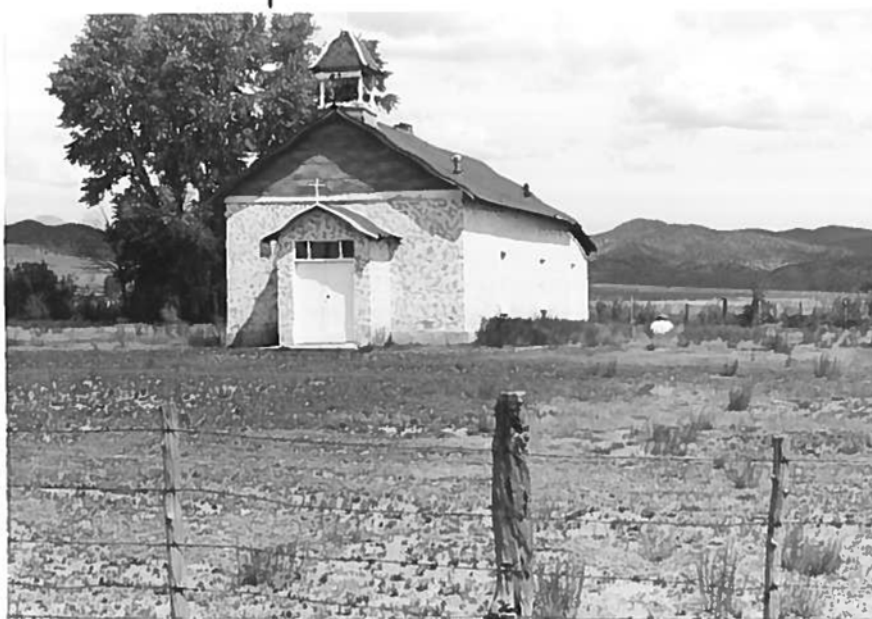
H001. Exterior View Church.

A July 1977 survey completed under the auspices of the United States Department of Housing and Urban Development (HUD) indicated that San Isidro was little altered since the 1930s with the exception of minor alterations around the door and the use of asphalt shingle in the gable front.⁴ Valdez and Associates' 1991 survey of the area indicated that: "In the 1930's many of the churches underwent alterations which were typical to the maintenance practices of the times, namely, concrete aprons at the wall bases, addition of buttresses at corners and wood shingles at the gables and roof."⁵
