MONTANA

HISTORICAL AND ARCHITECTURAL

INVENTORY

Roll#12 Frame# 21 Historic Name: John Lagerquist home Common Name: Lagerquist home Date of Construction:1907 X estimated documented Architect: John Lagerquist Builder: John Lagerquist Original Owner: John Lagerquist Original Use: residence Present Use: residence

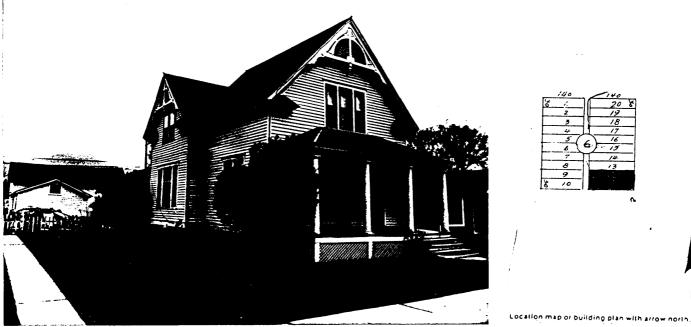
The John Lagerquist home is a 11/2 story, wood frame house resting on a random ashlar foundation. The building has a broad wood, water table, a full width hip roof, front porch supported by wood Doric columns and lattice work infill underneath the porch. Four wide, wooden risers lead to a wooden tongue and groove porch deck. The siding is narrow clapboard, 3" exposure, with vertical corner trim. There is a moderate frieze band below the horizontal soffit. Soffits are 10" projection with eave returns and molded fascia board. A beautiful bracket detail is seen in the peak of the gable and gable bays. The basic rectilinear plan has shallow, projecting, square bays to the south and north. The windows are narrow proportion, 1/1 double hung with wood 1x trim with cornice molding. There is a fixed cottage window with a transom lite with narrow, double hung windows to either side in the projecting bays and a triple double hung arrangement in the main gable. The front door is half-lite beveled glass with cross panel relief and a wood storm door.

There is a screened back porch with hip roof and a bay projecting to the back of the house. Shingles are asphalt with metal cap and ball detail. There is a corbeled brick chimney that projects from the back portion of the roof and also one close to the top of the roof on the north side of the main bay. Outbuildings include a moderate size, one story, wood frame barn building with hayloft doors and a low pitched gable roof shed building attached.

This building, with the exception of the asphalt shingles, has excellent architectural integrity. The exterior needs paint, but otherwise is great.
