NATIONAL REGISTER OF HISTORIC PLACES
REGISTRATION FORM

historic name KING, JOHN A., HOUSE

Section number 7 Page 1 **KING, JOHN A. HOUSE, LAKE BUTLER,
UNION COUNTY, FLORIDA**

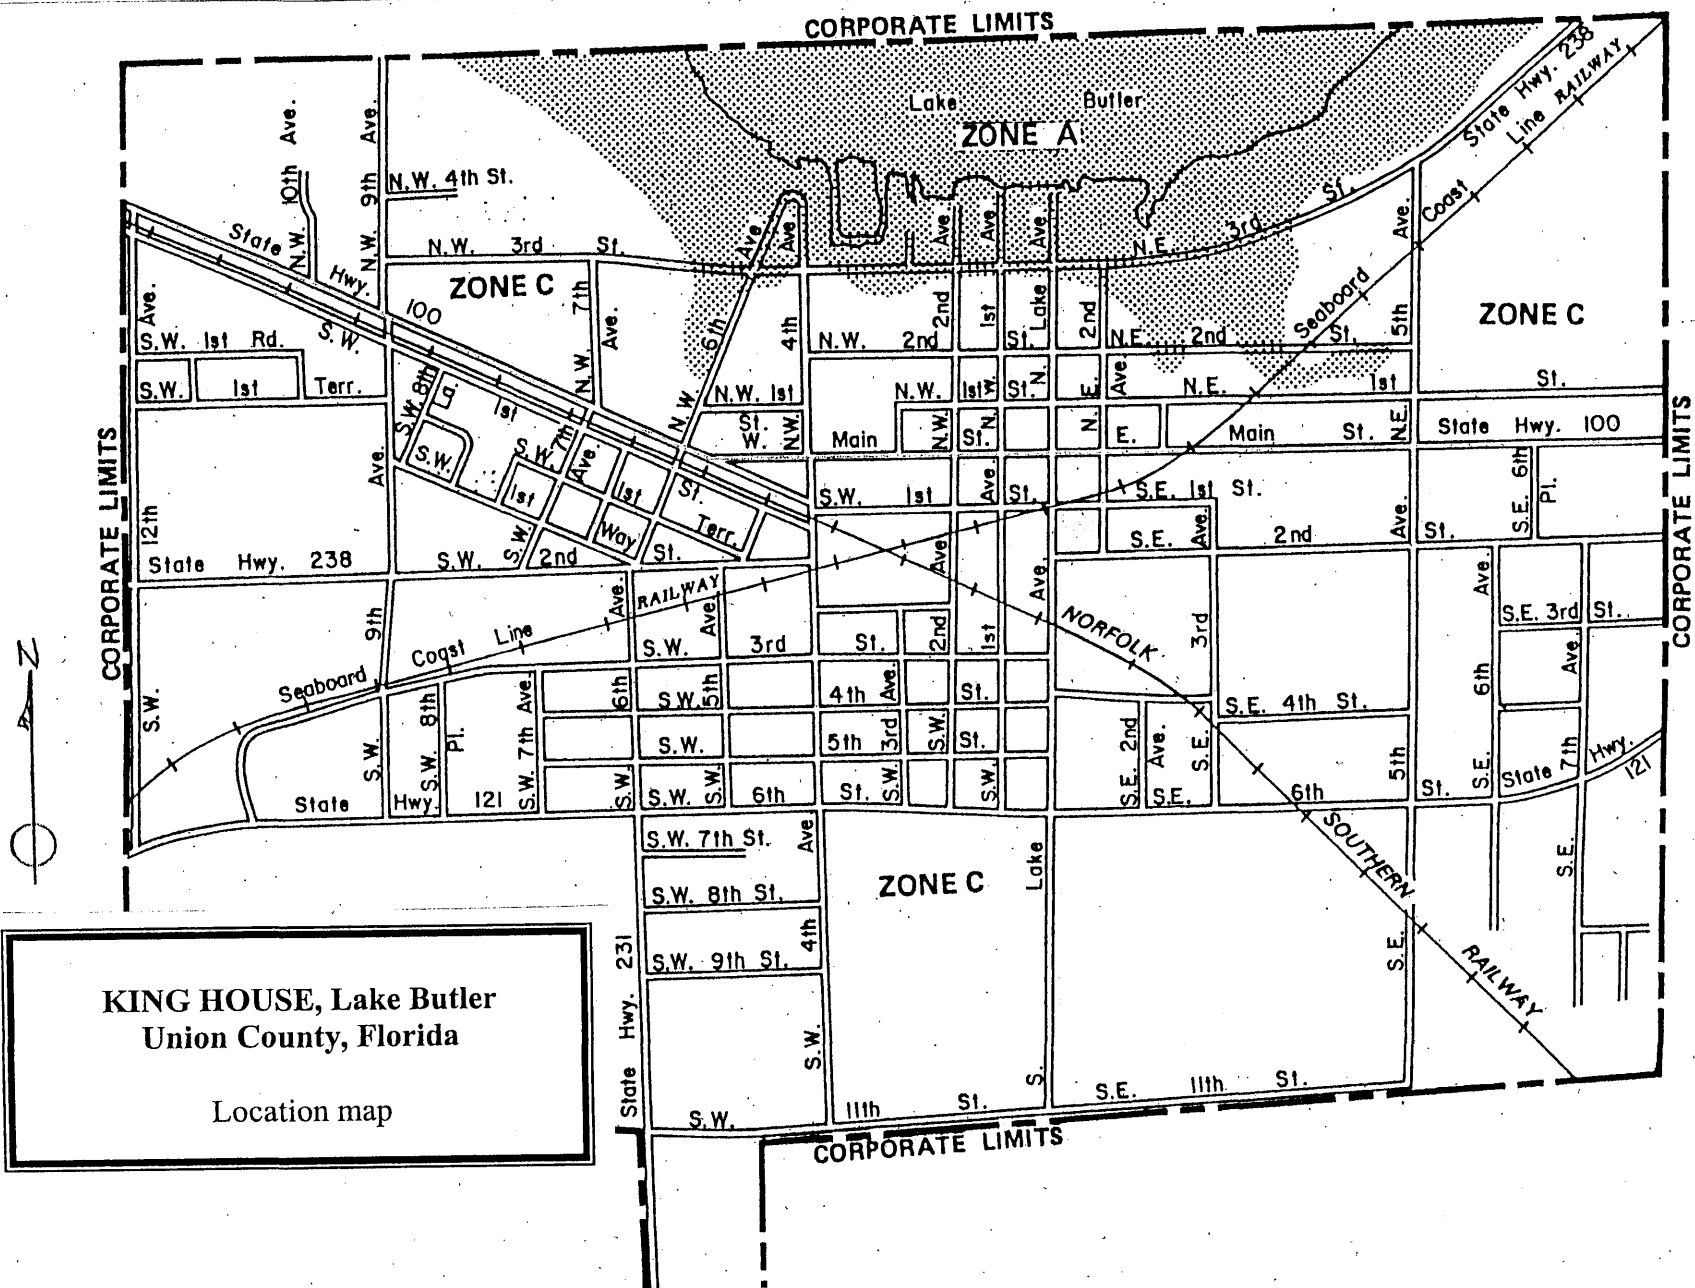
Location map

KING HOUSE, Lake Butler
 Union County, Florida

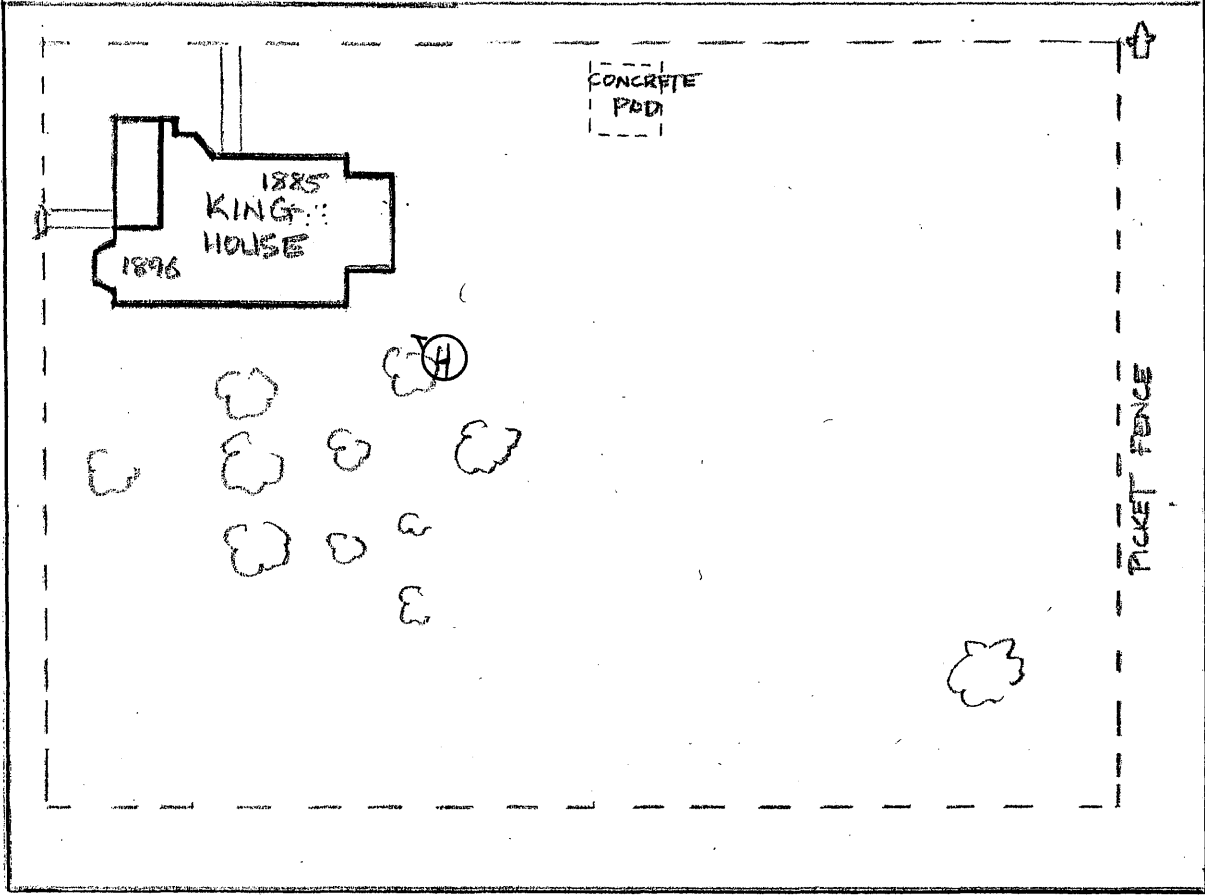
Site Map & Photo Diagram

**KING HOUSE, Lake Butler
Union County, Florida**

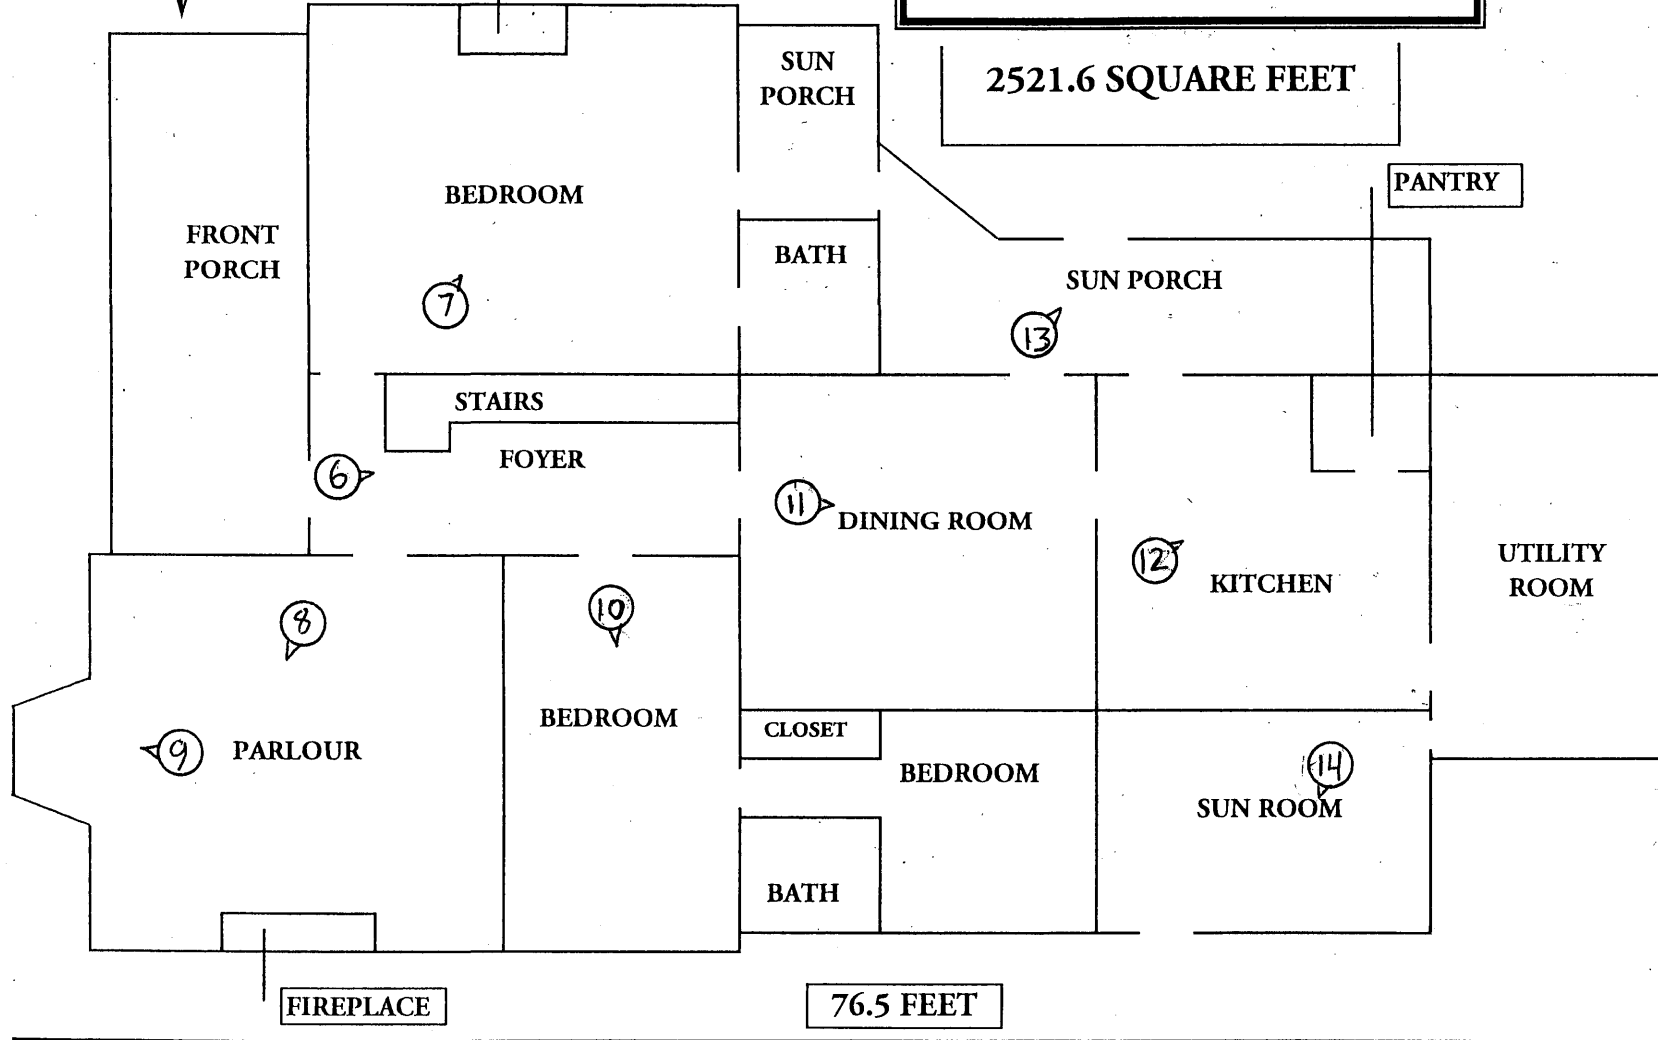
**KING HOUSE, Lake Butler
Union County, Florida**
First Floor Plan & Photo Diagram

2521.6 SQUARE FEET

76.5 FEET

The first floor contains a central entry hall with stair landing and dog-legged stairway against the north wall (Photo #6). Two large newel posts are turned, as are the railing balusters. A bedroom with a fireplace is to the north of the hall (Photo #7). A bathroom and sun room are entered through the east wall. A parlor with a fireplace (Photo #8), and a bay window (Photo #9) is in the southeast corner. A bedroom is south of the hall, and east of the parlor (Photo #10). A bathroom, closet, and small bedroom are to the east of this bedroom. At the eastern end of the hall is a door into the earlier portion of the house, and a large dining room (Photo #11). To the east of the dining room is the kitchen (Photo #12). East of the kitchen is a utility room that had been a porch. North of the dining room and kitchen is a window-enclosed porch (Photo #13). To the south of the kitchen is a window enclosed porch (Photo #14).

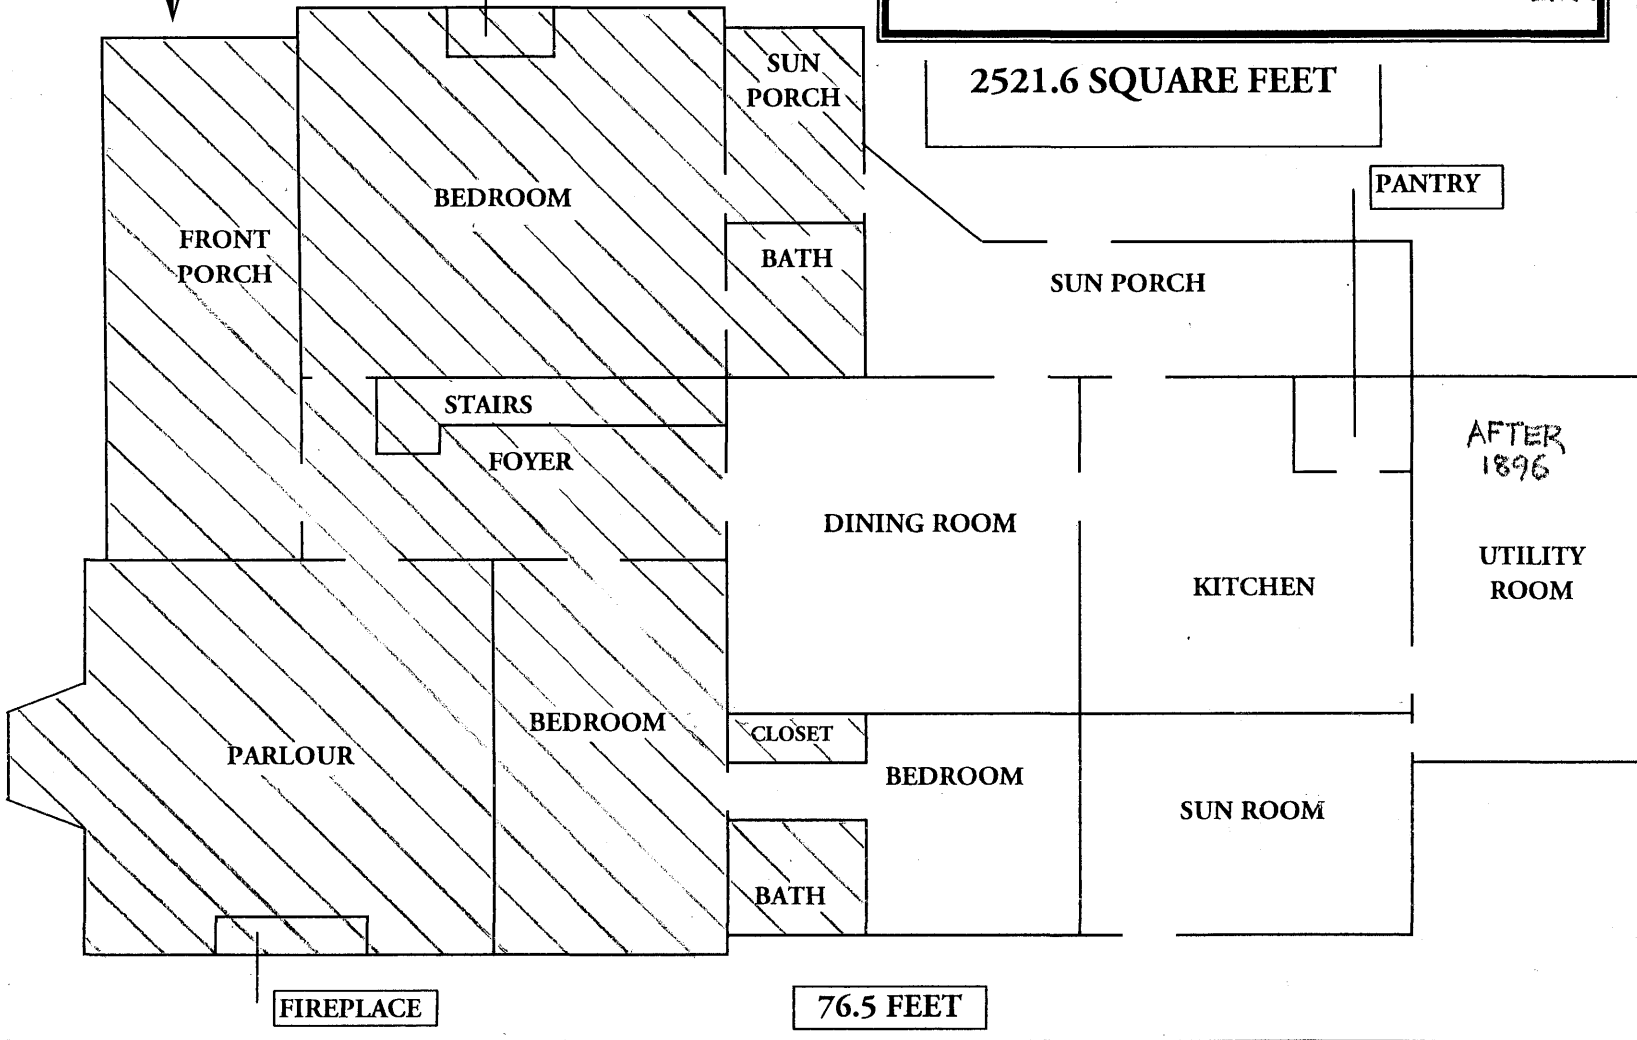
**KING HOUSE, Lake Butler,
Union County, Florida**

Pre-1885 construction & 1896 construction - // // //

2521.6 SQUARE FEET

The north elevation reveals the complex interaction between the 1896 construction and the pre-1885 one-story building (Photo #3). The gable end of the main block is to the west, and the one-story hall-and-parlor construction is to the east. The gable end has two single sash windows aligned on the first and second stories. The gable end has a small window and is surfaced with diamond shaped wooden shingles. The side view of the west elevation's main porch, balconies, and bay windows are visible toward the west. At the gable end's eastern corner is a small one-story, shed roofed extension, with half walls, and banks of six-light windows on its north and east walls. Adjacent to it is a canted, one-storied gabled roof connection to the enclosed porch of the hall-and-parlor wing. The connection and porch have half walls, and banks of six-light sash windows. Four steps and a single door provide entry to the enclosed porch. The one-story hall-and-parlor wing has a side gable roof whose roof ridge has been lowered in its western half to accommodate a second story sleeping porch with a broad hip roof that projects from the western middle of the 1896 construction. The sleeping porch has a half-high wooden wall with screened enclosure in the upper half. A short gable extension is at the northern junction of the sleeping porch and main block of the house. The gable intersects the eastern slope of the main roof. A wooden louvered vent is within the gable, and a small fixed window is in the extension's north wall. A one-story shed extension is on the east side of the hall-and-parlor portion, and has a window with a pair of metal awning sashes in its north wall.

The King House has a very high level of physical integrity. The primary alteration was the 1896 construction of the two-story Queen Anne Style house that incorporated the existing hall-and-parlor, side gabled house. The north and south porches of the pre-1885 construction were modified. A bath and sunroom were added to the west end of the north porch, and a bath and bedroom were added to the west half of the south porch. A portion of the roof ridge was lowered to accommodate the second-story sleeping porch. Sometime after the 1896 construction, the north and south porches on the hall-and-parlor portion were enclosed with windows. The shed roof porch extension was also added to the east elevation. In 1945, a kitchen building located to the west of the
