# NATIONAL HISTORIC LANDMARK NOMINATION

## ADENA (THOMAS WORTHINGTON HOUSE)

Historic Name: Adena (Worthington, Thomas, House)

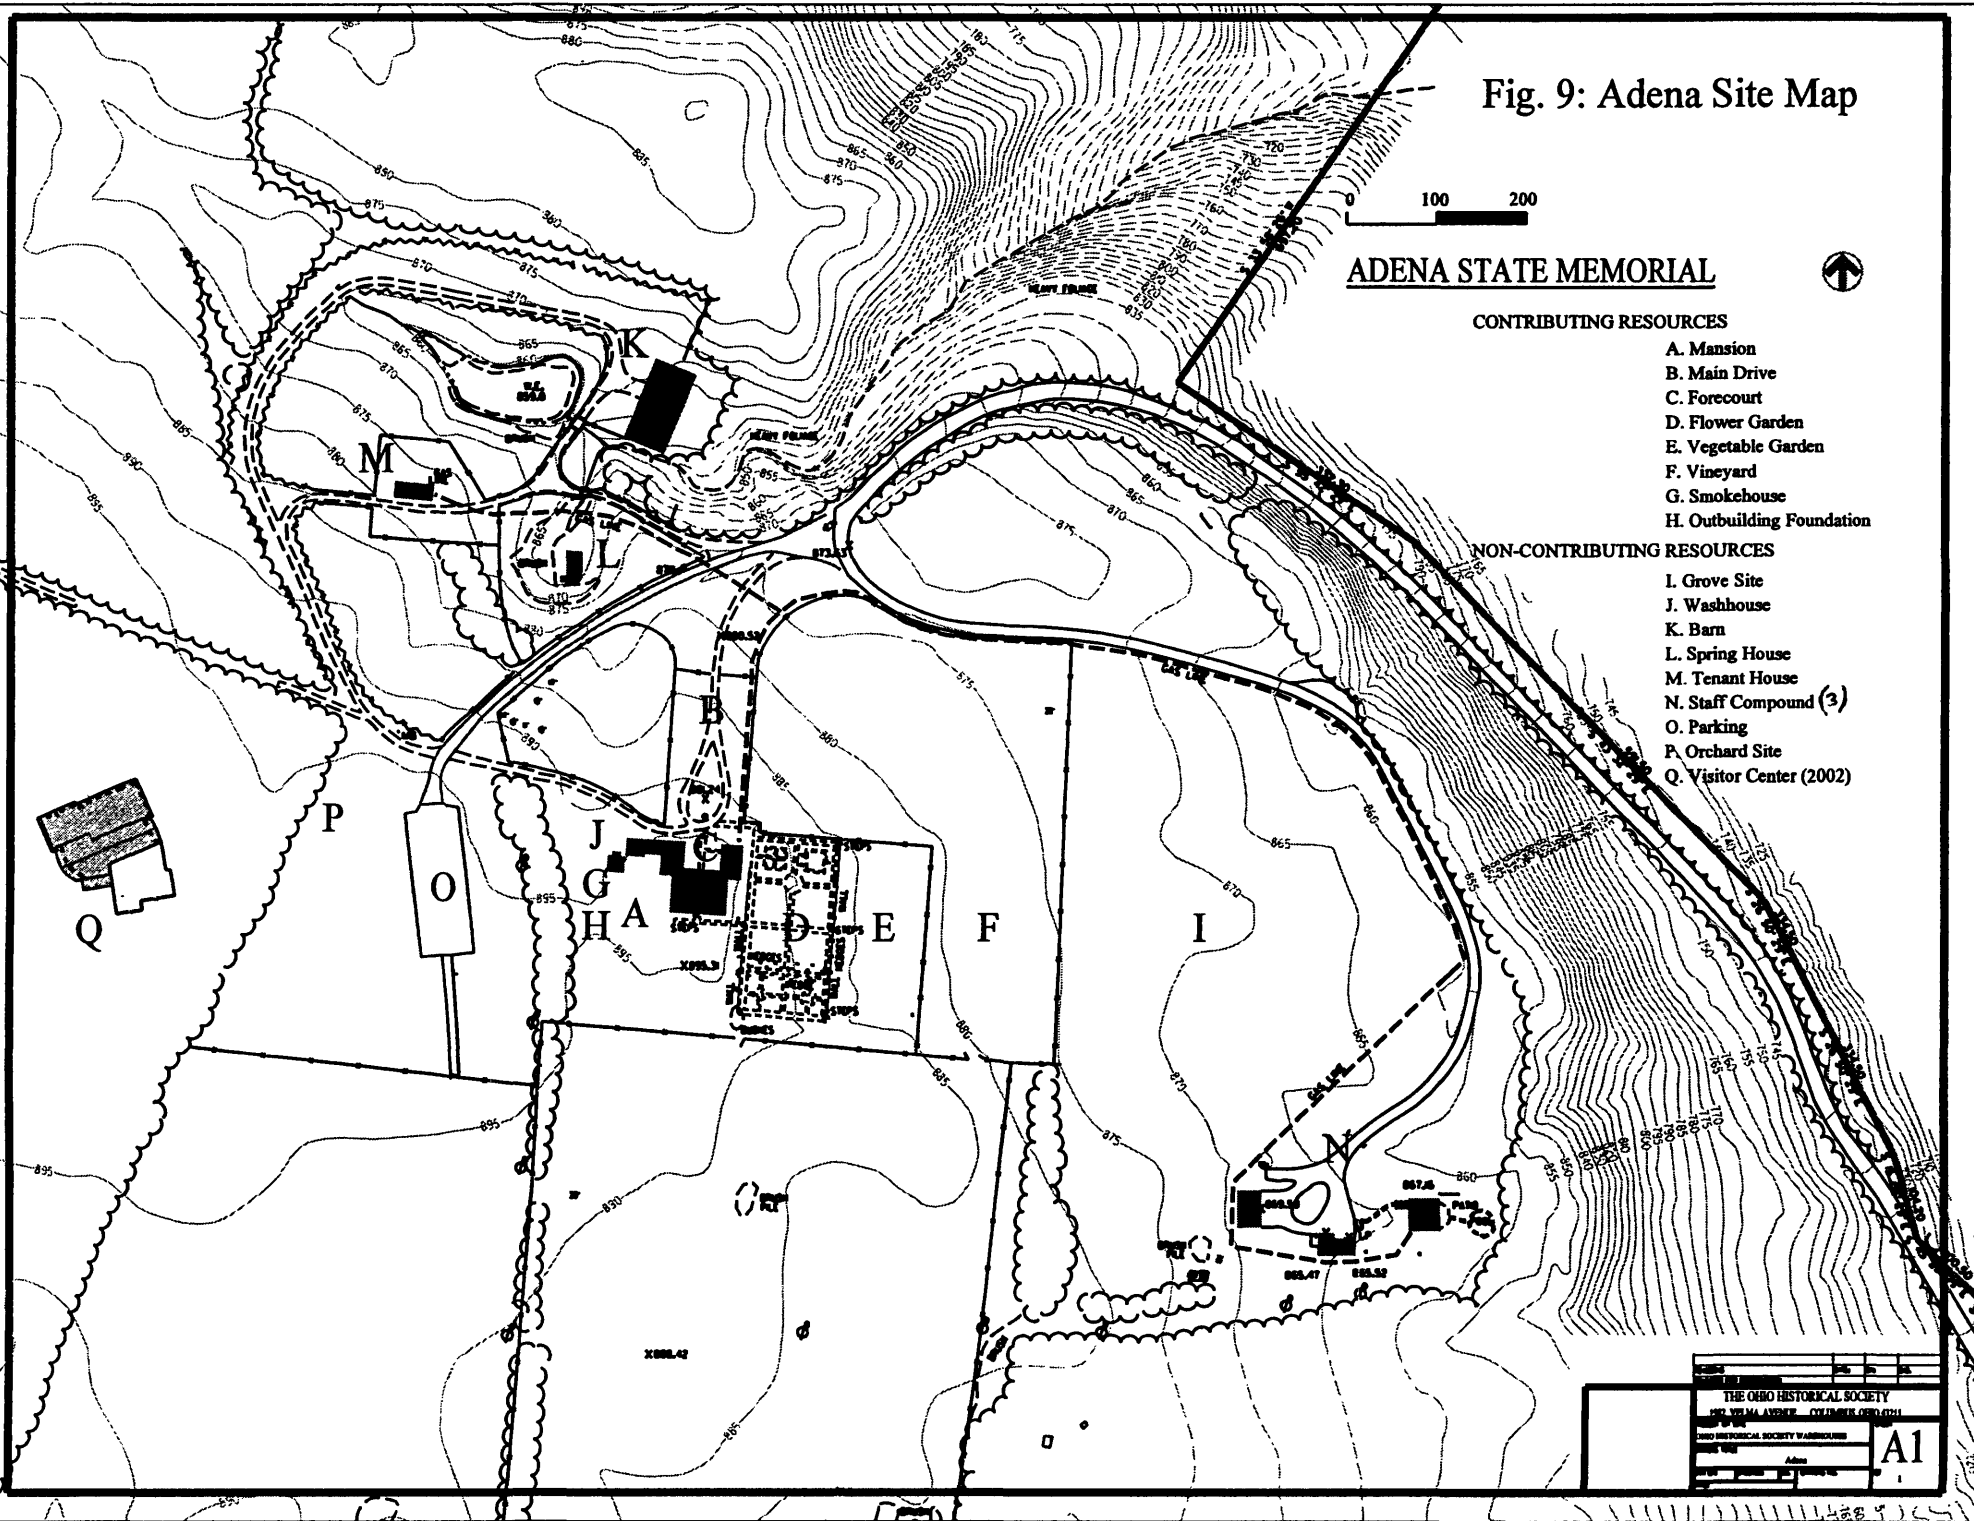
Fig. 9: Adena Site Map

- A. Mansion
- B. Main Drive
- C. Forecourt
- D. Flower Garden
- E. Vegetable Garden
- F. Vineyard
- G. Smokehouse
- H. Outbuilding Foundation

- I. Grove Site
- J. Washhouse
- K. Barn
- L. Spring House
- M. Tenant House
- N. Staff Compound (3)
- O. Parking
- P. Orchard Site
- Q. Visitor Center (2002)

The main house (A) is located at the top of the hill. (The letters refer to Figure 9.) On the north is the main drive (B) and forecourt©. On the east are three garden terraces: the flower garden (D), the vegetable garden (E), and the vineyard (F). Beyond the terraced gardens was another garden area called the grove (I)<sup>2</sup>. On the west side of the house was located another garden area, Worthington's orchard, consisting mostly of apple trees (P)<sup>3</sup>. Typical of Virginia style estates, there were numerous outbuildings. On the west side of the house was the service area consisting of the washhouse (reconstructed 1953)(J), the smokehouse (partially reconstructed 1953) (G), and a structure, probably a stable, whose foundation was recently uncovered by archaeologists (H). Northwest of the main house, three outbuildings were reconstructed on original foundations

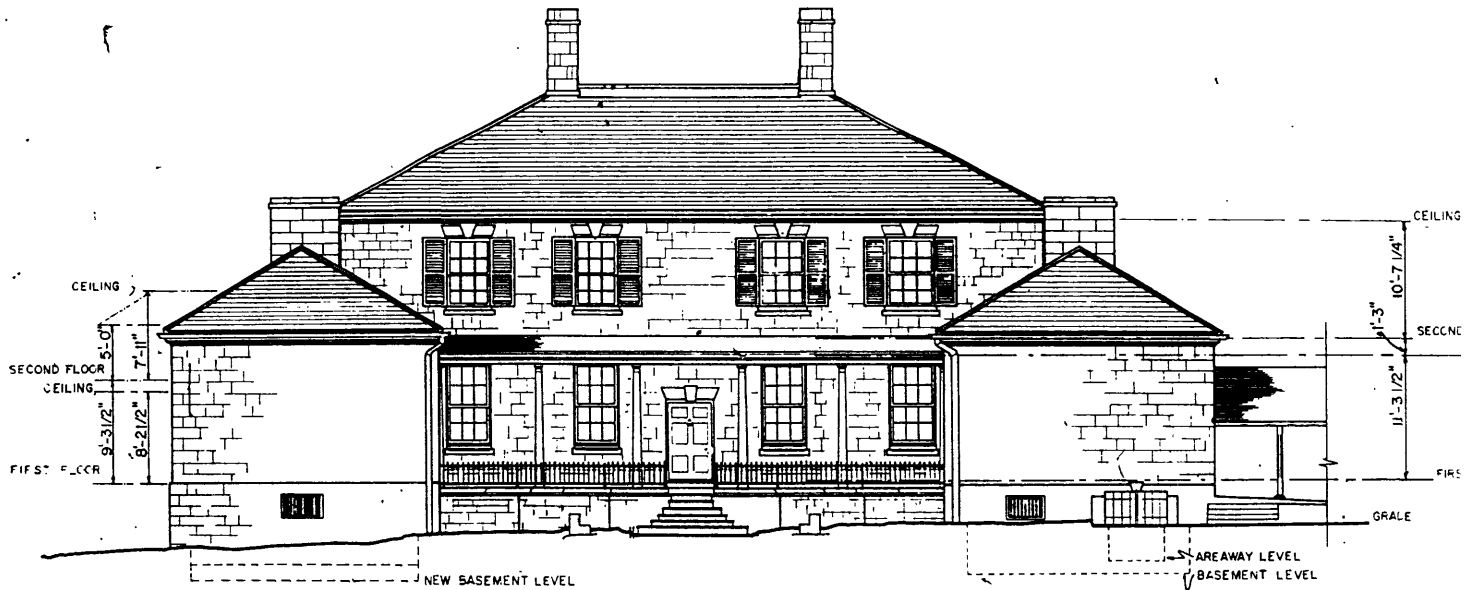
Fig. 12: Adena, north elevation.  
Source: HABS

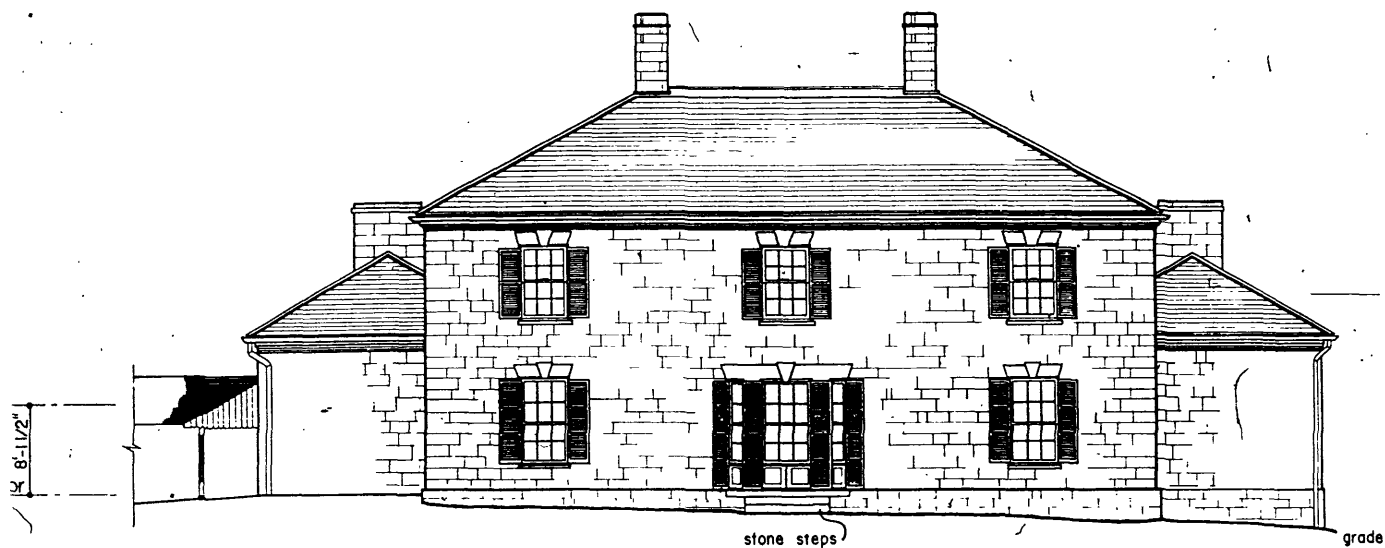
Fig. 14: Adena, south elevation.  
Source: HABS

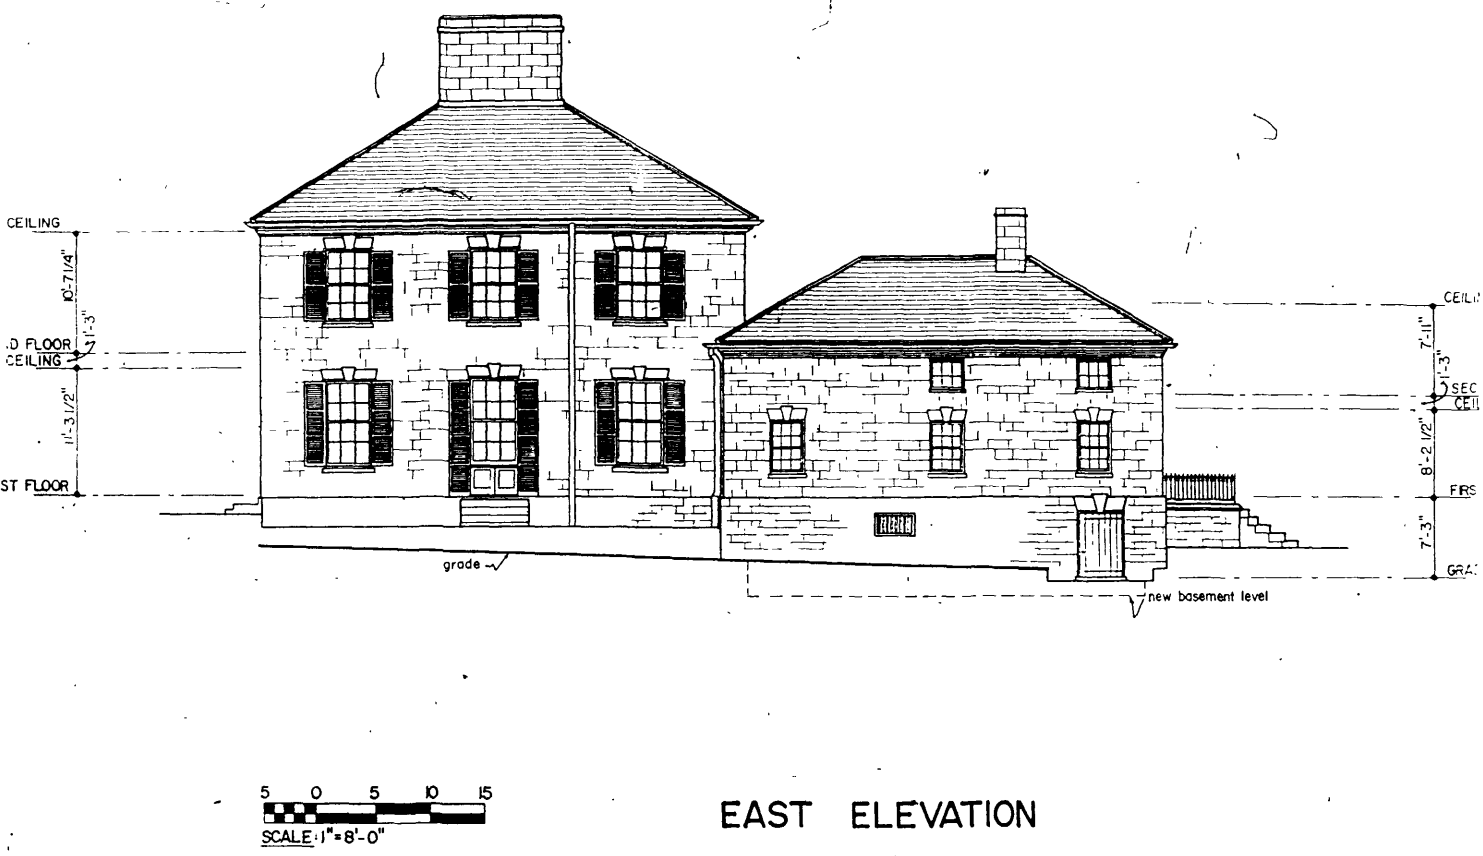
Fig. 16: Adena, east elevation.  
Source: HABS

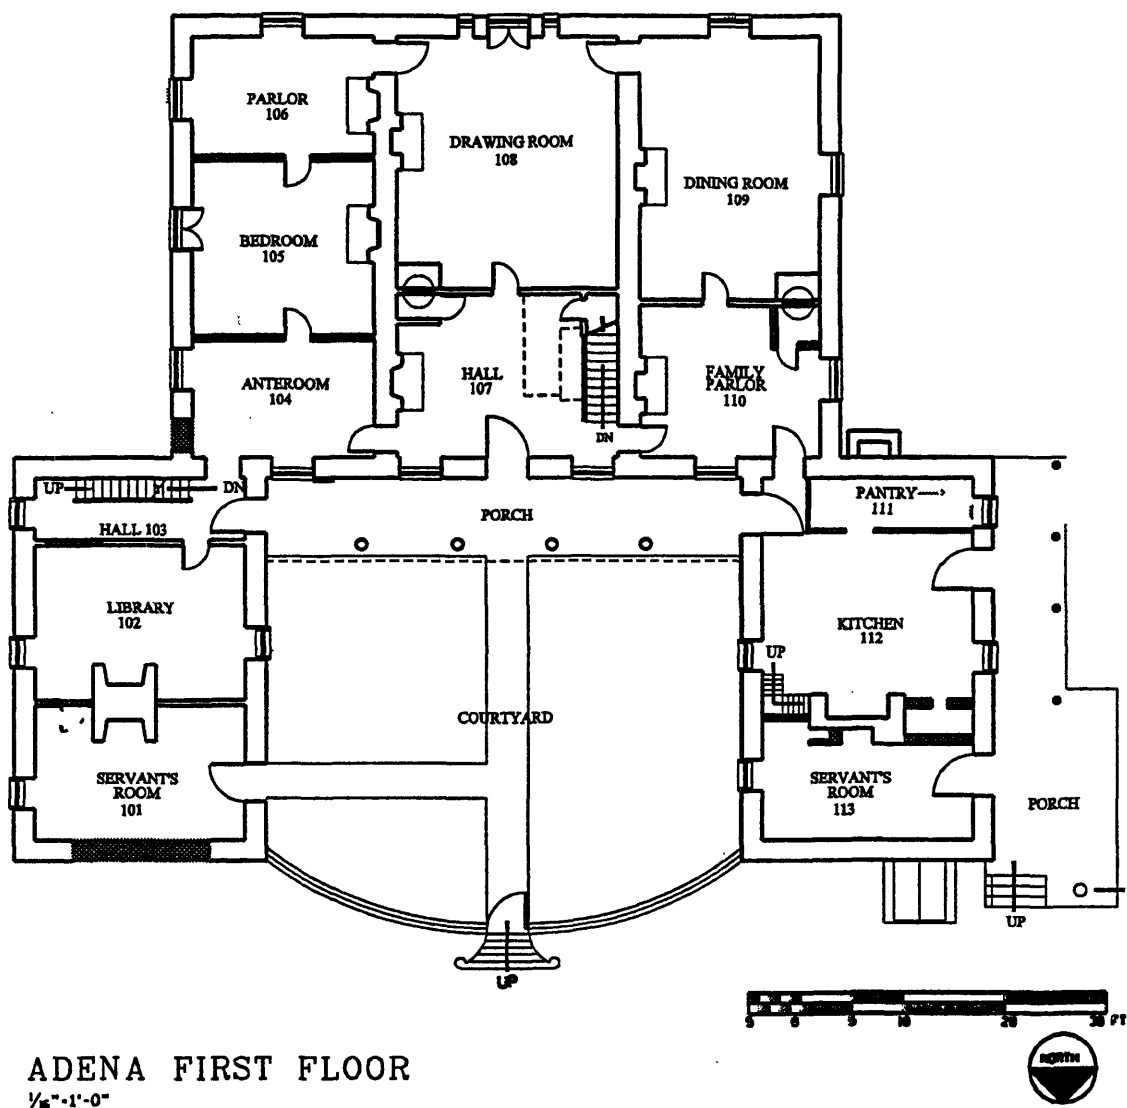
Fig. 17: First Floor Plan

The interior of the house is divided into three unequal sections by stone bearing walls that are almost two feet thick. Through these walls rise the flues to two interior chimneys that emerge through the roof. The functions of most of the rooms are described in an insurance survey prepared in 1821 and found in the Worthington Papers.<sup>7</sup> The central and western sections comprise mostly public spaces. The central section on the first floor consists of two rooms. The central room on the north side is an entrance hall with an open newel staircase rising on the right to the second floor. Behind the entry hall is the large drawing room. A revolving server is located

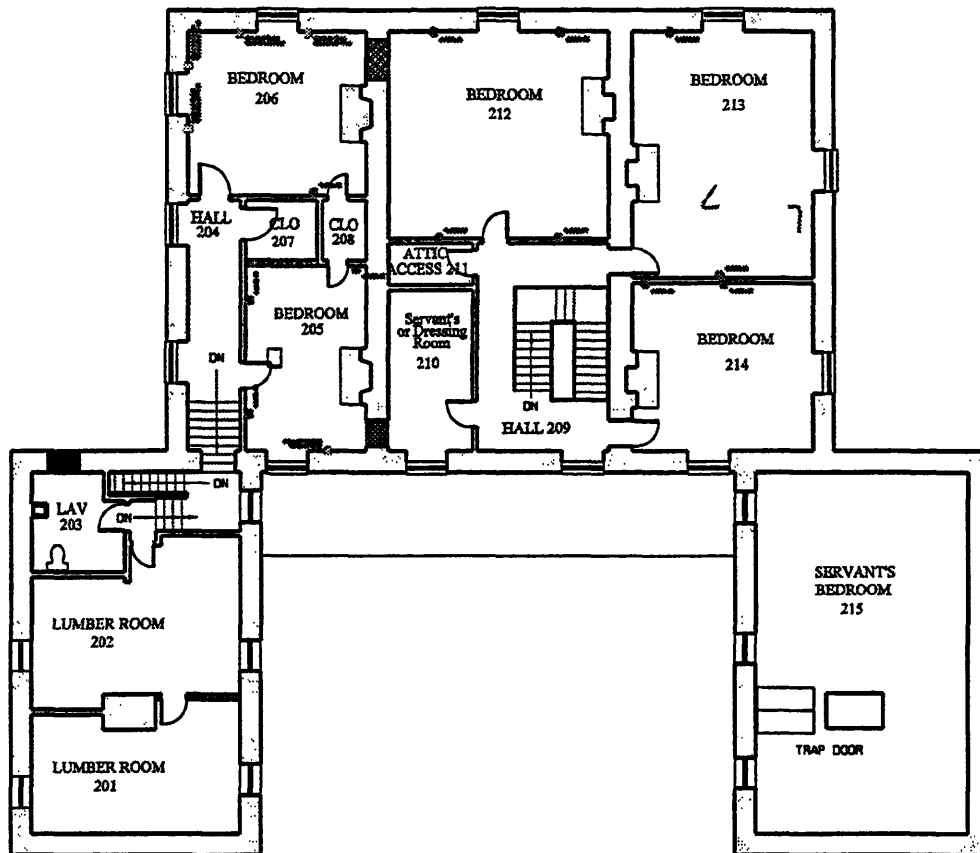
Fig. 18: Second Floor Plan

According to the insurance survey, the rooms on the second floor were all used as bedrooms. Three large guest bedrooms occupy the south center, southwest, and northwest portions of the house. A smaller room off the stairway is interpreted as a servant area, though it might have been a dressing room. Investigation into the original function of the room is ongoing. On the east end of the house are two bedrooms, separated from the other second floor rooms by the load bearing wall.<sup>9</sup> A stair in the east wing reaches these rooms, a continuation of the family suite from below.

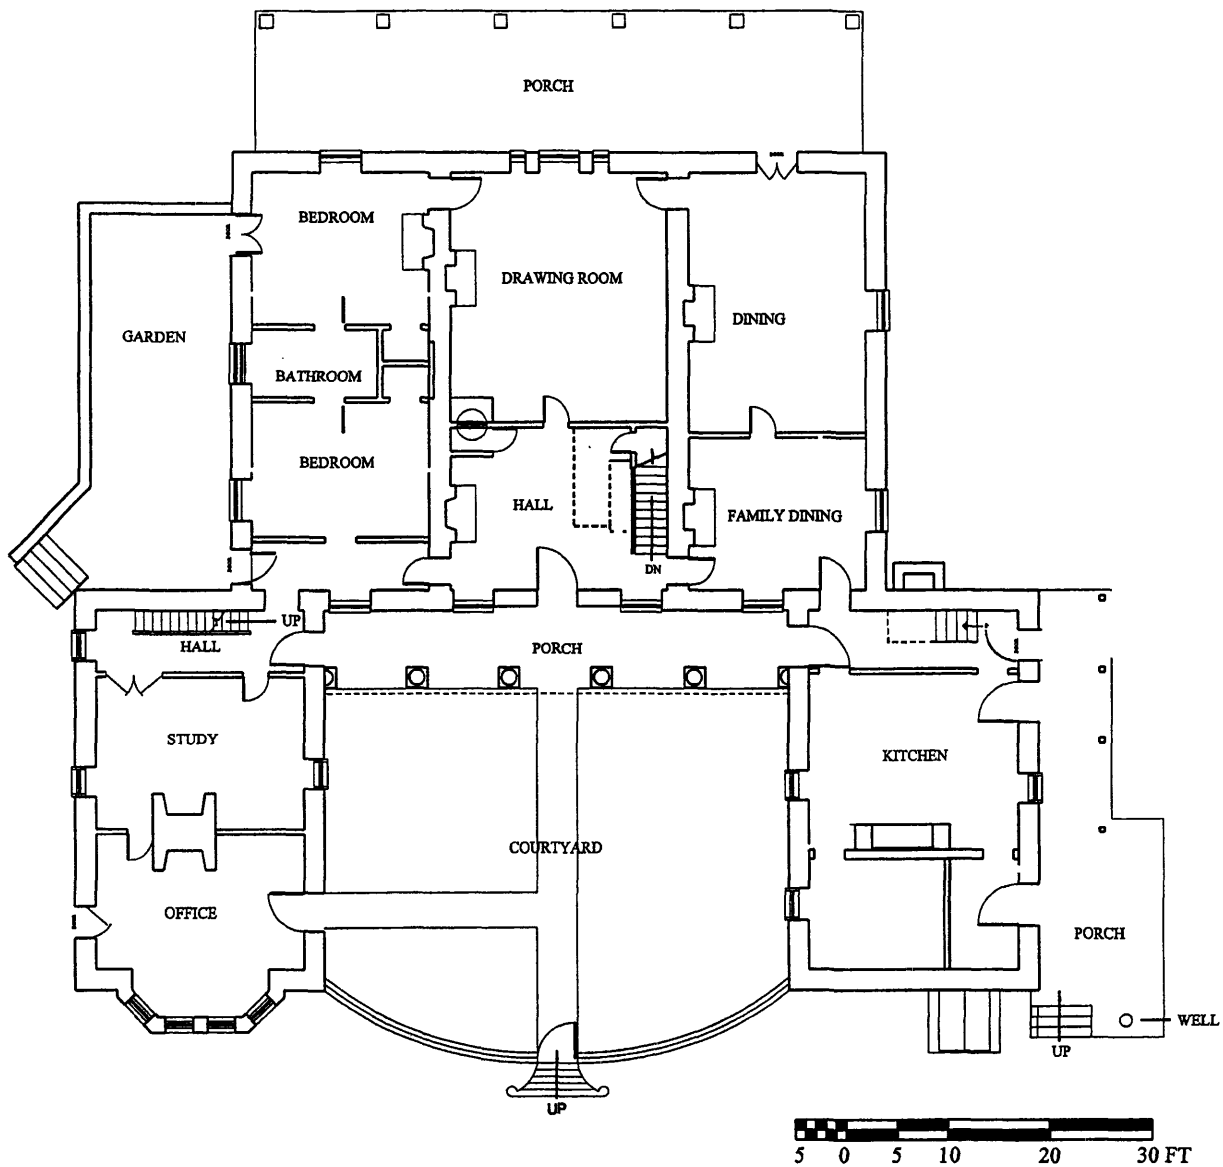
Fig. 22: Smith Floor Plan, First Floor

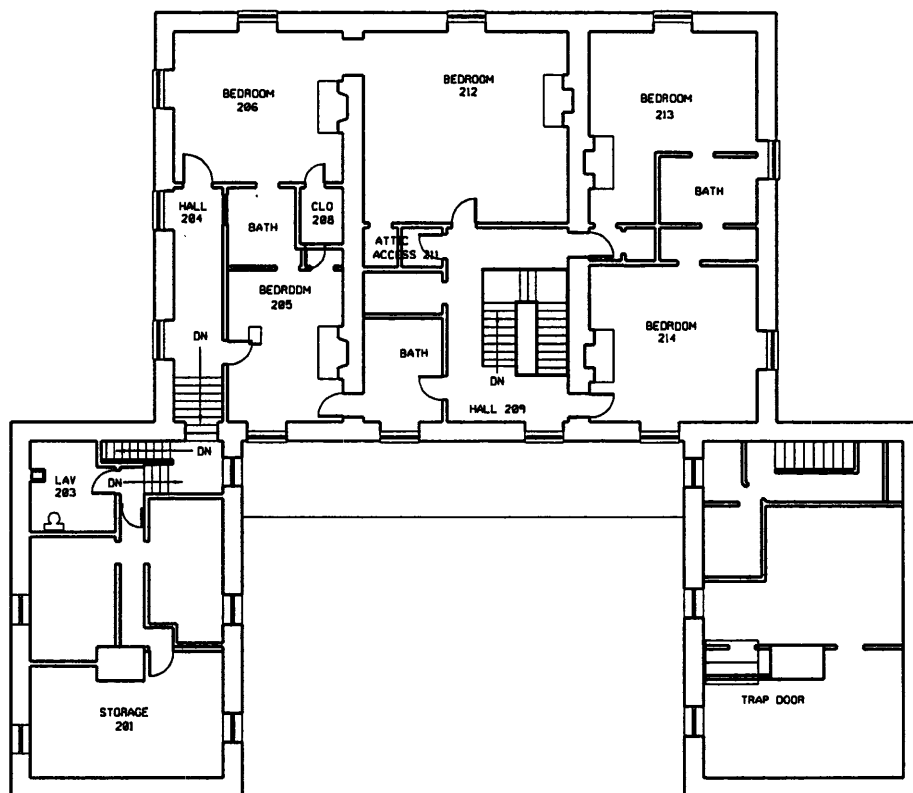
Fig. 23: Smith Floor Plan, Second Floor

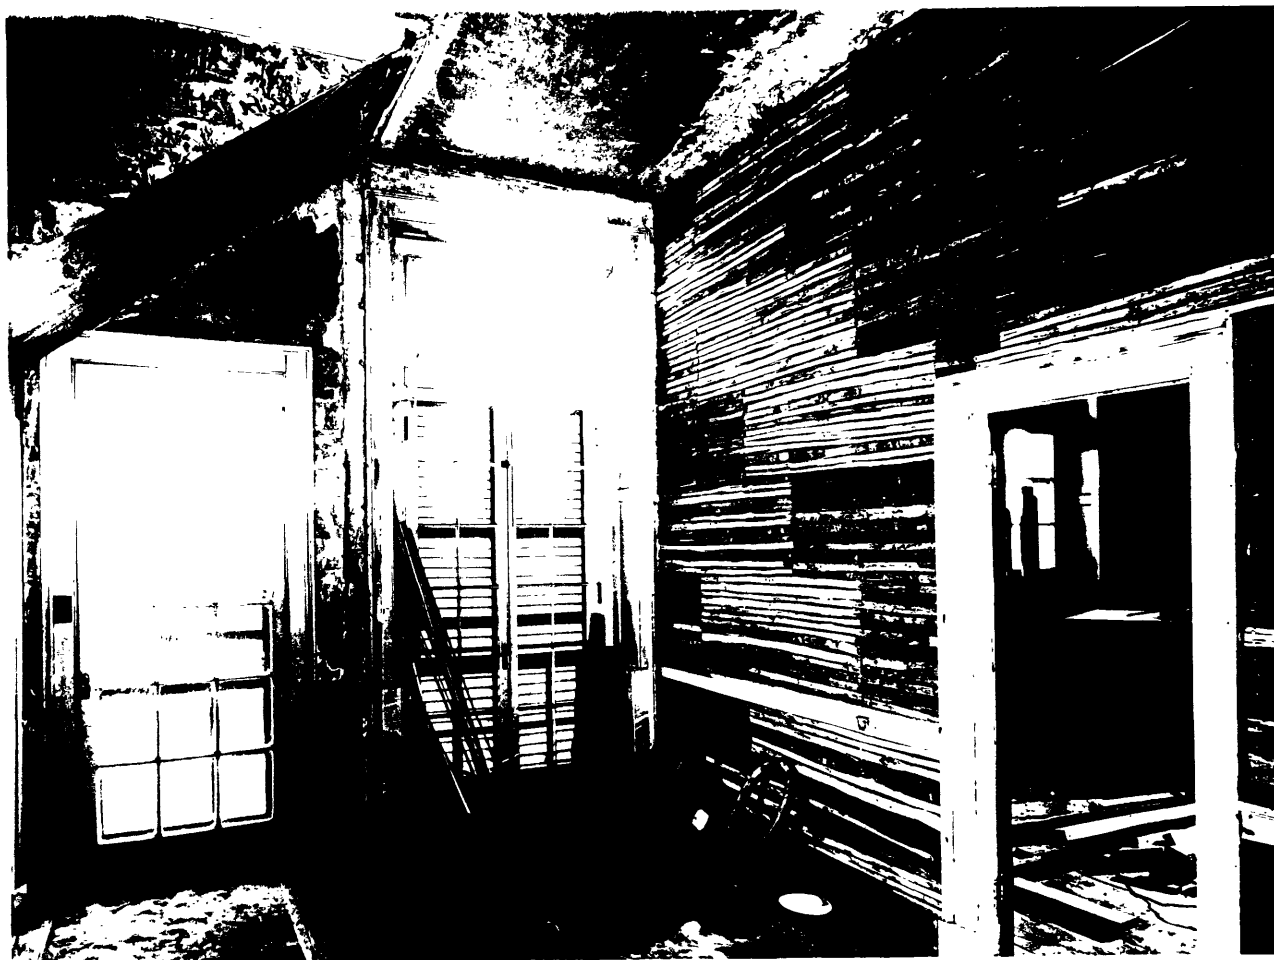
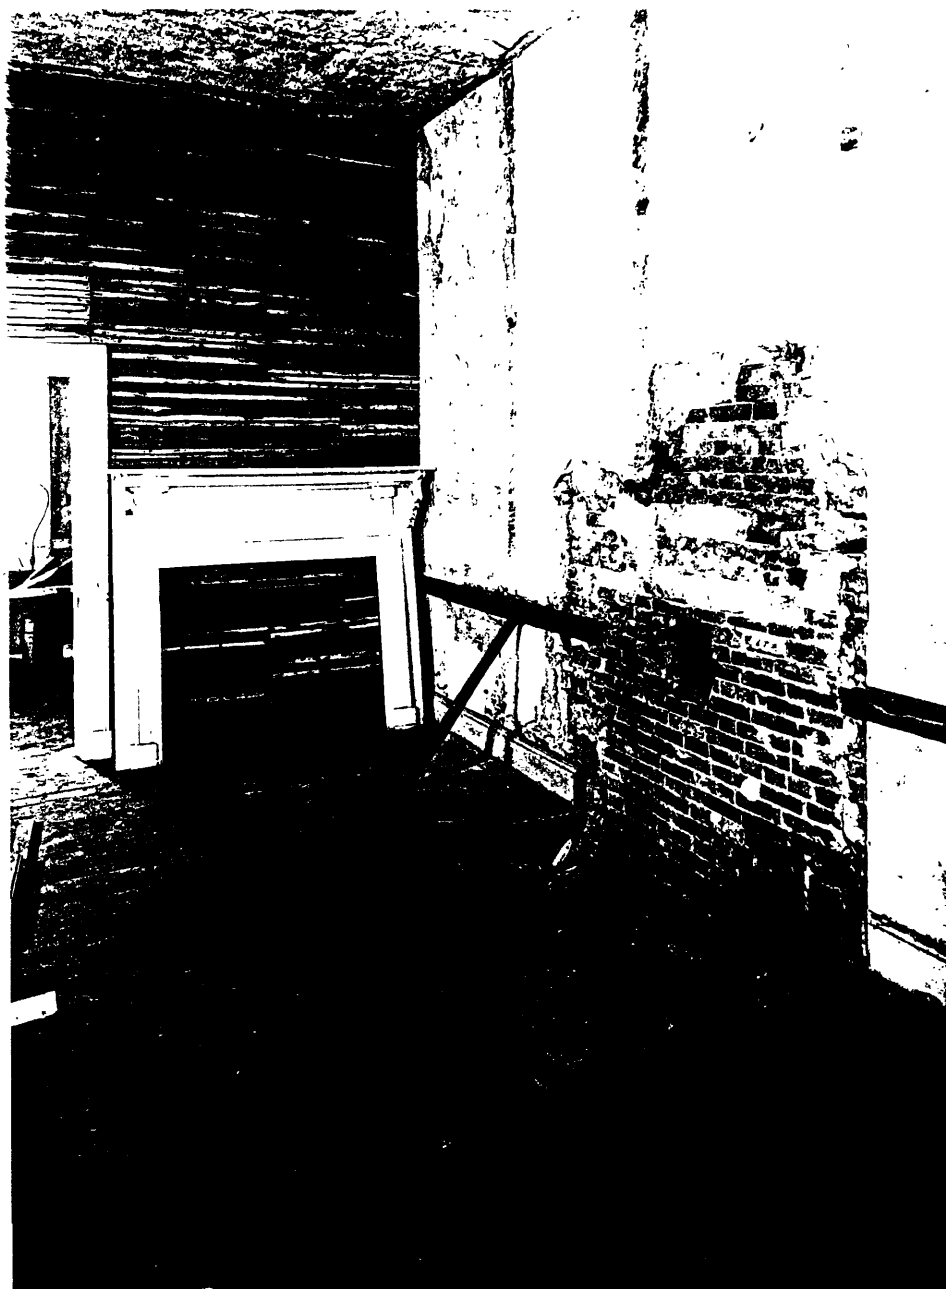
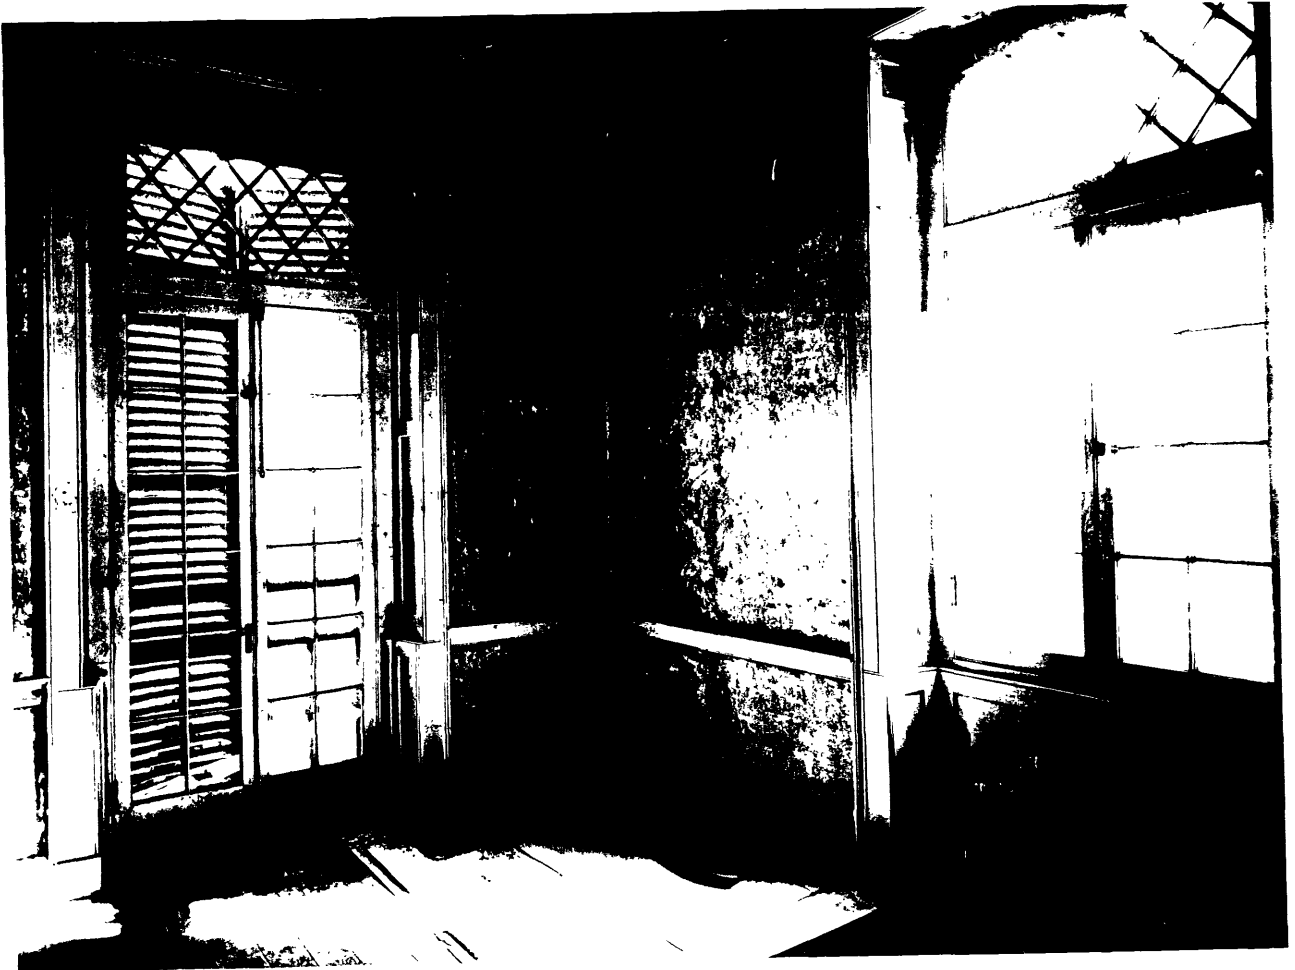
Fig. 26: Northeast room, first floor, southeast corner, during restoration, 1950.  
Source: OHS Archive, History Department, Curator's Files, Adena, box 527,  
file, "Northeast Room—First Floor," State Archives, OHS A/L

Fig. 27: Center east room, first floor, looking southwest, during restoration, 1950.

**Fig. 28:** Southeast room, first floor, southeast corner, before restoration, 1950.

<sup>11</sup> Figures 26 through 28 are photographs taken in March 1950 during the restoration conducted by Ohio Historical Society staff. These pictures illustrate some of the changes made by the Smiths. Figure 26 shows the northeast corner room (called the anteroom), looking east. The Smith wall to the left of the French doors has been removed, the location is still clearly visible, and a wall reconstructed to the right of the doors. The door on the right was carved out by the Smiths. The original window on the eastern wall has been turned into a French door. Figure 27 shows the work to uncover the fireplace in the center east room (the Worthington bedroom) that had become part of a closet during the Smith ownership. Figure 28 shows the southeast corner of the southeast room (the parlor). The Smiths changed the east window into French doors. The south window illustrates the typical Smith treatment to first floor windows. The Smith changes and restoration process are described in Hitch, et al., "Historic Structures Report: Adena." On the restoration process and its effect on interpretation at the site, see Stuart D. Hobbs, "Exhibiting Antimodernism: History, Memory and the Aestheticized Past in Mid-Twentieth Century America," *The Public Historian* 23 (summer 2001): 39-61.

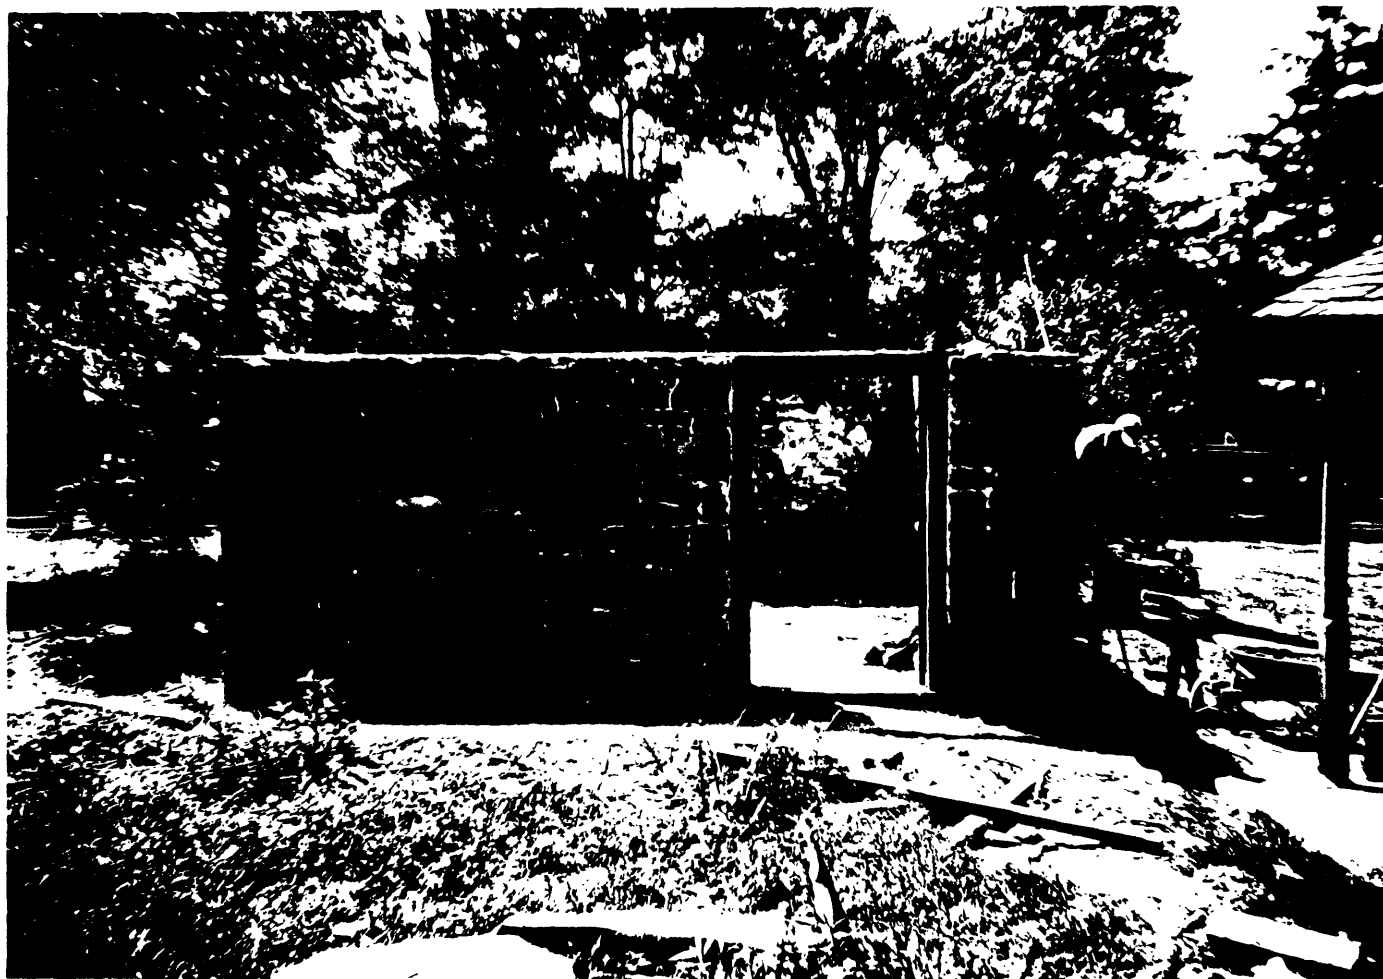
Fig. 32: The original walls of the smokehouse before restoration/reconstruction, 1 August 1952.  
Source: Ohio Historical Society Archive, History Department, Curator's Files, Adena, box 530,  
file, "West Side Outbuildings—Part 1," State Archives, OHS A/L

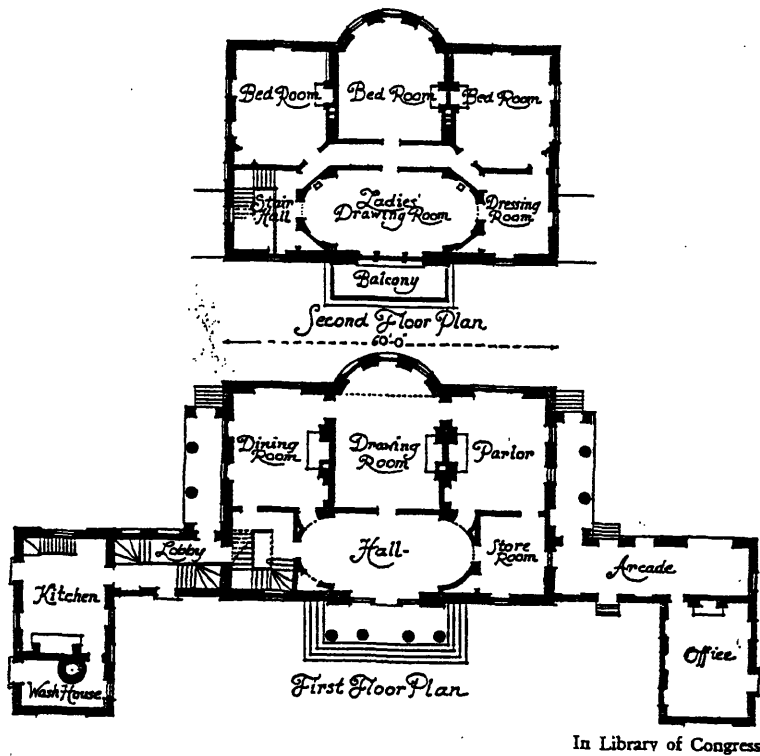
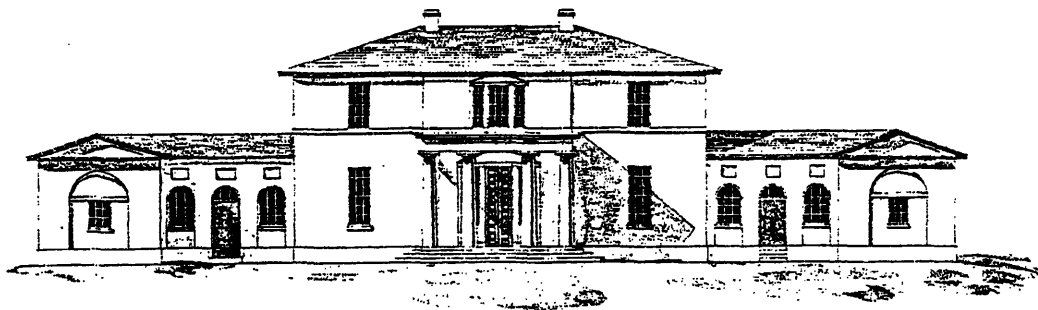
Fig. 35: Latrobe, Harvie-Gamble House: floor plans and north (entrance front) elevation.  
Plan: Hamlin (1955), 101; elevation: Latrobe (1994), 158.

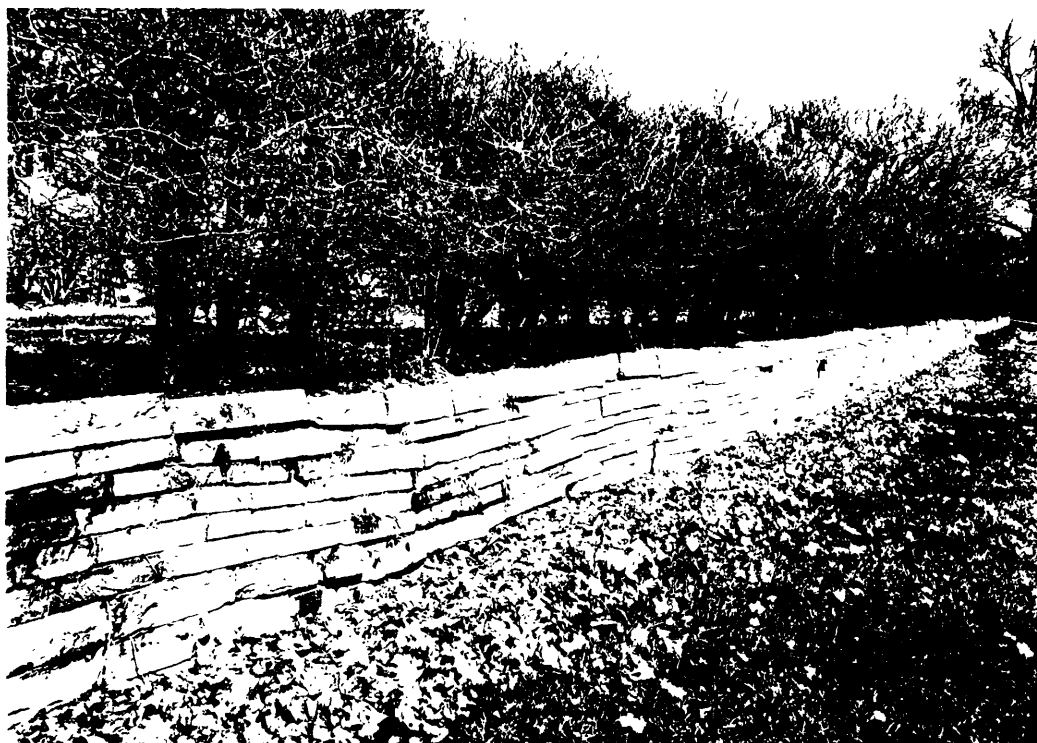
Fig. 36: Restored wall, east side flower garden terrace, from site of vegetable garden.  
Source: OHPO
