Quarai before Excavation and Stabilization

La Purisima Concepcion de Quarai Mission, Quarai State Monument,
New Mexico. Interior of church. Photo by A. H. Schroeder,
November 12, 1955. Negative in Southwestern Archeological
Center, National Park Service, Globe, Arizona.

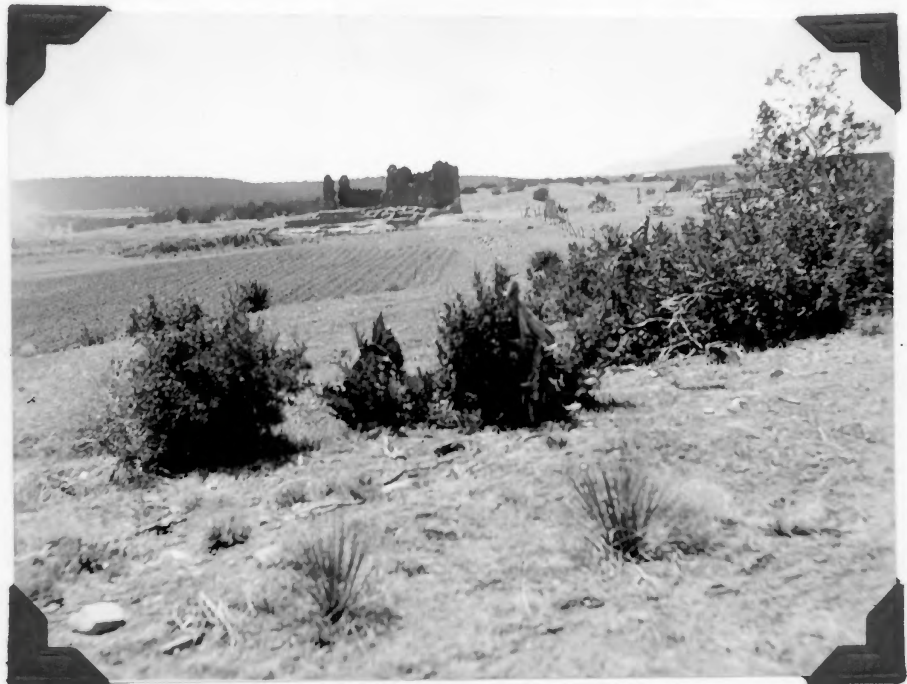
1. Quarai: on approaching. (From near the road). The church faces south (to the left). Monastery ruins on east (toward the spectator) of the church. Pueblo ruin mounds to right and behind. Manzano Mountains in right background.

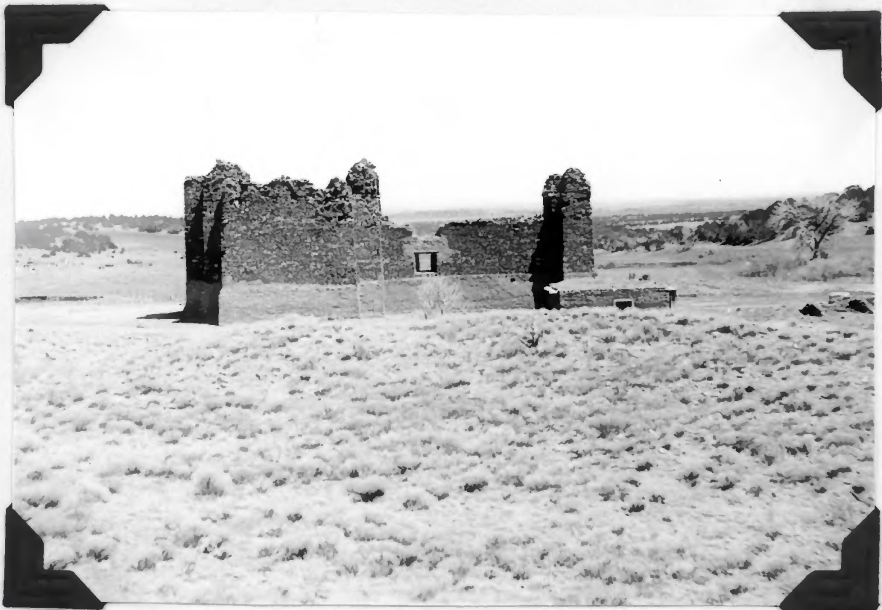
2. The church of Quarai, from the pueblo ruins, looking East.

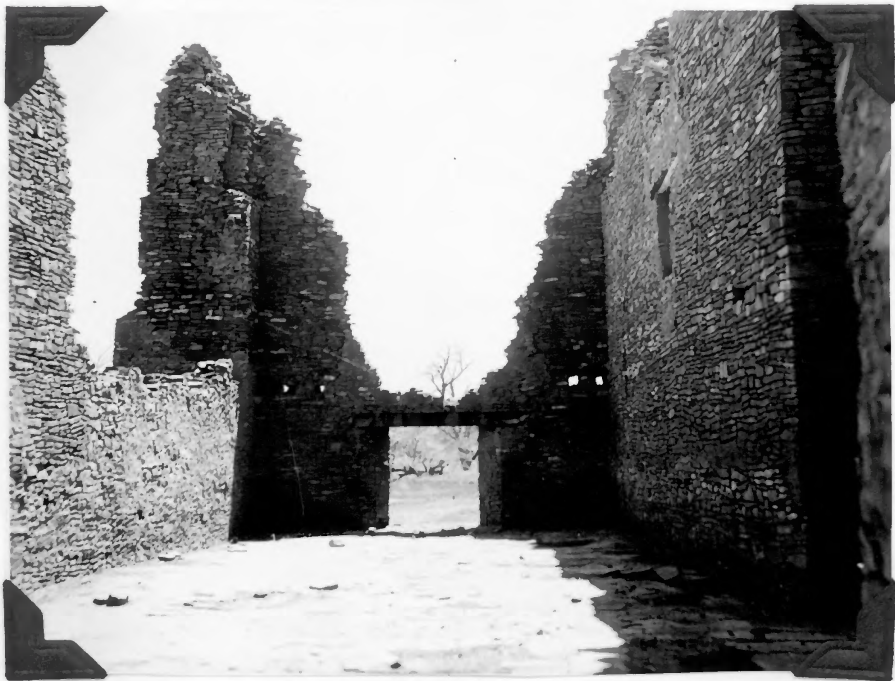
3. The front of the nave, Quarai (looking south through the main door). Note beam-holes; window at right.

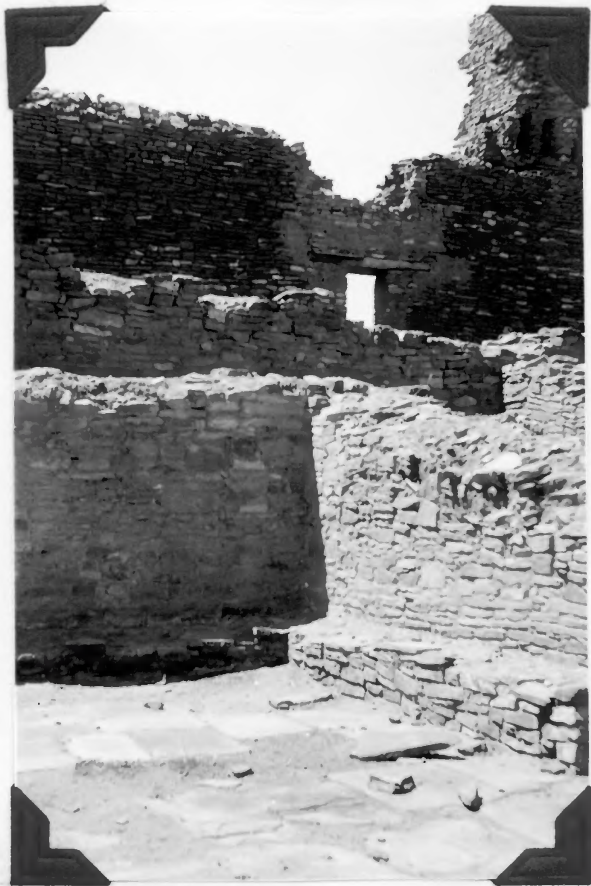
4. A portion of the monastery and of the east wall of the church, Quarai. Note flagstone floor in foreground; window.

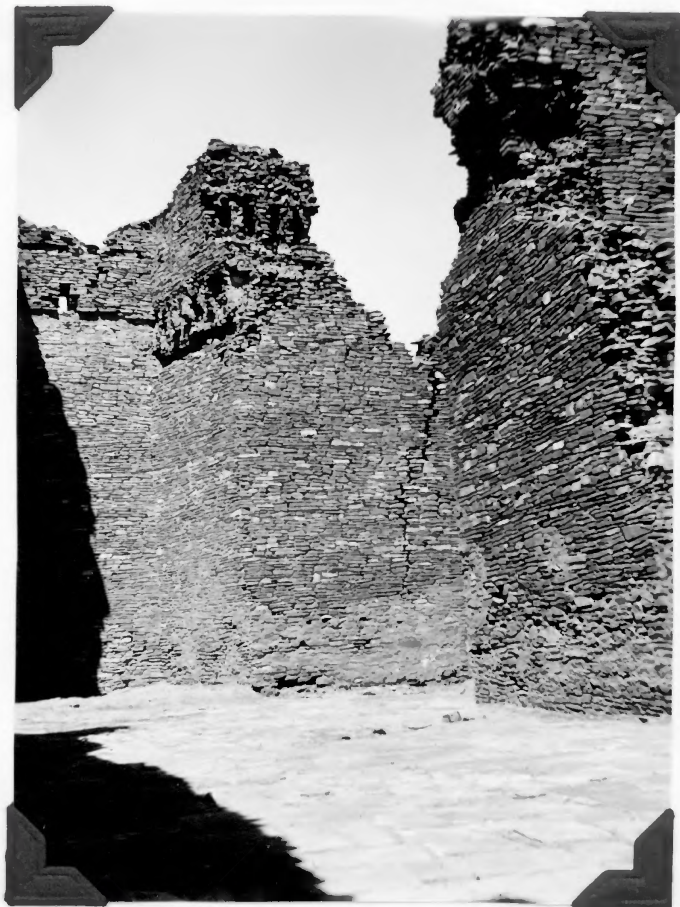
5. The northeast corner of the church, Quarai. Note rows of beam sockets, flagged floor, remnants of plaster, bad vertical crack.

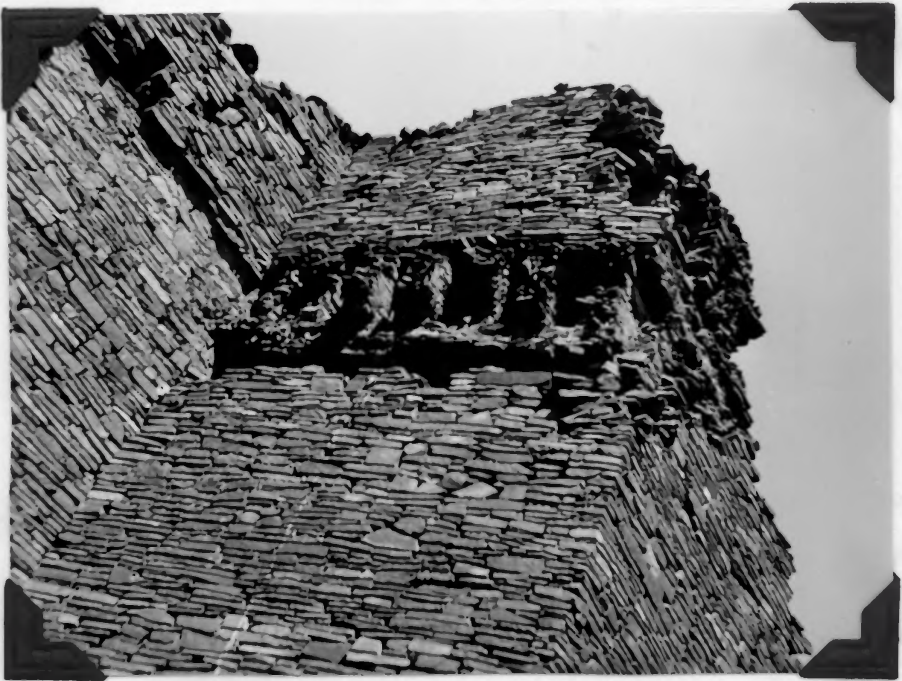
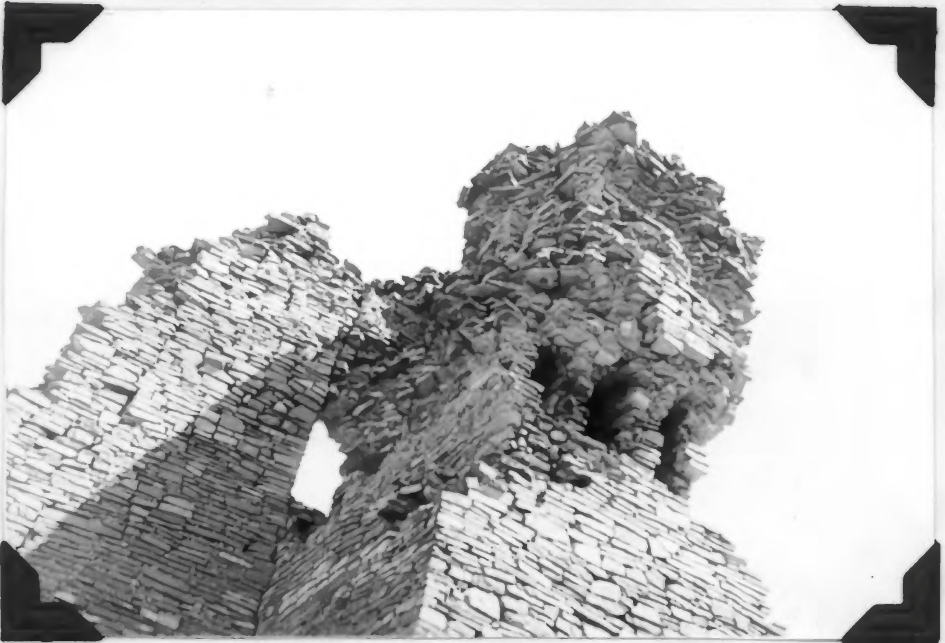
6a and b. Details from figure 5.

Note: the work done since these pictures were taken has not materially affected the appearance of the area; no work yet done on church.

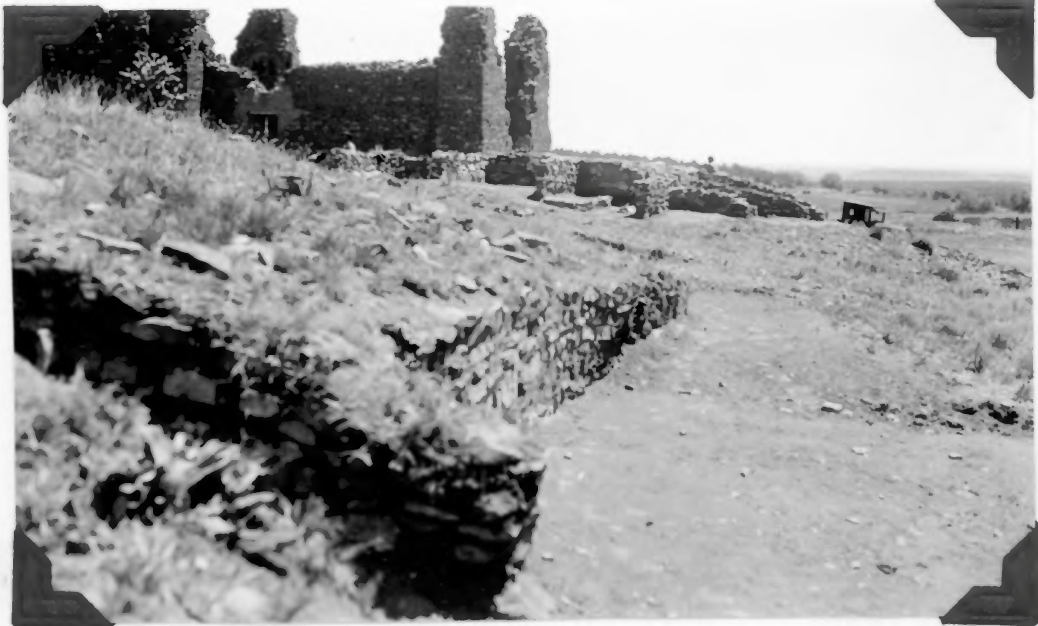
7. View showing, from front to back, recent outlining of a major portion of the pueblo ruin, excavated section of the pueblo, and west side of the church.

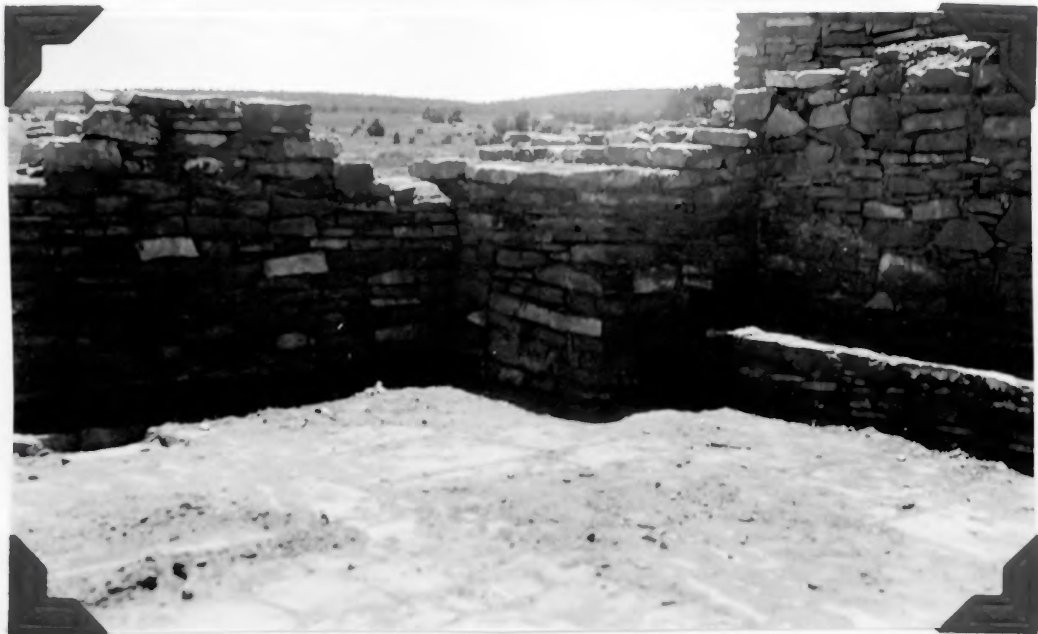
9. Room in southwest portion of the monastery. Note bench, believed to be for communicants waiting to see the priest, flagstone floor, peculiar structure in corner. Walls have been stabilized (top courses relaid in bitudobe, some minor rebuilding).

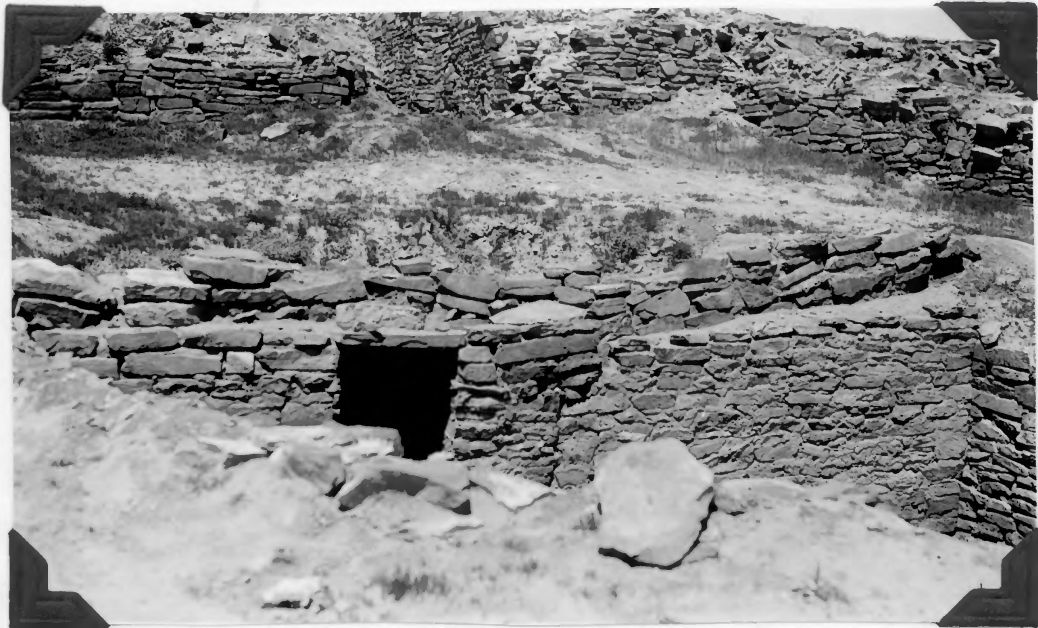
10. Round kiva in eastern portion of monastery area, with puzzling partition wall with a door partly filled, and with a terrace-enclosing monastery wall across the top of this partition wall.

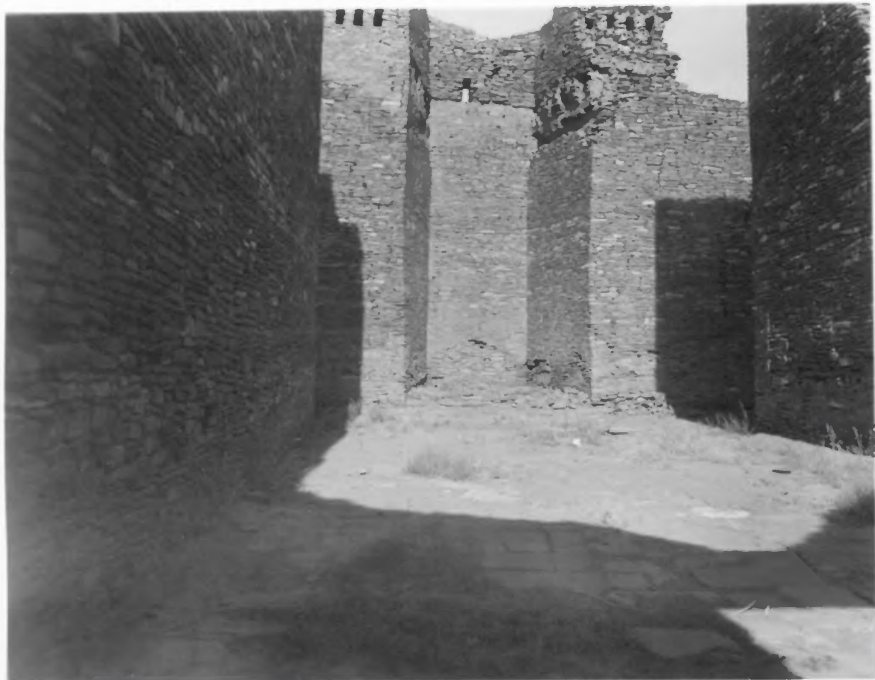
La Purisima Concepcion de Quarai Mission, Quarai State Monument, New Mexico. Looking north, church and convento. Photo by A. H. Schroeder, Nov. 12, 1955. Negative in Southwestern Archeological Center, National Park Service, Globe, Arizona.
