NATIONAL REGISTER OF HISTORIC PLACES

PROPERTY PHOTOGRAPH FORM GaG 683

COMMON: Old Sealy Building  
AND/OR HISTORIC: Hutchings, Sealy & Co. Building

STREET AND NUMBER:  
2326-2328 Strand

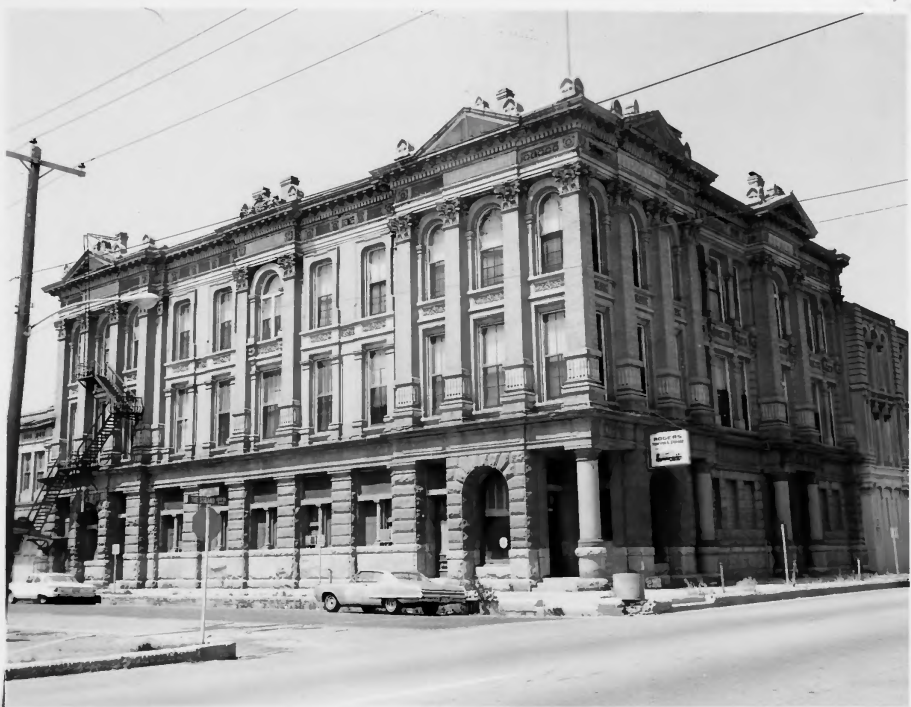
Front and side facade--Southwest elevation of a fine Post-Columbian exposition Classic revival building. The first floor of this three story building is made of rusticated granite with the other two floors constructed of brick and stone. There is rich detail in the moldings, capitals, bases, cornices and pediments.

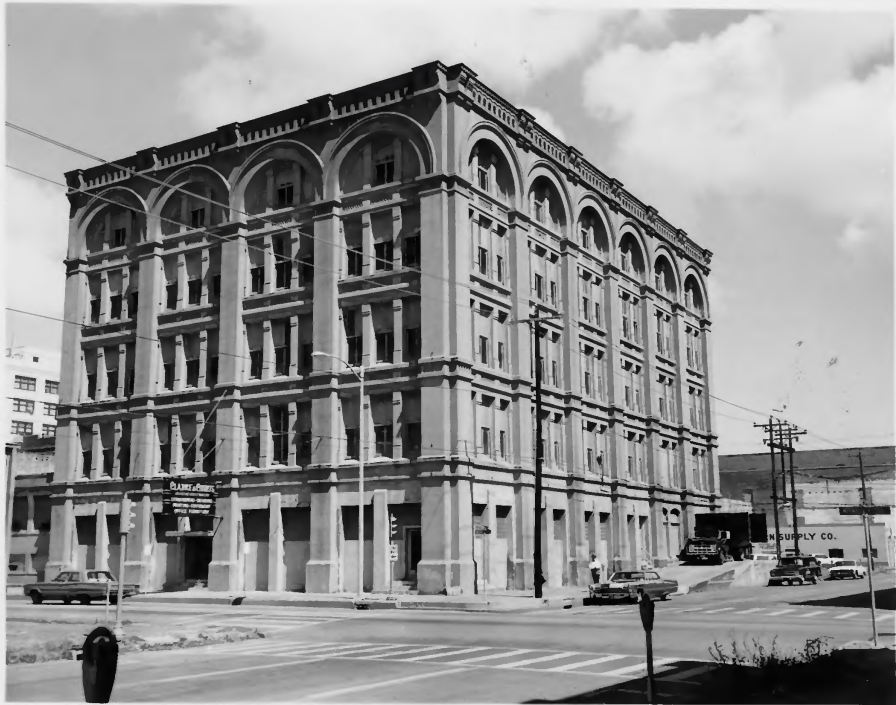
PROPERTY PHOTOGRAPH FORM GaG 624

DESCRIBE VIEW, DIRECTION, ETC. Front and side facades--Southeast elevation of a five story brick commercial structure showing the influence of Richardson and Sullivan bays are formed by colossal pilasters joined by arches at the fifth floor, each bay three windows wide with proportional large openings than were used in Galveston.

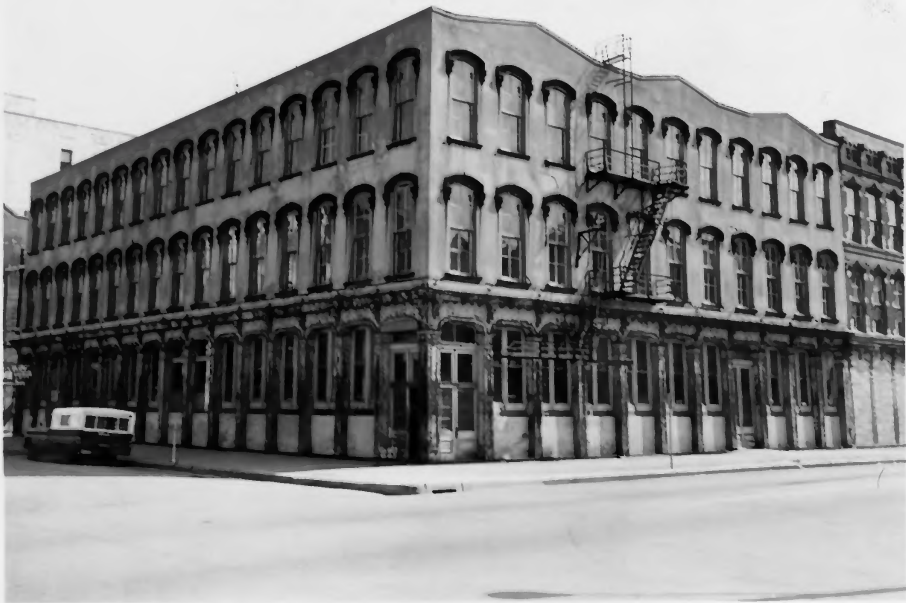
PROPERTY PHOTOGRAPH FORM GaG 623

1. NAME			
COMMON: Focke, Wilkens & Lange Building			
AND/OR HISTORIC:			
2. LOCATION			
STREET AND NUMBER: 2301-2307 Strand			
CITY OR TOWN: Galveston			
STATE:	CODE	COUNTY:	CODE
Texas	042	Galveston	167
3. PHOTO REFERENCE			
PHOTO CREDIT: Texas State Historical Survey Committee			
DATE OF PHOTO: March 19, 1969			
NEGATIVE FILED AT: Texas State Historical Survey Committee			
108 W. 15th. Street, Austin, Texas			
4. IDENTIFICATION			
DESCRIBE VIEW, DIRECTION, ETC. Front and side facades--Northeast elevation of a three story stuccoed brick with cast iron front on the ground floor and cast iron/wood molds and sills. Cornice now altered.

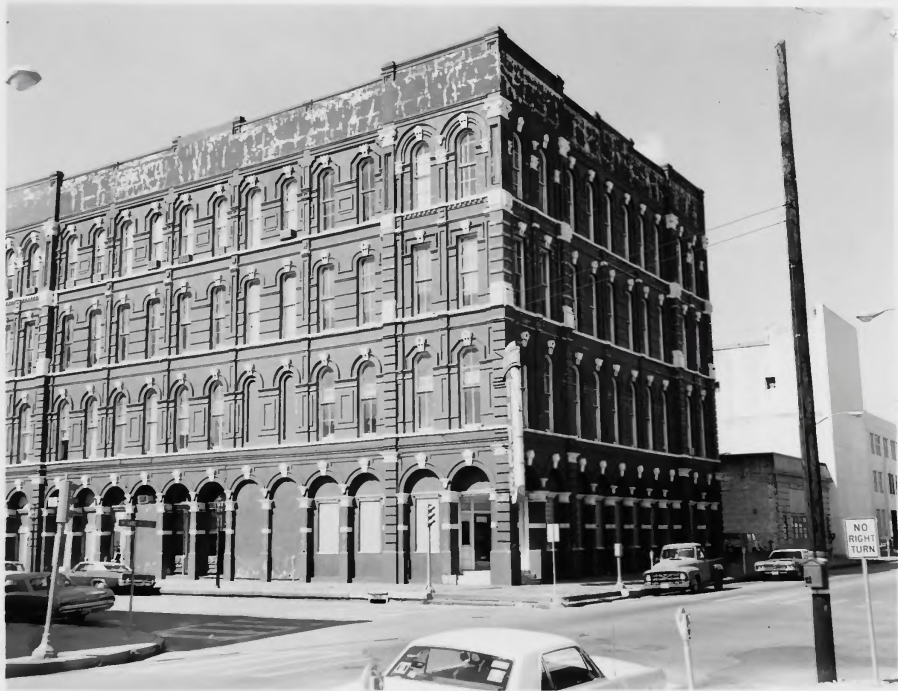
PROPERTY PHOTOGRAPH FORM GaG 621

DESCRIBE VIEW, DIRECTION, ETC. Front and side facades--Southwest elevation of a four story red brick building with white keystones, capitals, and bands. The original cornice and roof are missing, otherwise the building is unchanged. The excellent carved woodwork of some of the doors is notable.

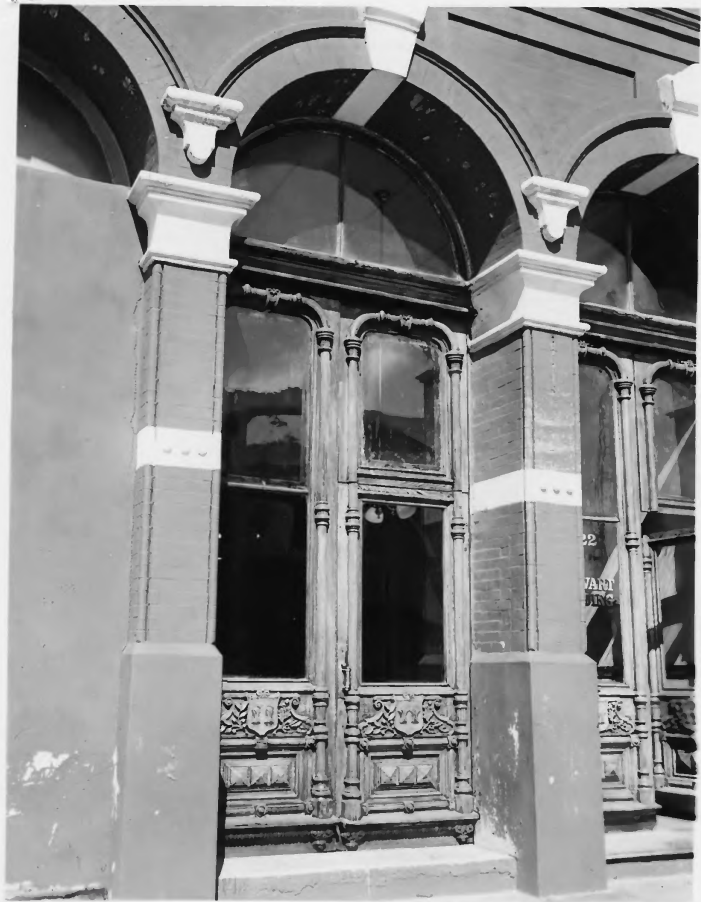
PROPERTY PHOTOGRAPH FORM GaG 621

Front facade--West elevation detail showing carved wood door recessed in brick and stuccoed columns and arch.

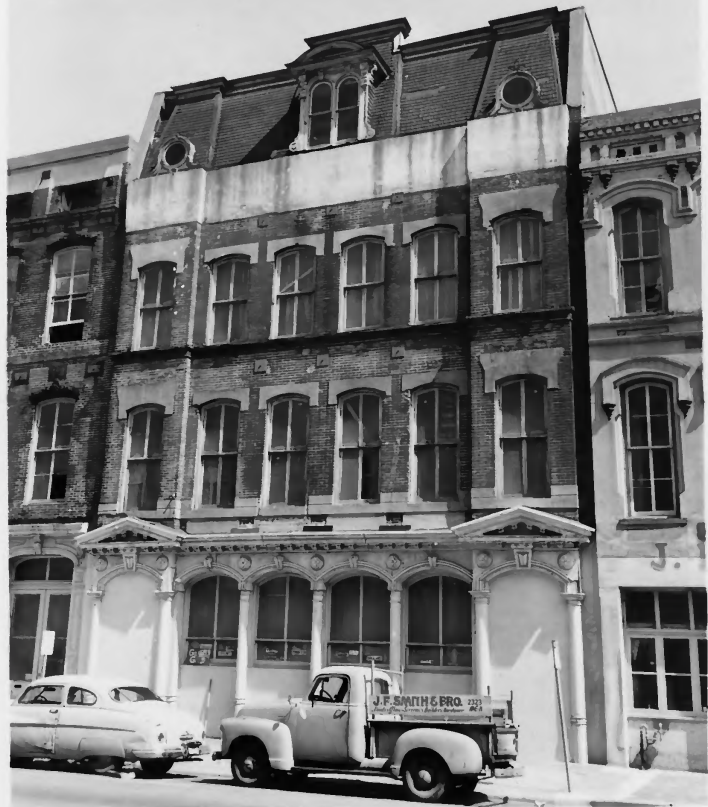
PROPERTY PHOTOGRAPH FORM GaG 623

<b>1. NAME</b>			
COMMON: <b>Merchants Mutual Ins. Co.</b>			
AND/OR HISTORIC:			
<b>2. LOCATION</b>			
STREET AND NUMBER: <b>2313-2319 Strand St.</b>			
CITY OR TOWN: <b>Galveston</b>			
STATE:	CODE	COUNTY:	CODE
<b>Texas</b>	<b>042</b>	<b>Galveston</b>	<b>167</b>
<b>3. PHOTO REFERENCE</b>			
PHOTO CREDIT: <b>Texas State Historical Survey Committee</b>			
DATE OF PHOTO: <b>March 19, 1969</b>			
NEGATIVE FILED AT: <b>Texas State Historical Survey Committee 108 W. 15th. Street, Austin, Texas</b>			
<b>4. IDENTIFICATION</b>			
DESCRIBE VIEW, DIRECTION, ETC. <b>Front facade--North elevation of a three story brick and cast iron commercial structure with a Mansard roof and an attic dormer. There is a fine Renaissance revival cast iron front at the street level with roundels, keystones, brackets, and two pediments. The cast iron cornice, drip stone mouldings and other decorations have been removed.</b>

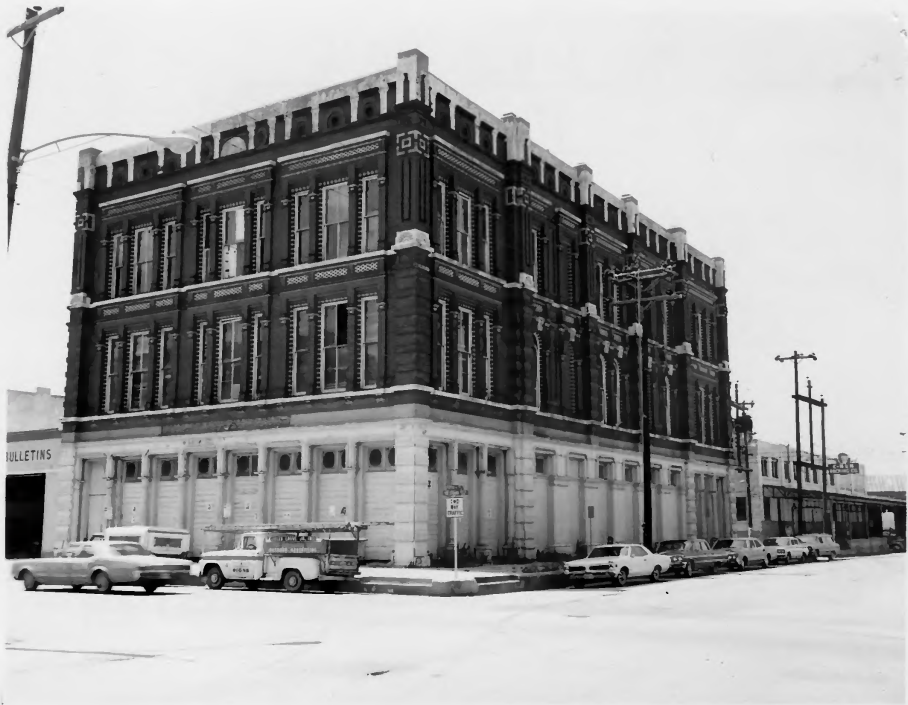
PROPERTY PHOTOGRAPH FORM GaG 682

Front and side facades--Southeast elevation of a three story pressed brick and terracotta building with the facade divided into bays by grouped flat moldings and pilasters. There are flat lintels throughout with the first floor supports made of cast iron columns in combination with brick piers.

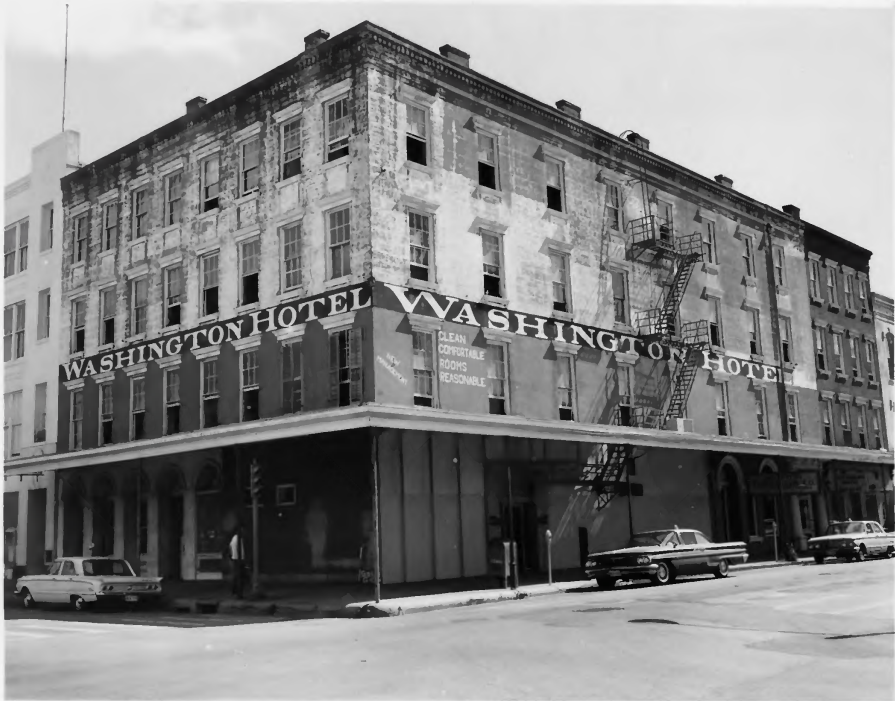
PROPERTY PHOTOGRAPH FORM GaG 622  
p12, 13, 14

<b>1. NAME</b>			
COMMON: <u>Washington Hotel</u>			
AND/OR HISTORIC:			
<b>2. LOCATION</b>			
STREET AND NUMBER: <u>2218-2222 Mechanic St.</u>			
CITY OR TOWN: <u>Galveston</u>			
STATE: <u>Texas</u>	CODE: <u>042</u>	COUNTY: <u>Galveston</u>	CODE: <u>167</u>
<b>3. PHOTO REFERENCE</b>			
PHOTO CREDIT: <u>Texas State Historical Survey Committee</u>			
DATE OF PHOTO: <u>March 19, 1969</u>			
NEGATIVE FILED AT: <u>Texas State Historical Survey Committee</u> <u>108 W. 15th. Street, Austin, Texas</u>			
<b>4. IDENTIFICATION</b>			
DESCRIBE VIEW, DIRECTION, ETC. <u>Front and side facades--Southwest elevation of a four story stuccoed brick Greek Revival commercial building with simple classic detail, simple brick cornice.</u>

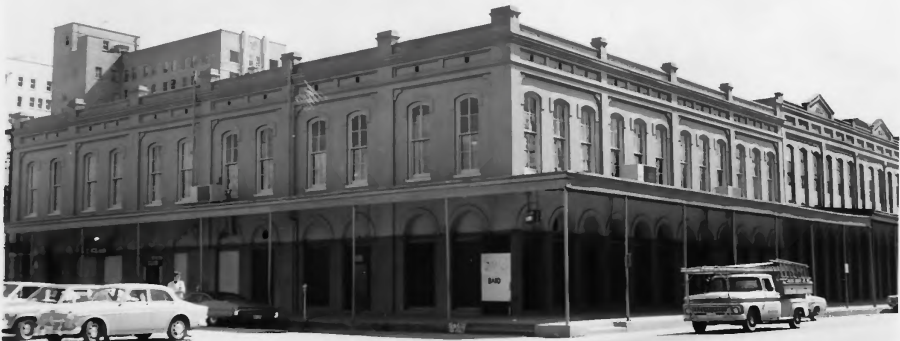
PROPERTY PHOTOGRAPH FORM GaG 620

DESCRIBE VIEW, DIRECTION, ETC. **Front and side facades--Northeast elevation of a two story brick building with three windows to a bay on the shorter (four bays) side and two windows to a bay (six bays) on the longer side. It has simple detailing with an arcade formed by the first floor arched opening and square piers.**

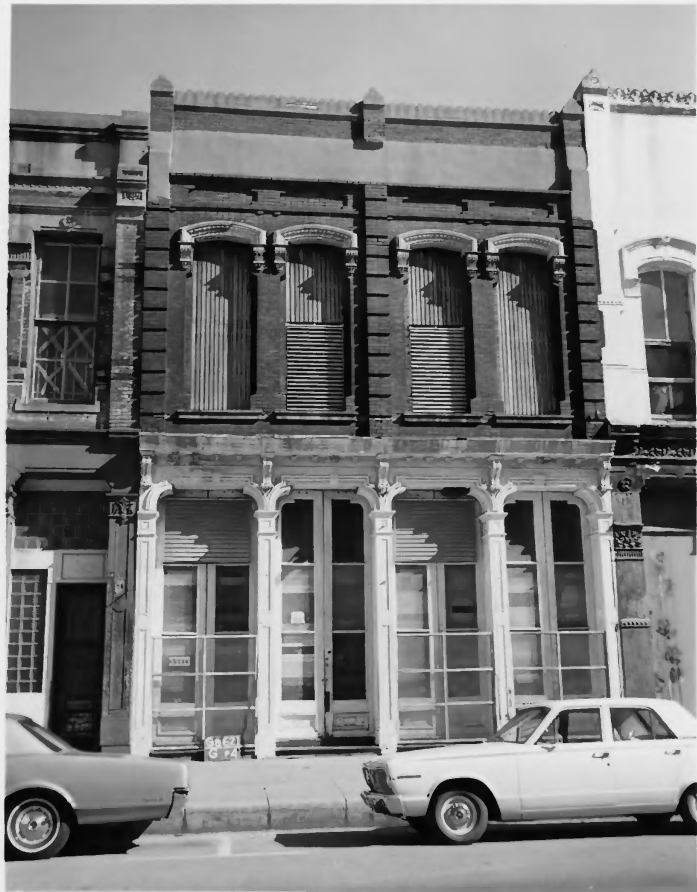
PROPERTY PHOTOGRAPH FORM GaG 621

DESCRIBE VIEW, DIRECTION, ETC. Front facade--North elevation of a two story brick and iron structure divided into two bays with two windows per bay. The first floor has a cast iron front with slender pilasters. The second floor is exposed brick with cast iron hood moulds above the windows.

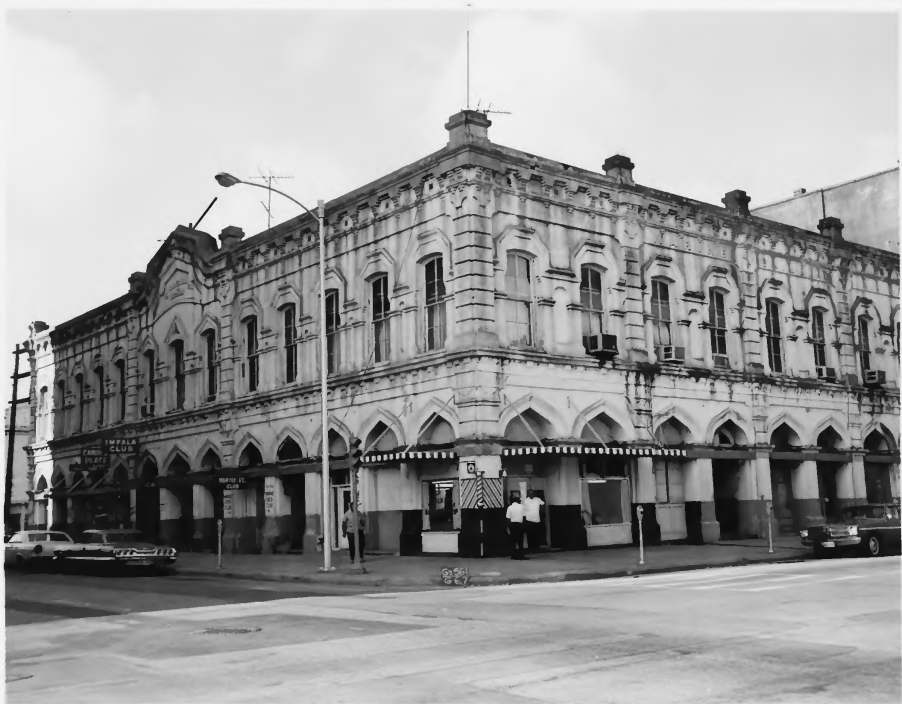
PROPERTY PHOTOGRAPH FORM GaG 561

DESCRIBE VIEW, DIRECTION, ETC. Front and side facades--Northeast elevation of a Victorian style two story stucco covered brick building. The first floor openings form an arcade with ogee or "Moorish" arches. A central pavilion is created with rusticated pilasters and slightly raised cornice. Segmental arched second floor windows are emphasized by an ornamental string course. The names "Suderman & Dolson" and date 1904 inscribed above main entrance.
