**NATIONAL REGISTER OF HISTORIC PLACES  
INVENTORY - NOMINATION FORM**

HISTORIC Mesa Verde National Park Headquarters, Museum, Post Office, Ranger  
Dormitory, Superintendents Residence, and Community Building

AND/DR COMMON  
Mesa Verde Administrative District (Preferred)

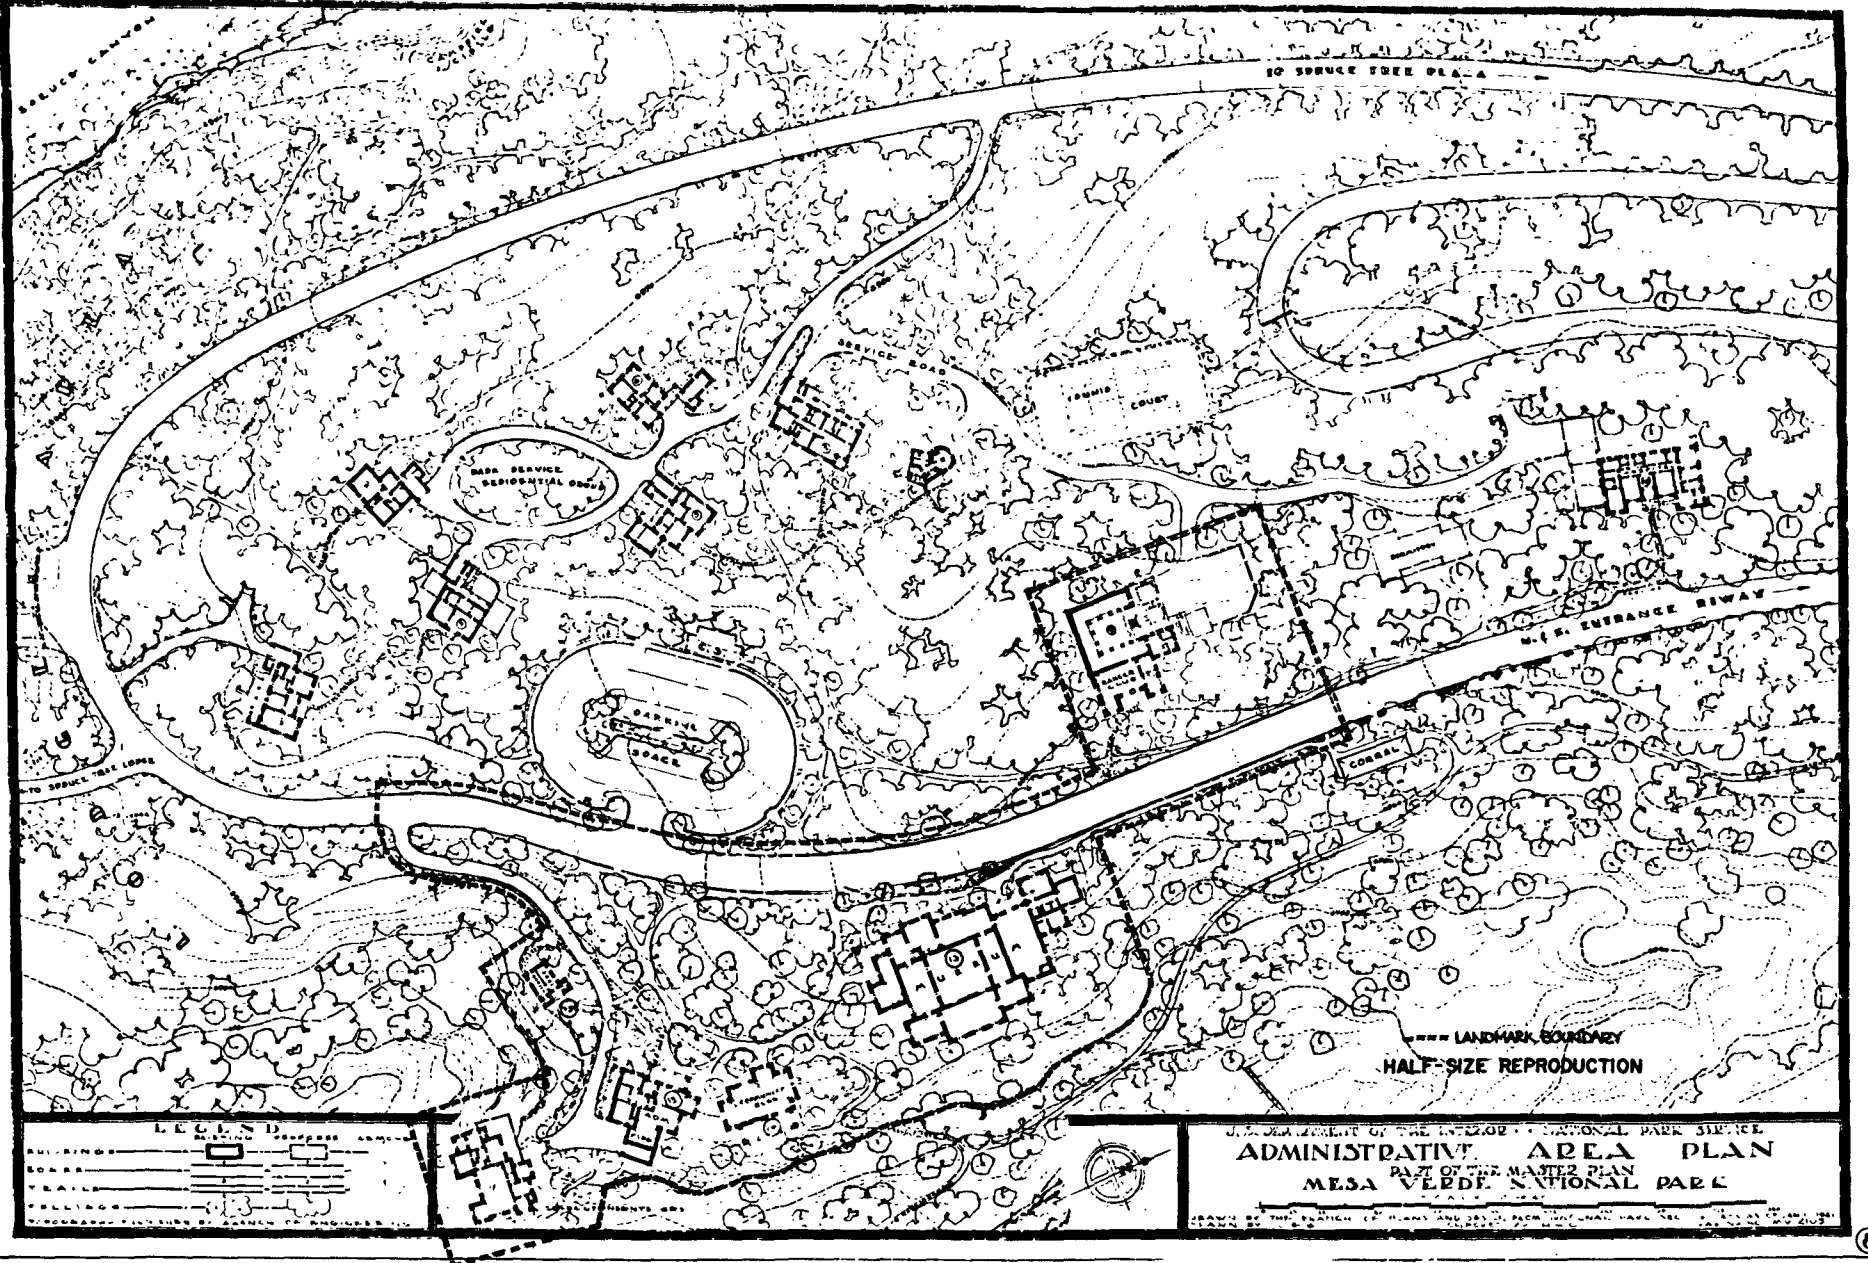
U.S. DEPARTMENT OF THE INTERIOR • NATIONAL PARK SERVICE  
**ADMINISTRATIVE AREA PLAN**  
 PART OF THE MASTER PLAN  
 MESA VERDE NATIONAL PARK

The boundary, as shown on the enclosed map, begins at a point 20 feet southwest of the southwest corner of the post office, then proceeds east running parallel to and 20 feet out from the south wall of the post office; then south running parallel to and 20 feet out from the westernmost wall of the superintendent's residence; then northwest approximately thirty feet to a point 25 feet from the southern corner of the administration building; then traversing along the canyon slope at the 6,940-foot contour approximately 25 feet behind the community building and 45 feet behind the museum to a point 75 feet northeast of the northeast corner of the museum building; then west running parallel to and 20 feet north of the north wall of the museum to a point 10 feet east of the east road edge; then north approximately 190 feet; then west 180 feet; then south 180 feet running parallel to and 20 feet out from the west wall of the ranger club; then approximately 150 feet east to a point 10 feet west of the west side of the road edge; then running in a south-southwesterly direction staying 10 feet west of the road to a point across from the intersection of the main road and the post office access road; then crossing the main road and running 10 feet south of and parallel to the south side of the access road to a point 20 feet northwest of the northwest corner of the post office; then running south in a straight line to the starting point.

Buildings	—
Roads	—
Trailings	—
Landmark Boundary	---

--- LANDMARK BOUNDARY  
 HALF-SIZE REPRODUCTION
