National Register of Historic Places Multiple Property Documentation Form

Traditional Patterned Brickwork Buildings in New Jersey

Traditional Patterned Brickwork Buildings in New Jersey, ca.1680 – ca.1830 (Statewide)

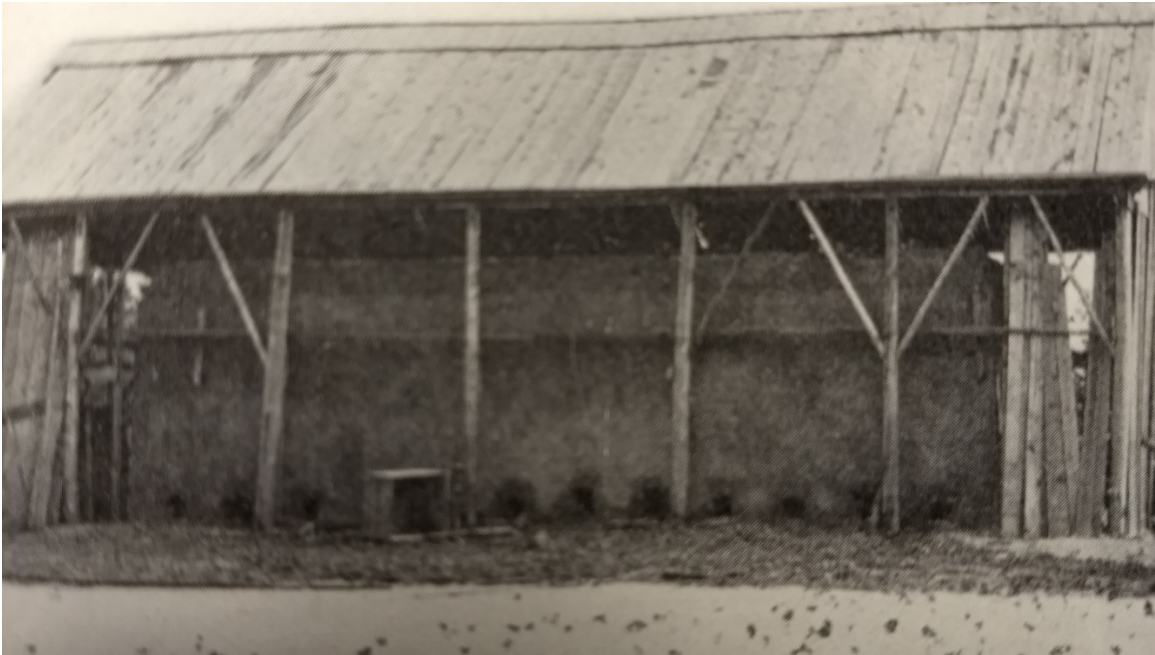
Figure 7 Scove kiln (evolution of the "arches"-type clamp), in NJ, ca.1900

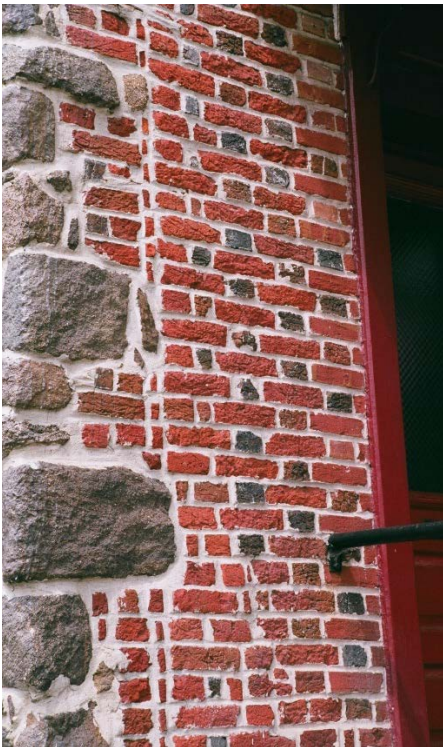
Figure 10 Mount Holly, NJ. Local stone was combined with patterned brickwork in some buildings.

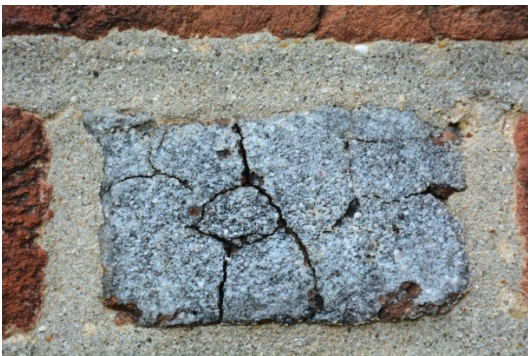
*Figure 13 Bluish gray. The original color before surface deterioration was much bluer.
(Photo courtesy of Janet Sheridan.)*

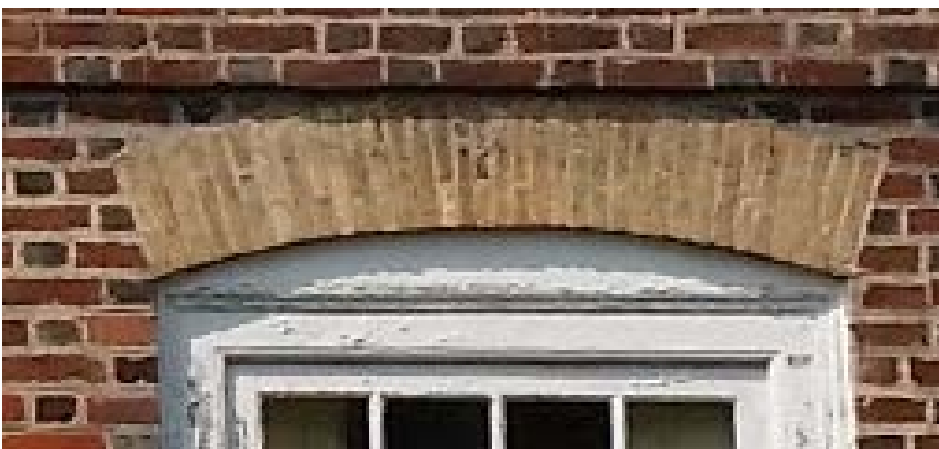
Figure 16 Off-white bricks, rubbed and gauged in a relieving arch.

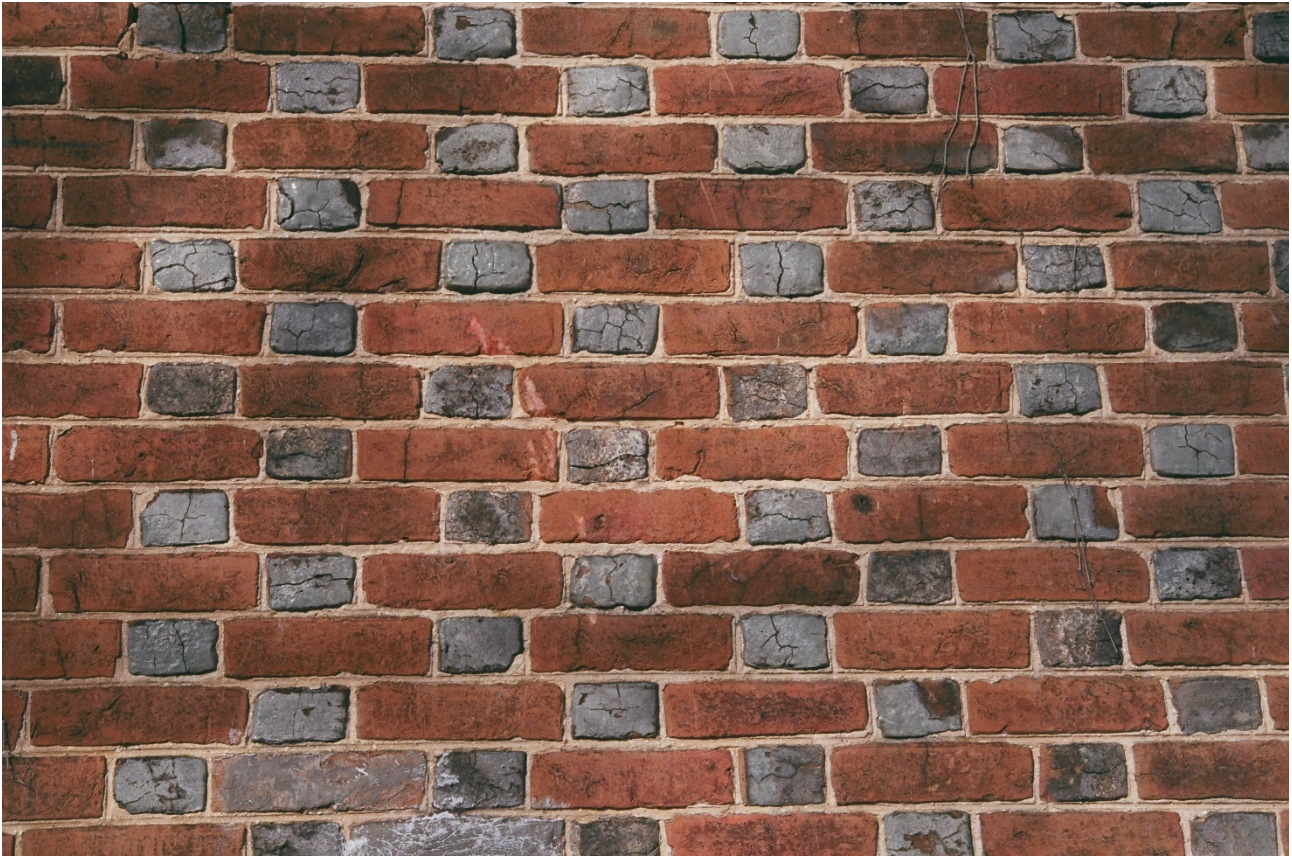
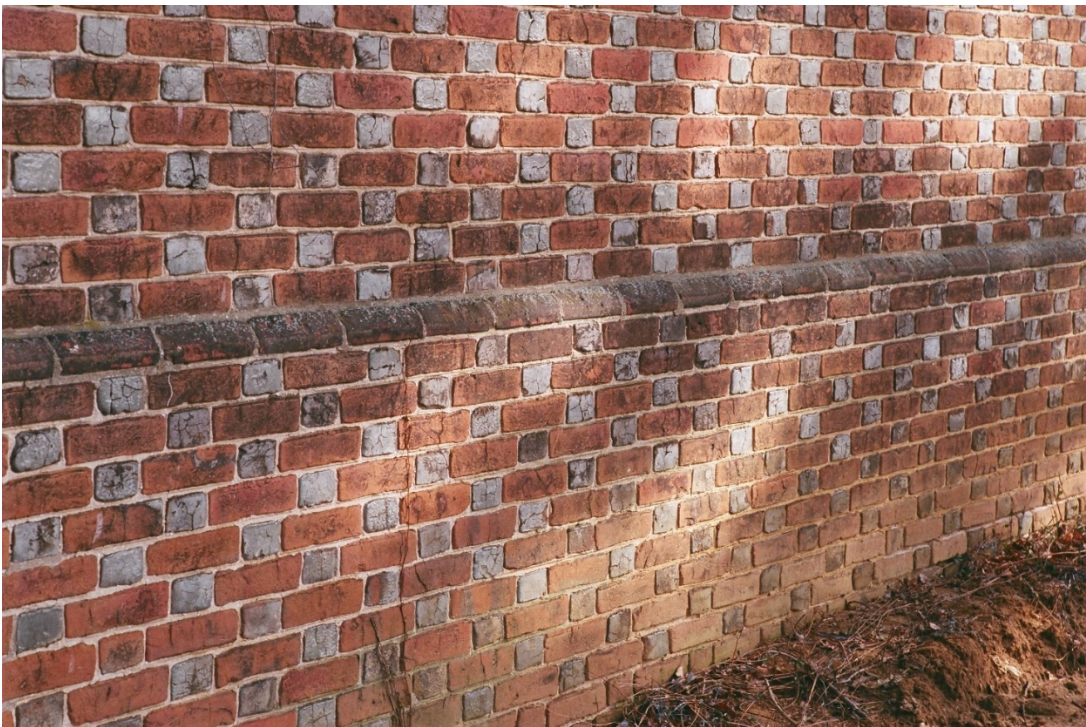
Figure 17 Flemish checker, above and below the water table, an unusual practice.

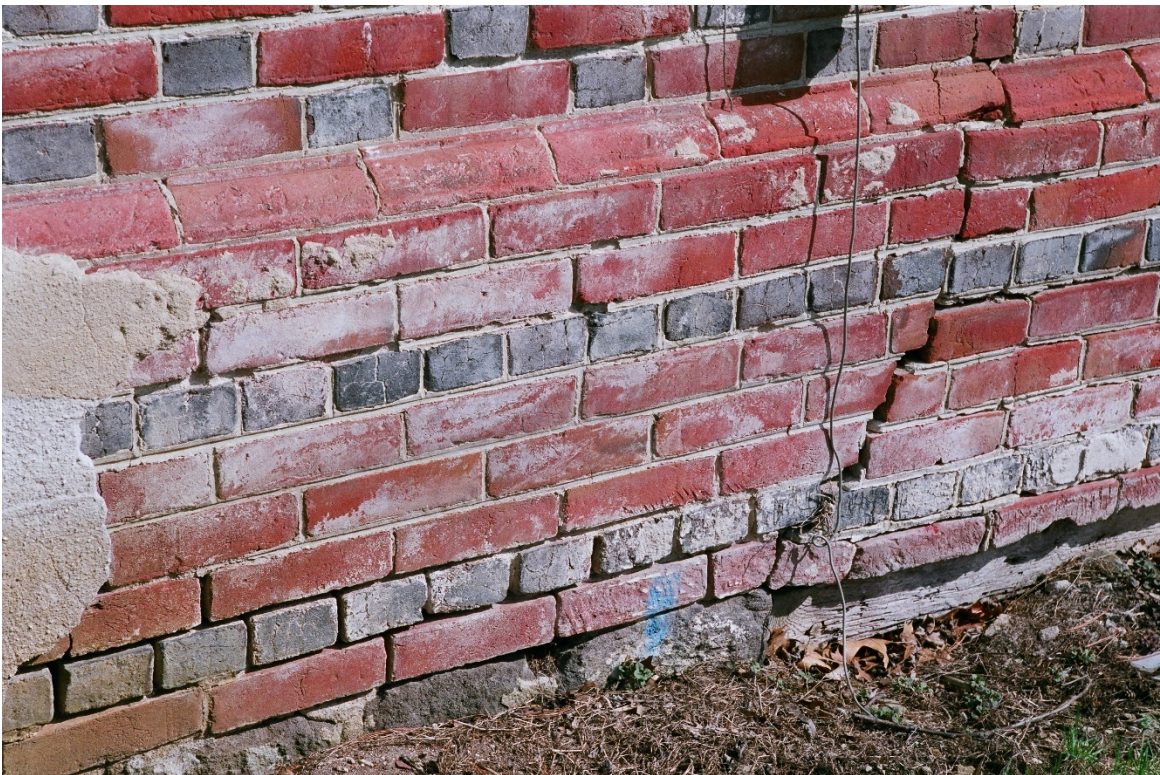
Figure 22 Banding, below the water table.

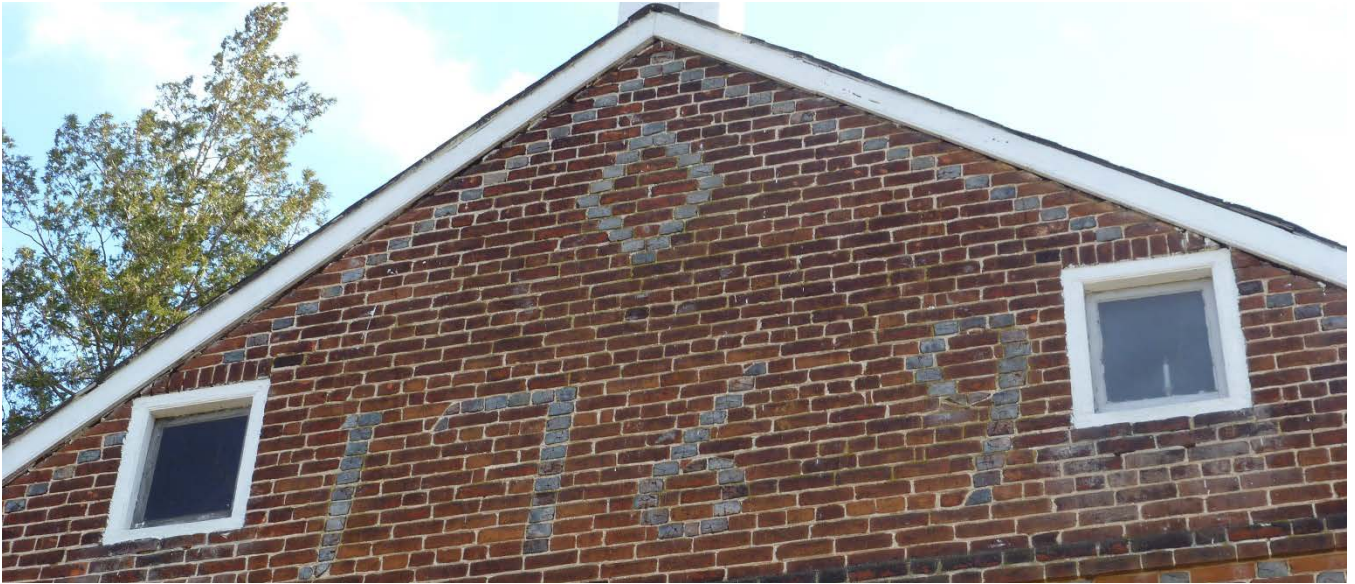
Figure 23 Pediment outline, with hollow diamond at apex.

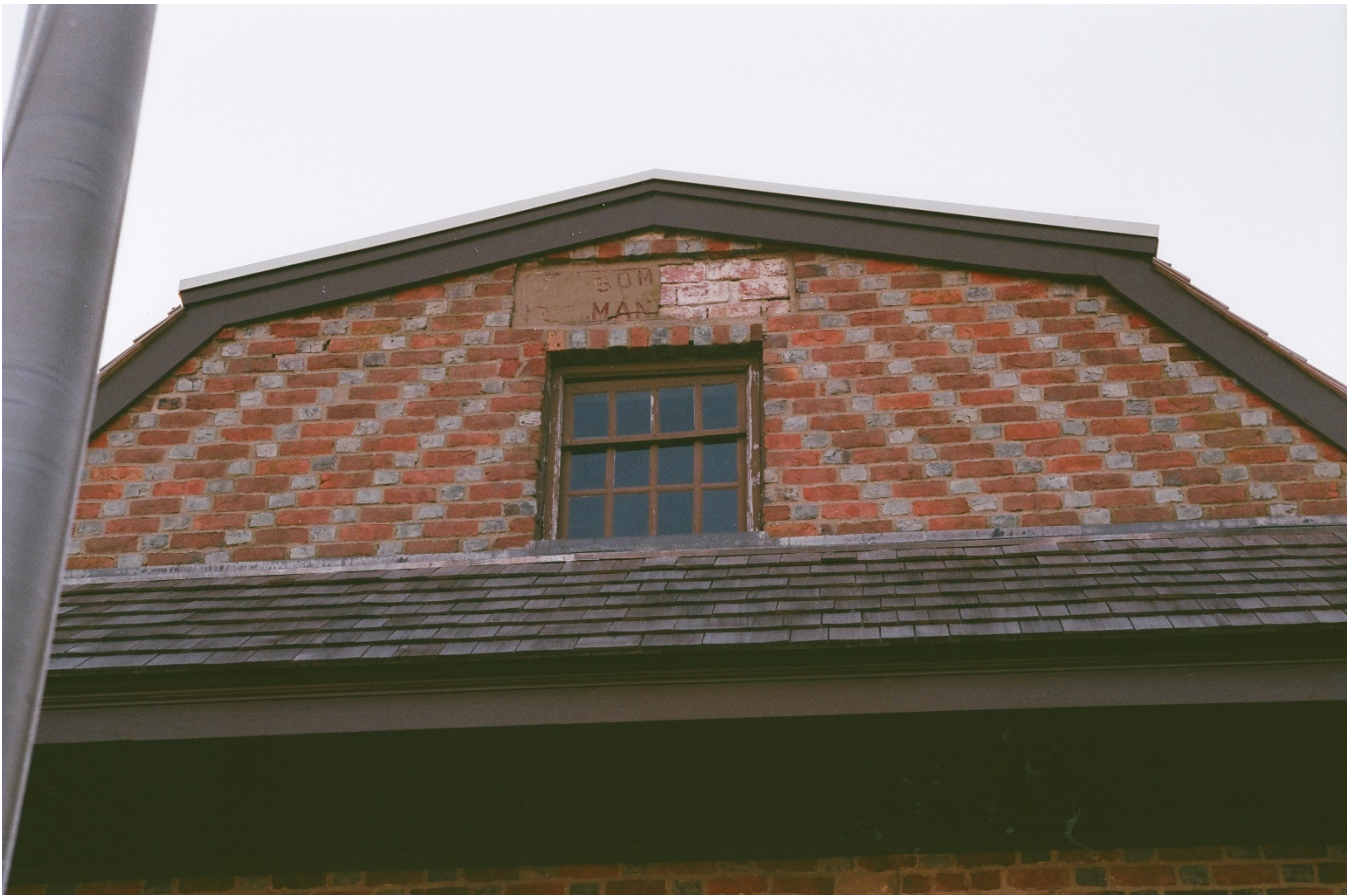
Figure 24 Diagonals in the Somers Mansion.

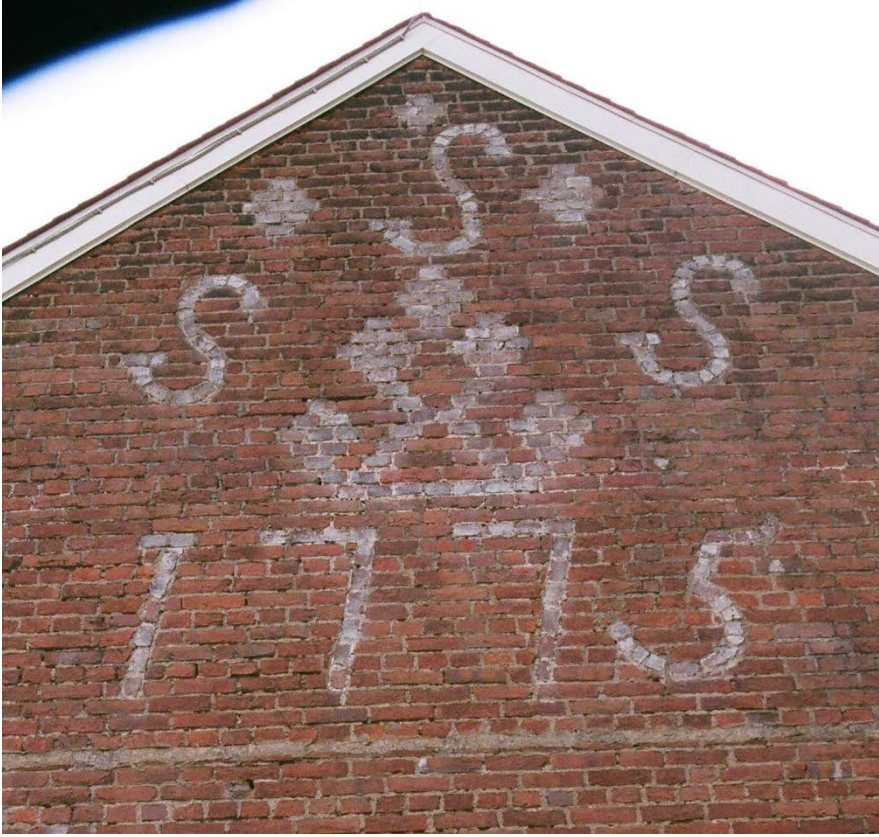
Figure 27 A simple coronet, with balanced date and owners' initials

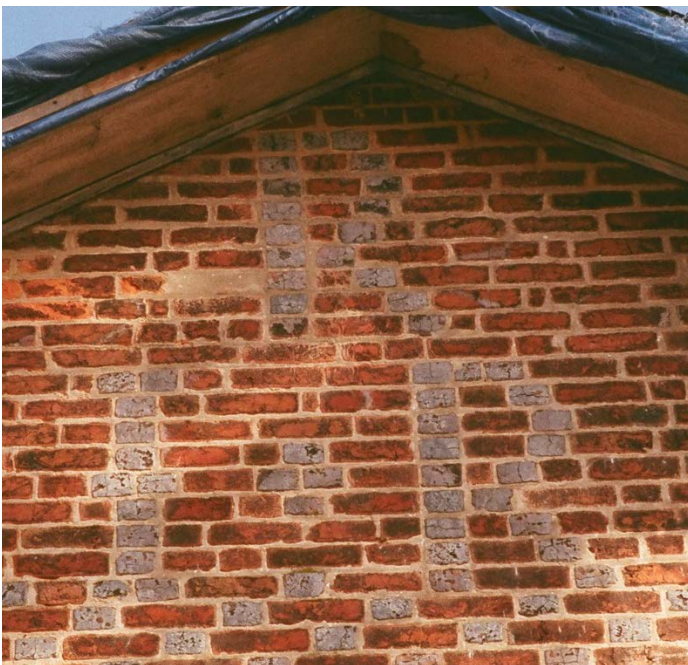
Figure 28 The initials are for John and Rachel Rogers. The "I" with two headers in the middle stands for a "J."

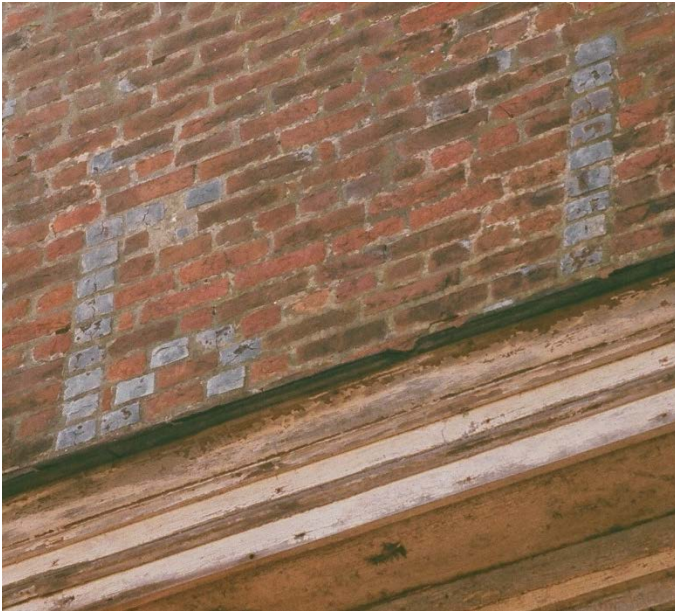
Figure 29 The figure on the left appears to be an awkward '5', not a '6.'

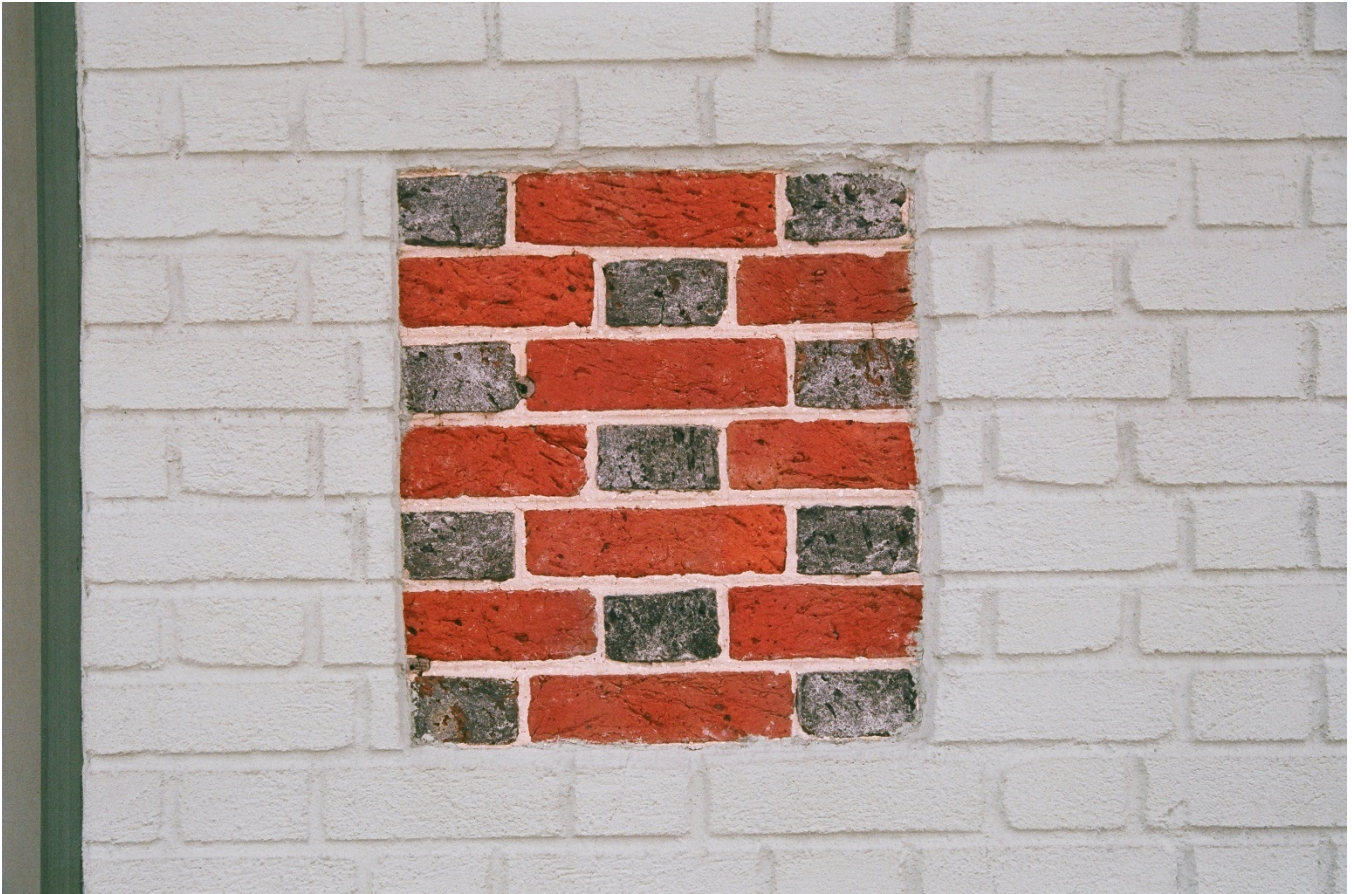
Figure 36 This building has Flemish checker lurking under brickface.

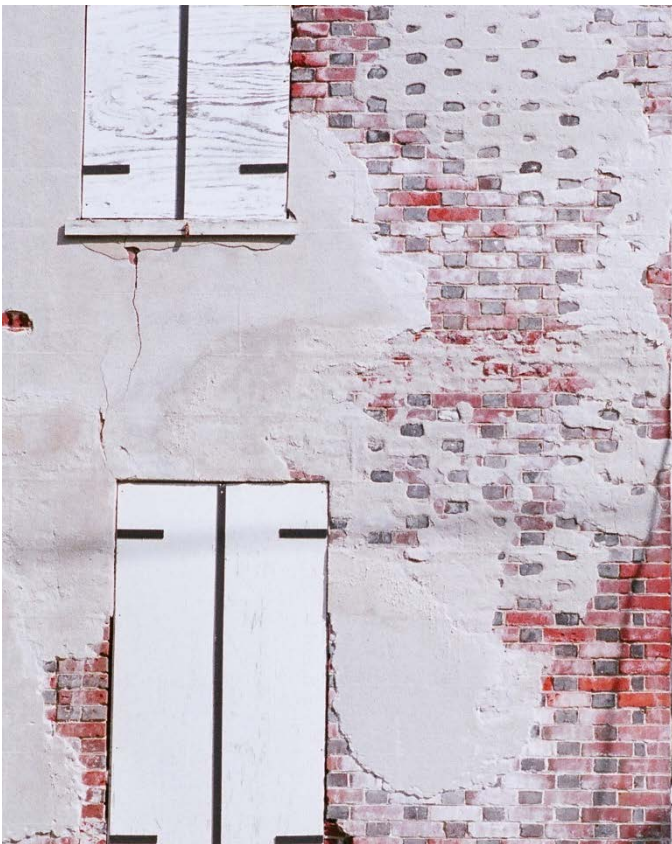
Figure 37 Stucco eroding away...

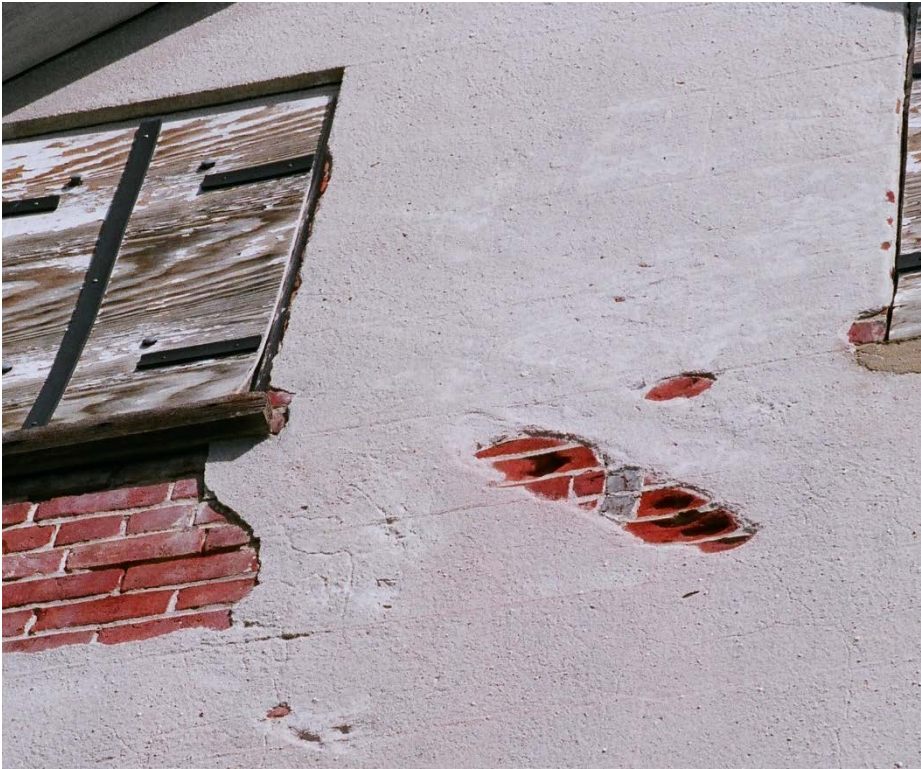
Figure 38 Stucco spalling, slowly revealing a date.

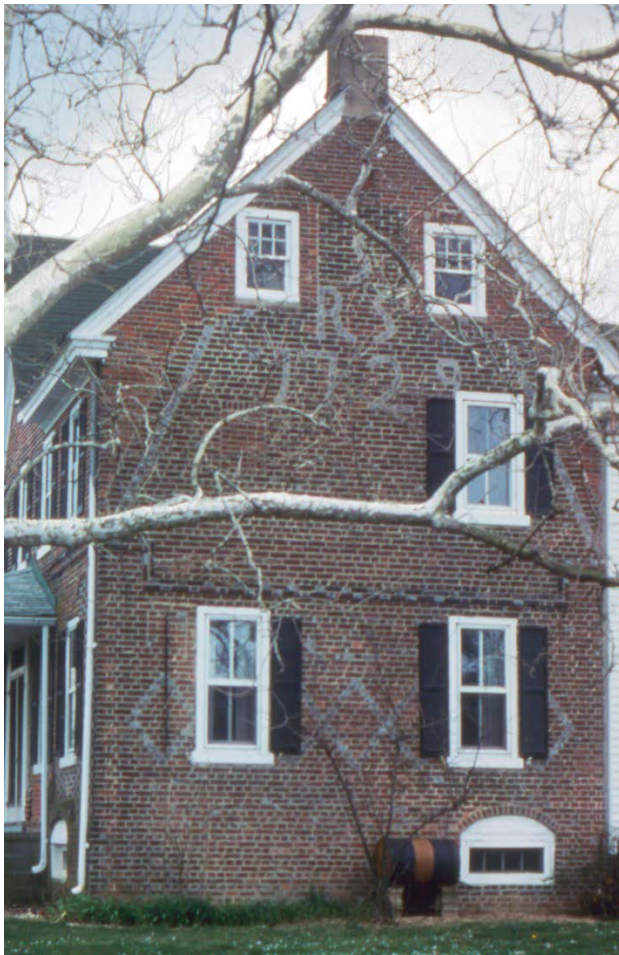
Figure 4 Vitrified brick shows profile of gambrel roof before enlargement to two full stories.

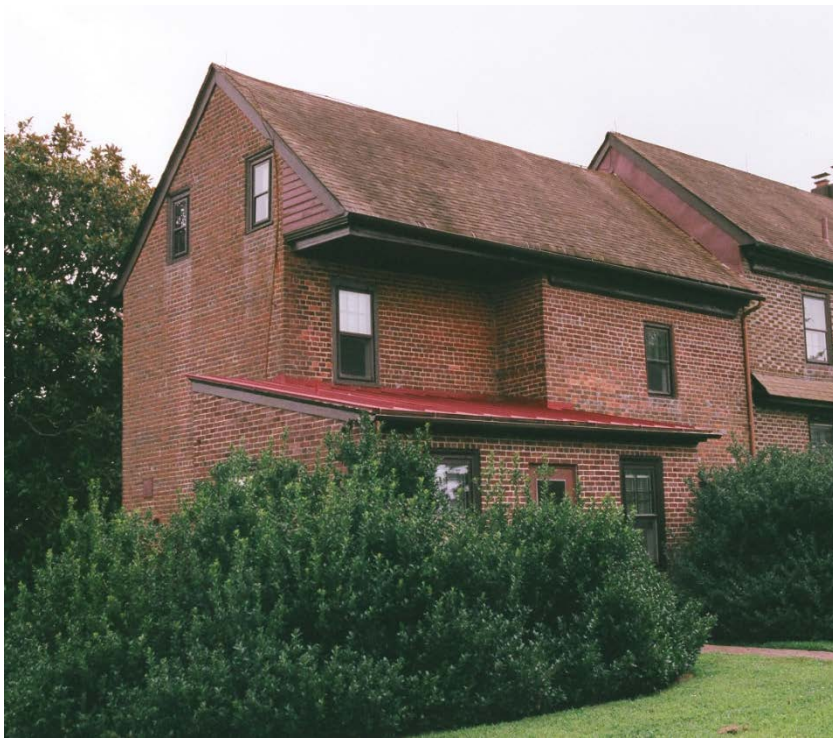
Figure 6 A rare house type, view of rear elevation. This example has a façade of Flemish checker.

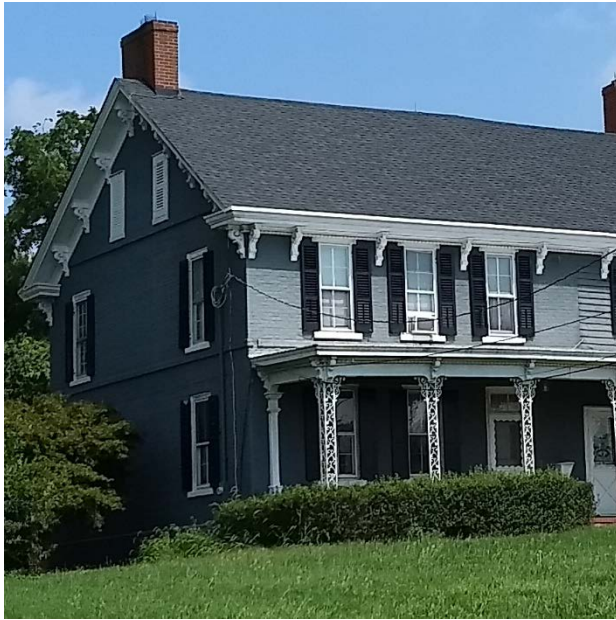
Figure 7 Side-hall house, 3 bays wide, 2 rooms deep. Chiefly seen in counties from Camden northward.
