# National Register of Historic Places Multiple Property Documentation Form

Historic and Architectural Resources of the Mound-Horace Area,  
Montgomery County, Ohio (Dayton)

Historic and Architectural Resources of the Mound-Horace Area  
Montgomery County, Ohio

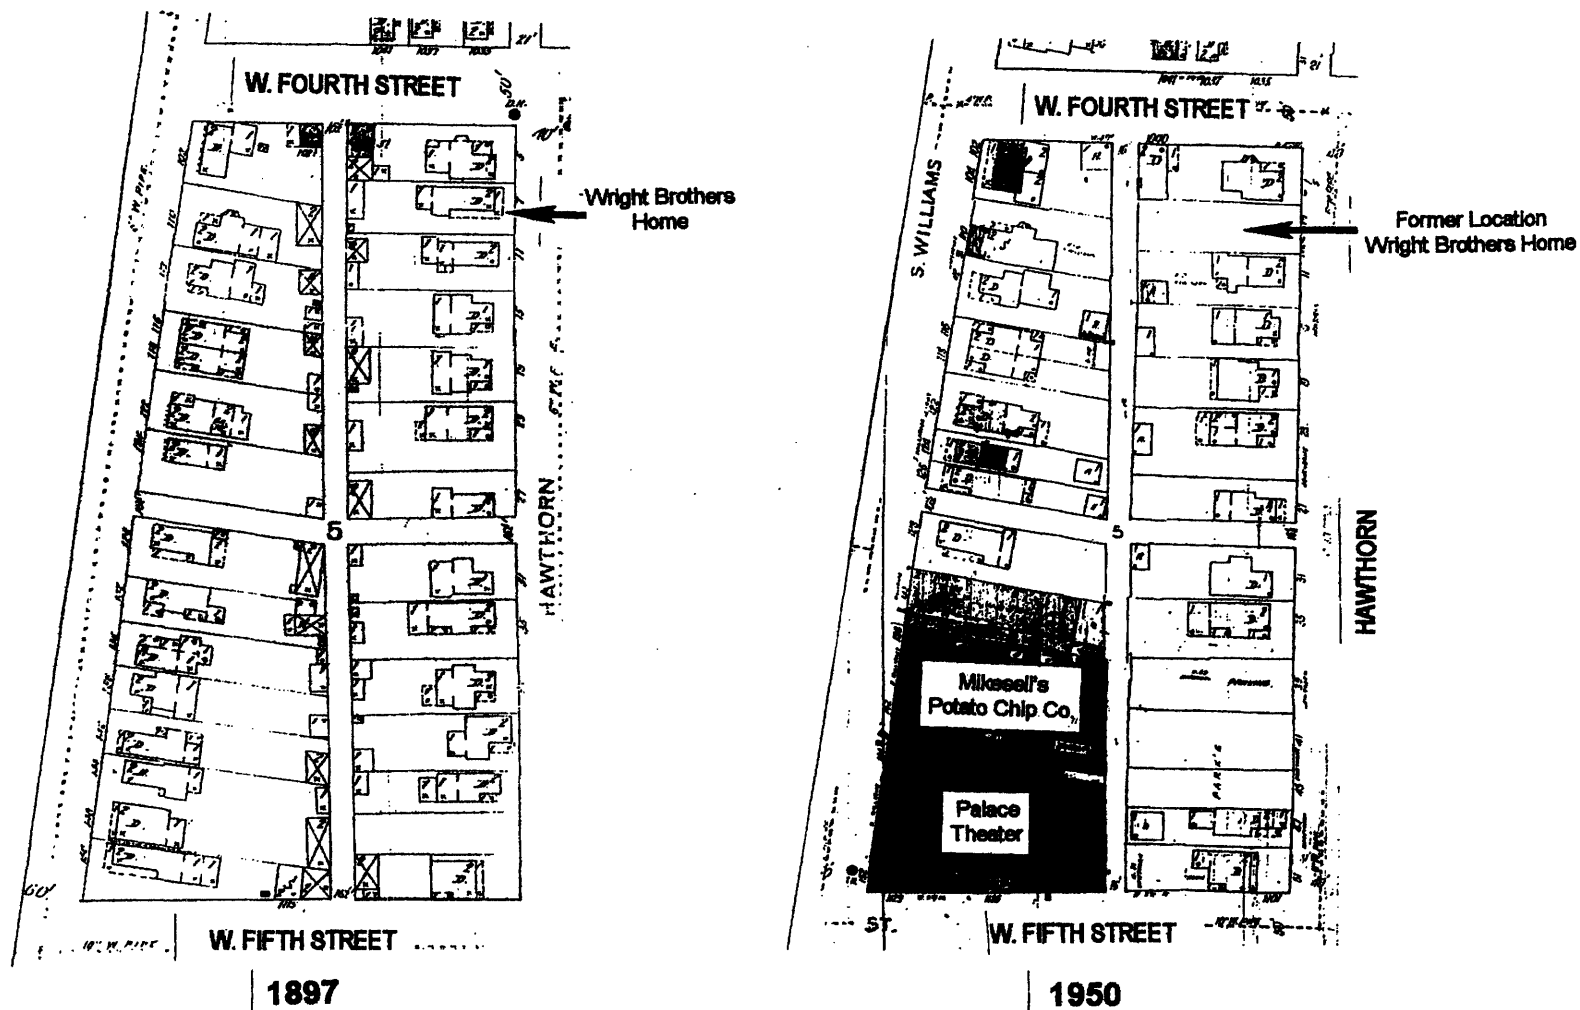
## Mound-Horace Area Example of One Block's Development Over Time

Source: Sanborn Insurance Map (dates as stated)

The architectural development of the area resulted in numerous small scale, working class houses being placed on small width lots. This resulted in a tight, dense, compact built form for the streetscapes. Houses were predominantly single family residential, however, several two family

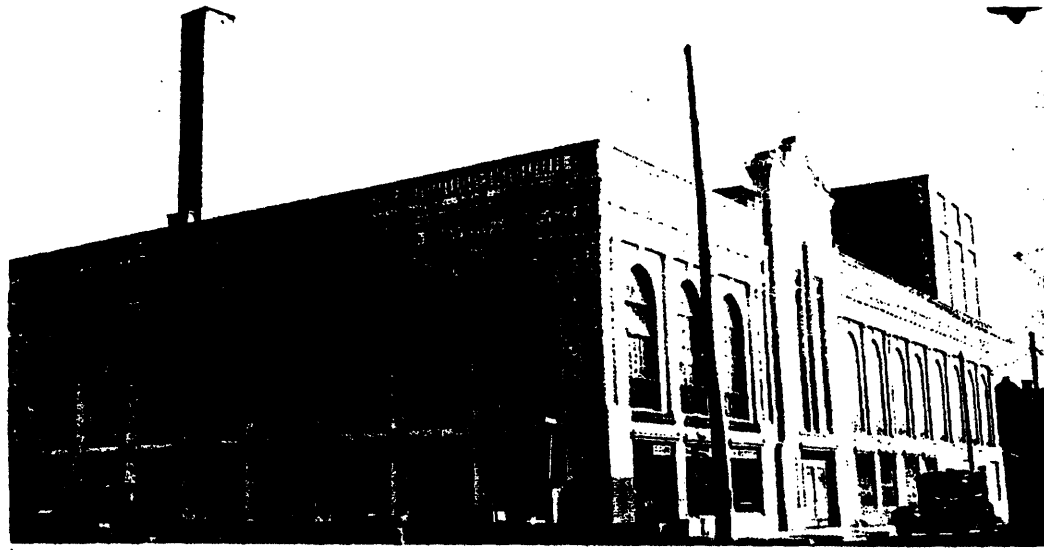
**Palace Theater**

**A) View of Main Exteriors**

Found along West Fifth Street, are two larger scale buildings that incorporated commercial and public oriented land uses. These buildings emerged as West Fifth Street became one of the most important commercial streets to be associated with Dayton's African American culture. One aspect of this development was tied to the establishment of movie and live production theaters. In 1927, the Palace Theater was built in the Second Renaissance Revival style. It is distinguished by the use of lighted and blind arcades which are separated by engaged flat brick columns. Main entry bay projects slightly from the south facade is capped with a low parapet and stone fractables. The theater interior reflects a Spanish motif with pseudo stucco building facades and red tiled roofs at and projecting from either side of the stage. This is a large building that

incorporated the theater designed for motion picture and live performances, a large second floor ballroom used for dances, meetings, and banquets, and retail spaces at the first floor.

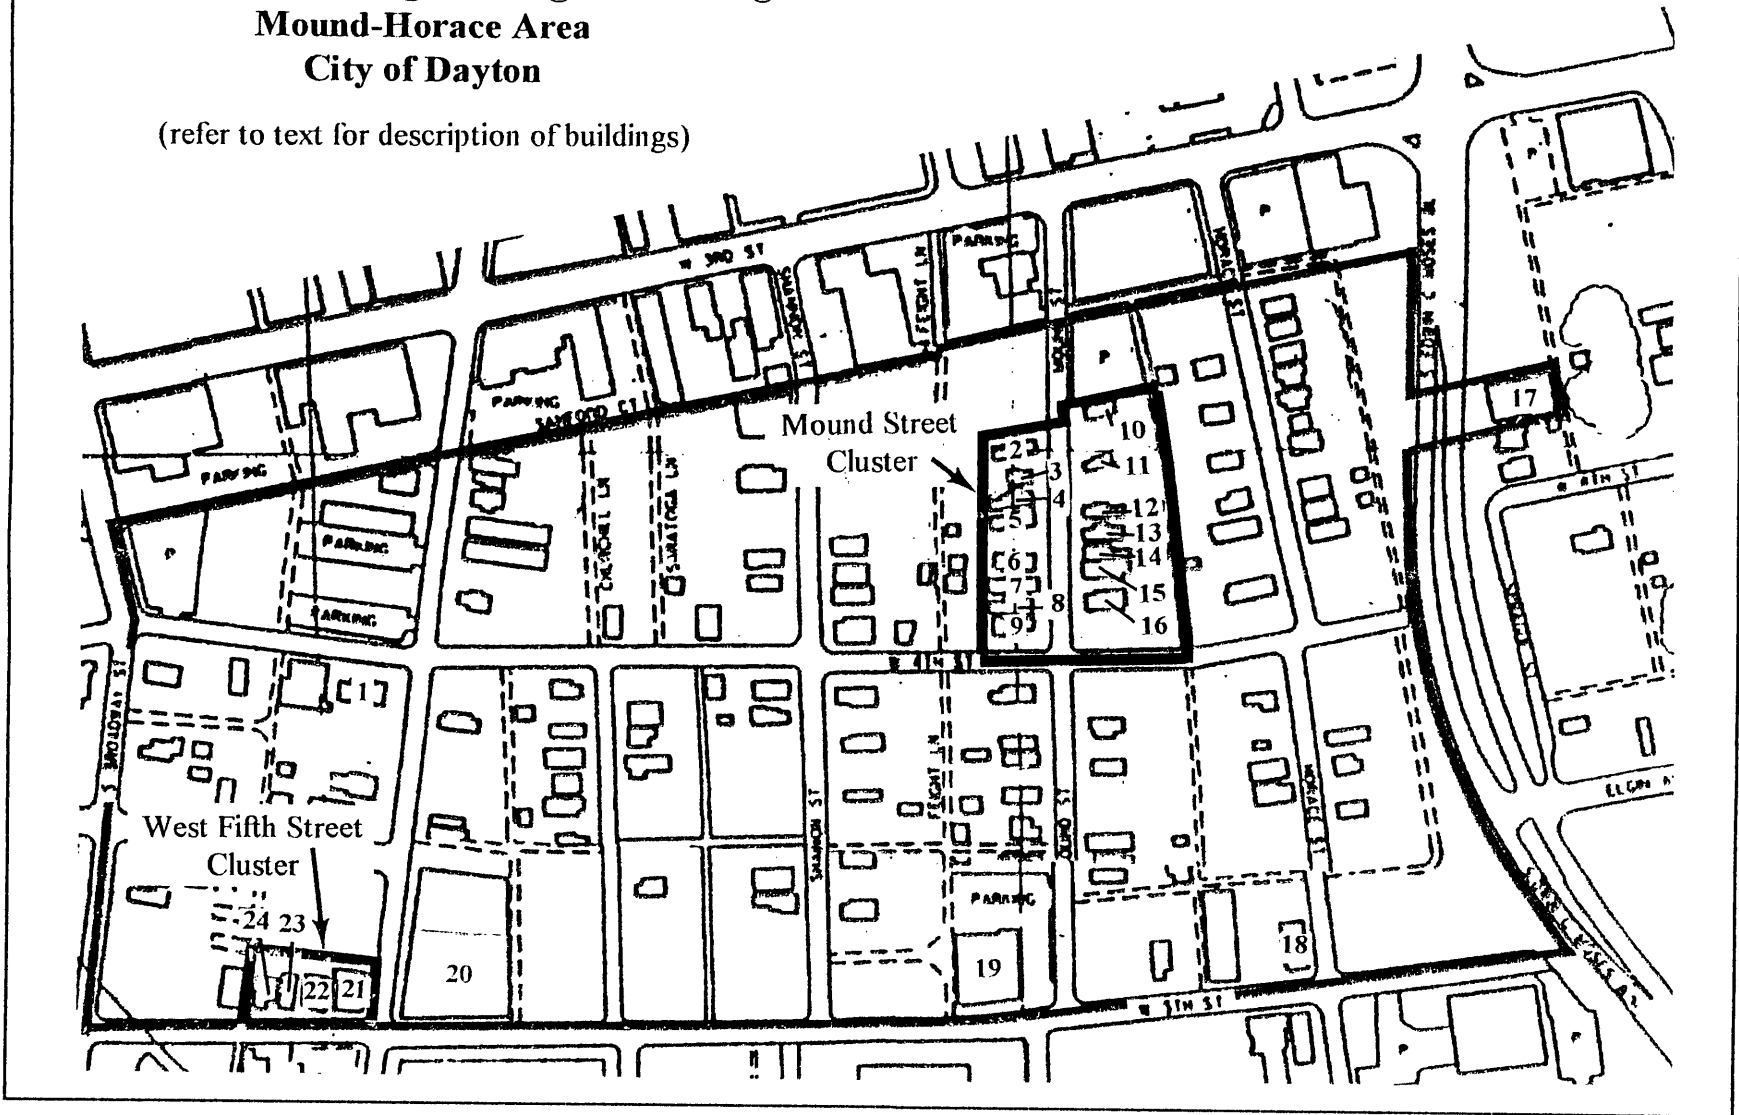
Multiple Property Documentation  
Potential National Register Eligible Buildings  
Mound-Horace Area  
City of Dayton

(refer to text for description of buildings)
