National Register of Historic Places Multiple Property Documentation Form

Historic Resources of Downtown Columbia, Missouri

Historic Resources of Downtown Columbia, Missouri
Boone County, Missouri

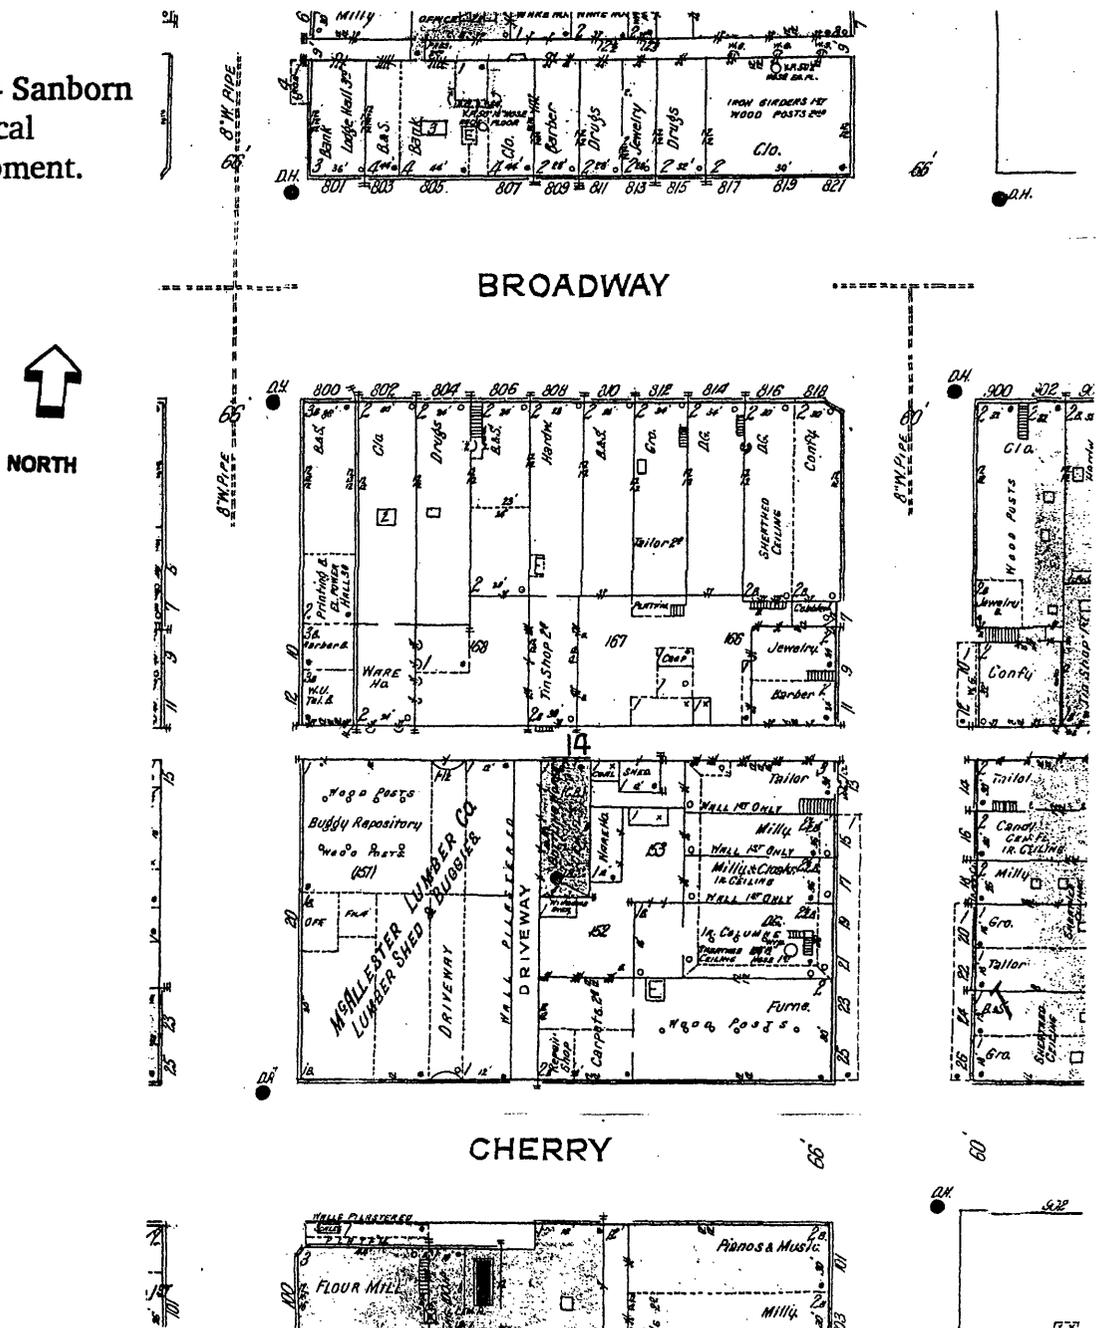
Figure Four. 1914 Sanborn Map, showing typical patterns of development.

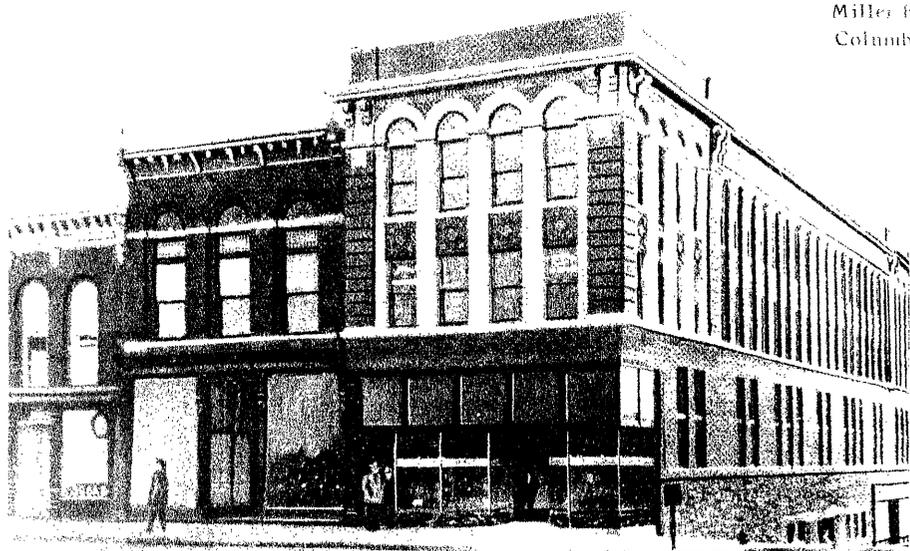
Figure Six. Historic Photo of the Intersection of Eighth Street and Broadway, with typical 19th century storefronts, taken ca. 1915.

Many North American commercial buildings of the late 1800s and early 1900s, including several in downtown Columbia, reflect the widespread availability of prefabricated building parts, which varied from individual elements such as cornices or widow hoods to entire storefront "kits." Mass-produced architectural elements were available from a number of manufacturers, all easily shipped by rail to any interested building owner. One account noted that "factory-produced architectural elements, sold by catalogue, offered small-town merchants....an opportunity to order complete 'store fronts' for their buildings. Even without a local architect, the latest in eclectic and lavish ornament could be added to any kind of building, of any age, or any material."⁶⁰ Columbia's connection to the North Missouri Railroad in the 1860s provided local merchants and builders with easy access to such components.

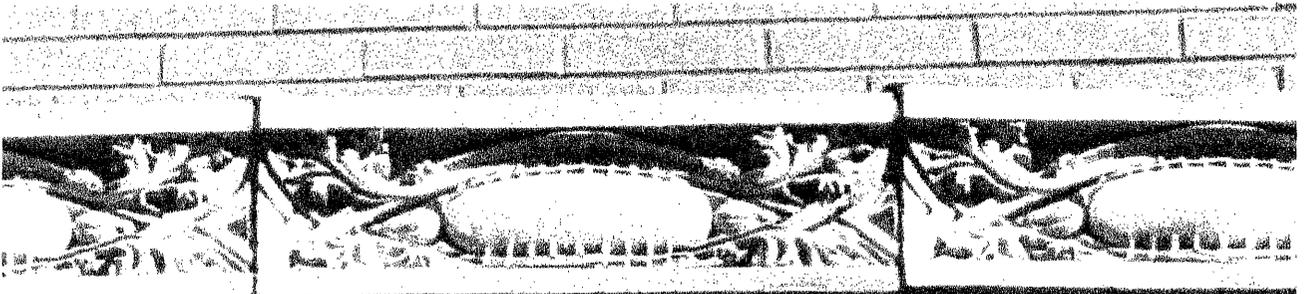
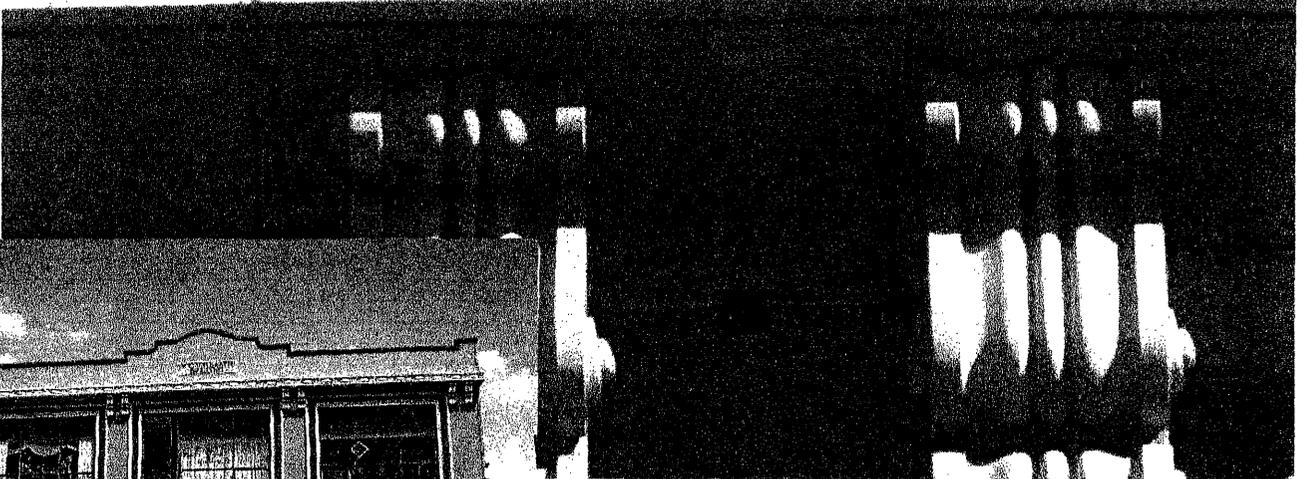
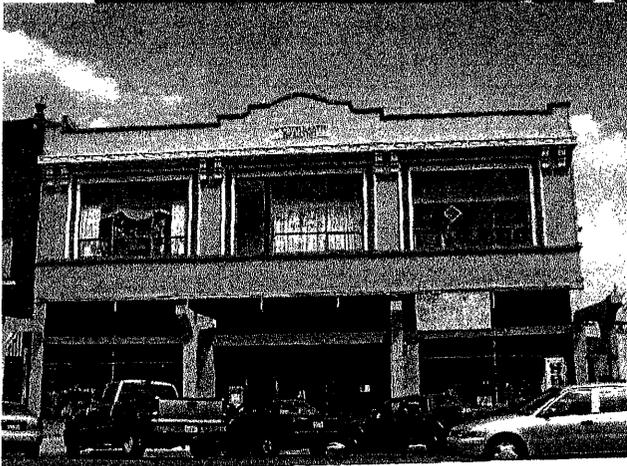
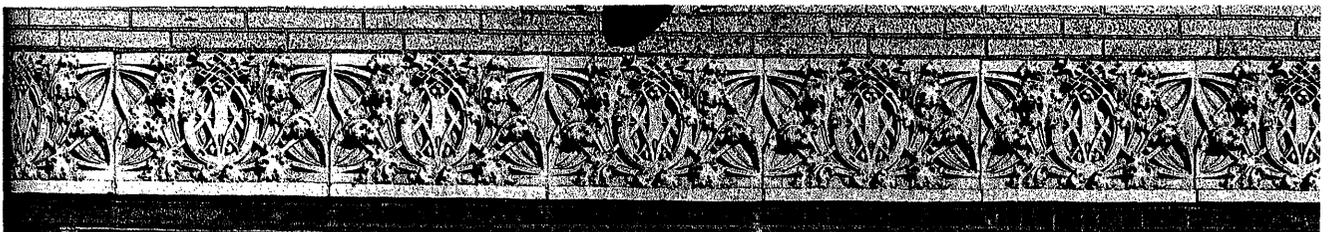
Top: The Victor Barth Building, with a detail of the cornice ornament.

Bottom: Detail of terra Cotta ornament designed by Louis Sullivan ca. 1913. (From William de Witt, ed. Louis Sullivan: The Function of Ornament. New York and London: W. W. Norton and Co., 1986, p. 137.)

The new century also saw new building materials. As noted above, specialty bricks of varying colors and textures became popular, as did a new architectural product—terra cotta. The survey report noted that, “around 1910 terra cotta came into use and from that point on was to dominate architectural detailing in Columbia well into the 1930s.”⁶³ Recent study has shown that more than one fourth of the surviving historic 20th century commercial buildings downtown today have some type of terra cotta detailing. Historic terra cotta components range from ornamental rooftop coping to full wall sheathing; the earliest known example was built in 1909, and the latest application was ca. 1940.

Terra cotta was particularly popular in Chicago, which experienced a great surge in high rise construction during that same period. The flexibility of the medium made it adaptable to a number of architectural styles, and it was embraced by several master architects; one source noted that “architectural terra cotta was significant in the development of important architectural
