**NATIONAL REGISTER OF HISTORIC PLACES
INVENTORY -- NOMINATION FORM**

Wallpack Center Historic District

(Wallpack Center) Description 7 2

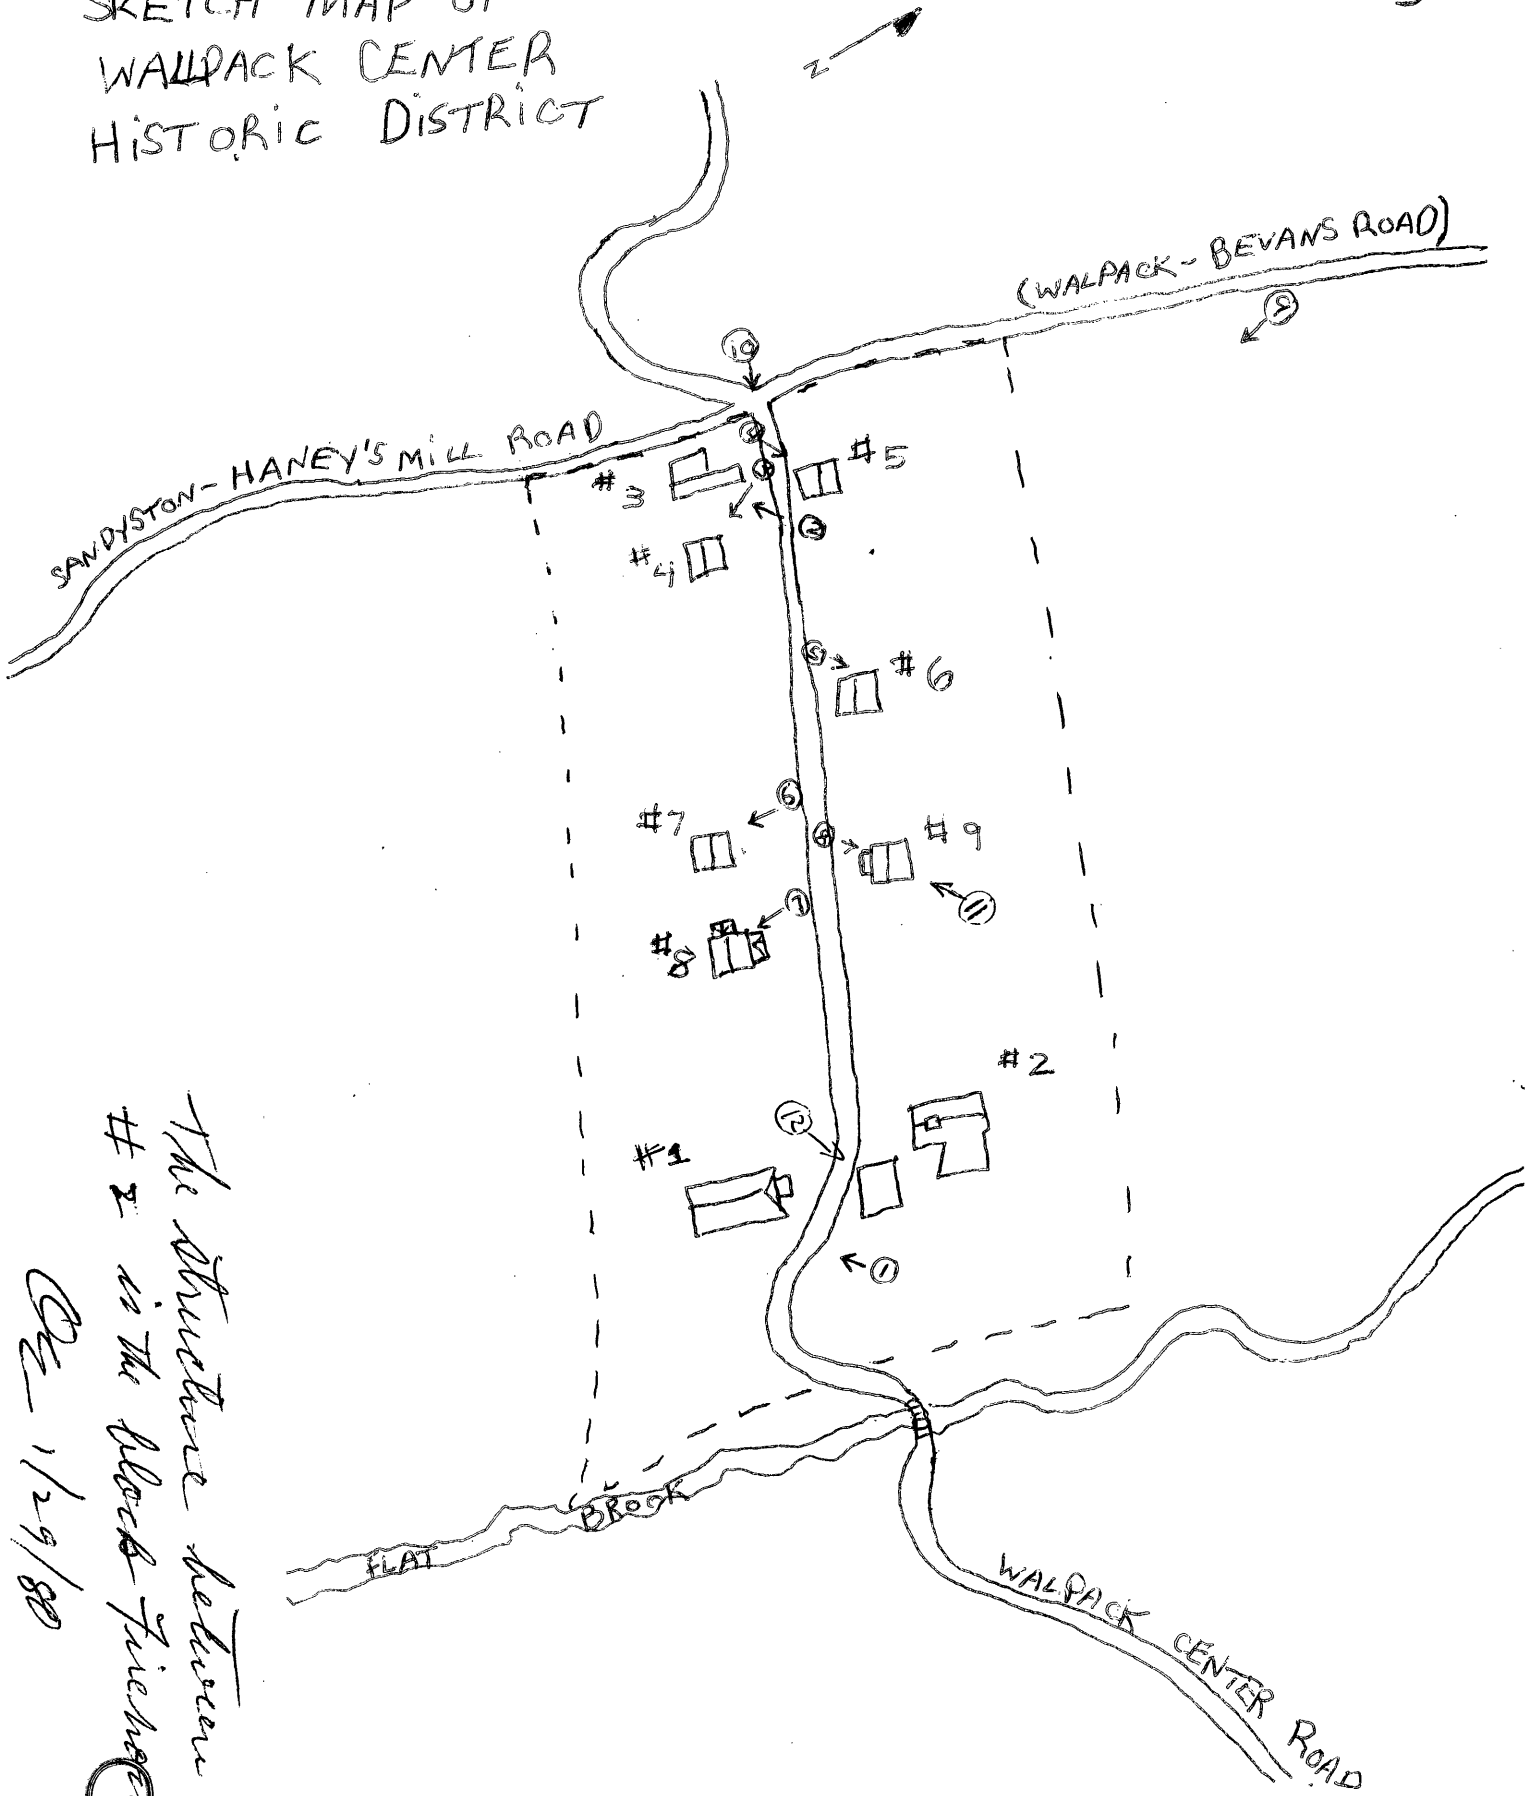
SKETCH MAP OF
WALPACK CENTER
HISTORIC DISTRICT

(NOT TO SCALE)

The structure between #1 and
#2 is the Black Friar house.
CZ 1/29/80

The boundary of the Historic District begins at Point A, on the southwestern edge of the right-of-way of Sandyston-Haney's Mill Road, where the right-of-way intersects with the southern tract line between tracts # 8202 and 8203, approximately 425' southwest of the intersection of Sandyston-Haney's Mill Road with the Walpack Center Road. From this point, the boundary extends to the southeast for approximately 560' to Point B, at the southwestern corner of the tract # 8207, as shown on the accompanying Army Corps of Engineers tract map. From this point, the boundary continues in a southwesterly direction along the southwestern boundary line of tract 8207, for 140', and thence beyond that line for another 300' to Point C, and on the northwestern bank of the Blat Brook. From this point, the boundary turns to the northeast and extends of 650', crossing the Walpack Center Road immediately to the southeast of the village, to Point D. From this point, the boundary turns to the northwest and extends for approximately 1040' to Point E on the southeastern edge of Sandyston-Haney's Mill Road right-of-way, northeast of Point A. From this point, the boundary turns to the southwest and extends along the abovementioned right-of-way, for approximately 700' back to Point A.
