# DAVENPORT

## SURVEY 1982

SITE #82-10-KR-628                      MAP NUMBER 6  
HISTORIC DISTRICT  
NAME Thomas Murray House  
ADDRESS 628 Kirkwood Blvd.

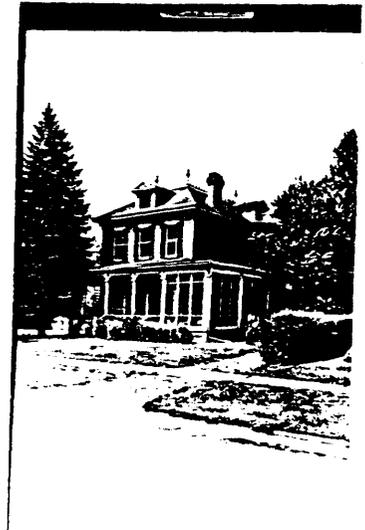
**PHOTO ID 1735-23**

ARCHITECTURAL STYLE Italianate    DATE 1881  
FORM                      2 stories, decked hipped roof, 3-bay front w/entrance to left  
of center; extends to irregular plan at rear w/gabled and shed additions;  
polygonal bay E. side, edged with balustrade  
MATERIALS                      frame on dressed limestone foundation; clapboarded  
FENESTRATION                      2/2 d.h.s. 1st, in flat surrounds w/narrow cornices; 1/1 d.h.s.  
2nd story  
FEATURES                      bracketted cornice with scallops applied to frieze; iron roof  
cresting; full length veranda w/chamfered posts, brackets, and scallop motif in  
frieze; brick chimney w/corbelled cap  
ALTERATIONS                      pedimented roof dormers added c. 1900  
SITE                      shaded lot, moderate setback

**ARCHITECTURAL SIGNIFICANCE** This house is a representative example of the Italianate style from post-Civil War Davenport. Characteristic features include the boxy form, hipped roof with deck, projecting side pavilions and a prominent, bracketted veranda. The cornice is enriched with brackets and a scalloped motif applied to the frieze. The roof cresting, which appears to be quite intact, is another important element. Houses such as this reflect the changes that transformed the earliest (1850's) local versions of the style, which retained many Greek Revival features, to a fully Victorian expression of verticality and millwork embellishment.
