KENTUCKY HISTORIC RESOURCES  
Individual Inventory Form

Resource # 211  
Shelby County

1. Name of Resource:  
Dr. Nash House

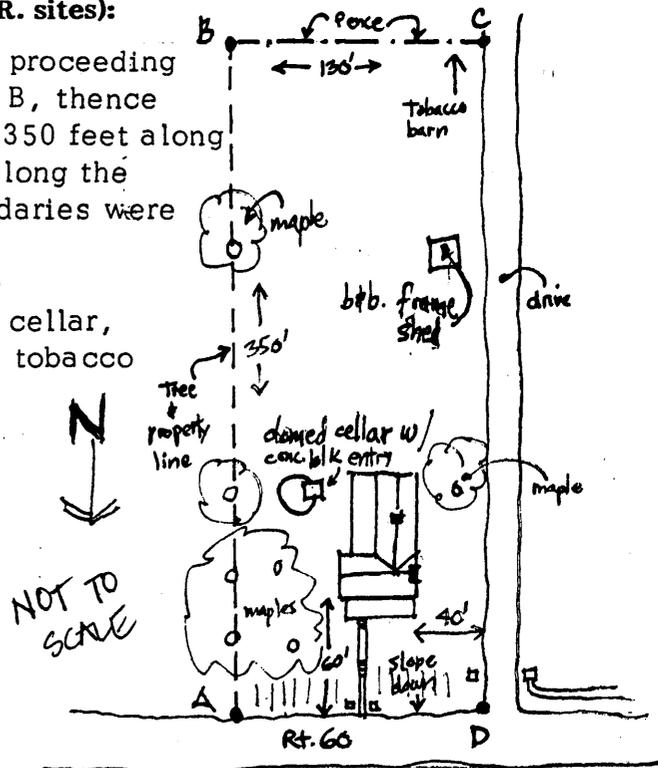
44. Site Plan (and boundary description and justification for N.R. sites):

Beginning at point A on the south side of U.S. 60 and proceeding south 350 feet along a property and tree line to point B, thence west 130 feet along a fence to point C, thence north 350 feet along the east side of a drive to point D, thence 130 feet along the south side of U.S. 60 to the point of origin. The boundaries were drawn to include the main house and domestic space enclosed by fences, property lines, a drive, and the highway, and includes a contributing circular domed cellar, and a non-contributing frame shed. Not included is a tobacco barn to the south.

Point A is located at the intersection of a tree and property line defining the eastern edge of the yard with the southern edge of U.S. 60, and is 91 feet northeast of the northeastern corner of the house.

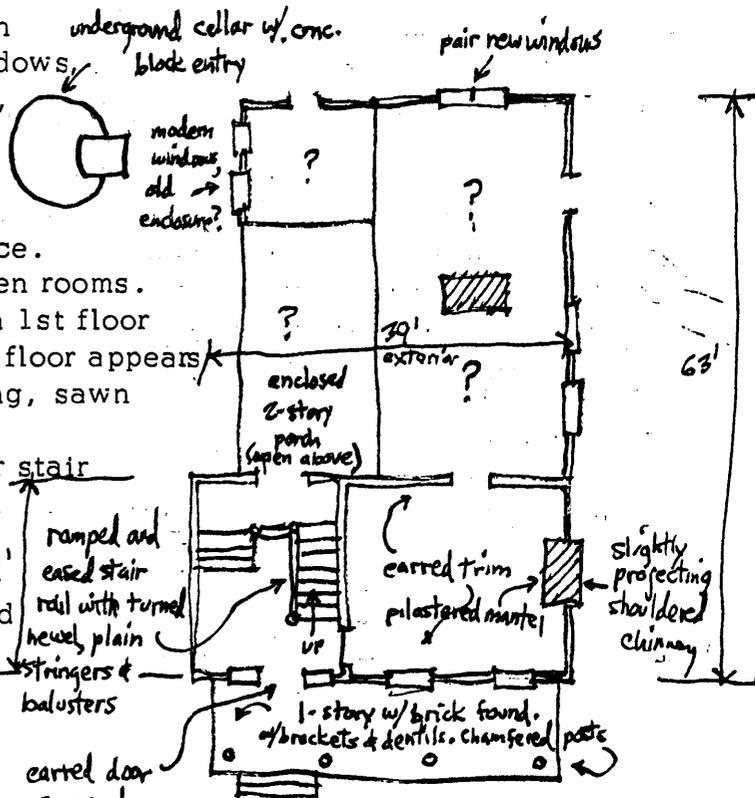
45. Description and House Plan:

Exterior: 2-story 3-bay frame side-passage plan dwelling. Narrow weatherboard, 6/6 sash windows, original blinds, returned cornice at gable ends, slightly projecting brick shouldered chimney at west gable end. One-story hip-roofed porch of three bays: chamfered posts support sawn brackets, panelled frieze with dentillated cornice. 2-story ell w/2 rooms per floor, chimney between rooms. 2-story porch along east wall of ell enclosed on 1st floor and end of second floor. End enclosure on each floor appears original. 2nd floor retains sq. columns w/necking, sawn flat balusters in railing.

Interior: ramped and eased rail on open-stringer stair in entry passage, with plain stringer and sq. balusters. Eared trim in room in main section as well as plain pilastered mantel.

Outbuildings: A contributing circular underground cellar w/ a concrete block entry just east of the end of the ell, and a non-contributing board-and batten frame shed. The nominated area includes two contributing buildings,
