KENTUCKY HISTORIC RESOURCES
Individual Inventory Form

Resource # Be-296
Boone County

1. Name of Resource: Big Bone Methodist Church

5. Location: 3435 Beaver Road
Union, KY

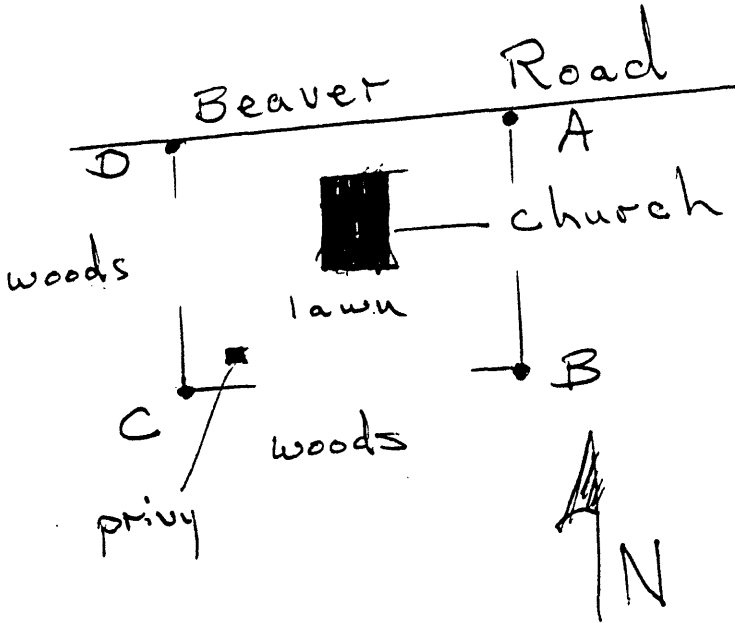
44. Site Plan (and boundary description and justification for N.R. sites):

The nominated property occupies tax parcel 31-48 and is roughly 125' x 75' in size. The boundary includes the building and sufficient acreage, marked on two sides by lines of woods, to provide a setting. The privy is also included.

Contributing: 2 buildings

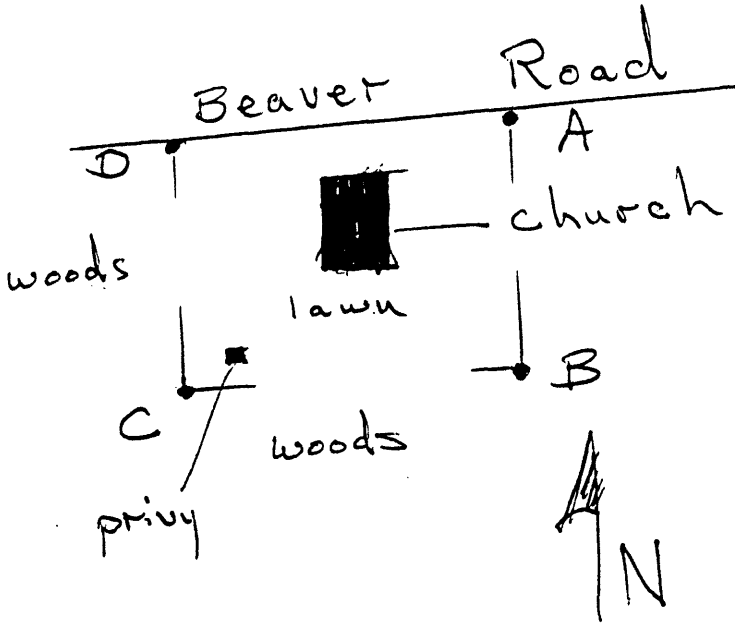
44. Site Plan (and boundary description and justification for N.R. sites):

The nominated property occupies tax parcel 31-48 and is roughly 125' x 75' in size. The boundary includes the building and sufficient acreage, marked on two sides by lines of woods, to provide a setting. The privy is also included.

Contributing: 2 buildings
