National Register of Historic Places
Registration Form

1. Name of Property Golden West Lodge Historic District
historic name Golden West
other names/site number Stehekin Lodge

Golden West Lodge Historic District

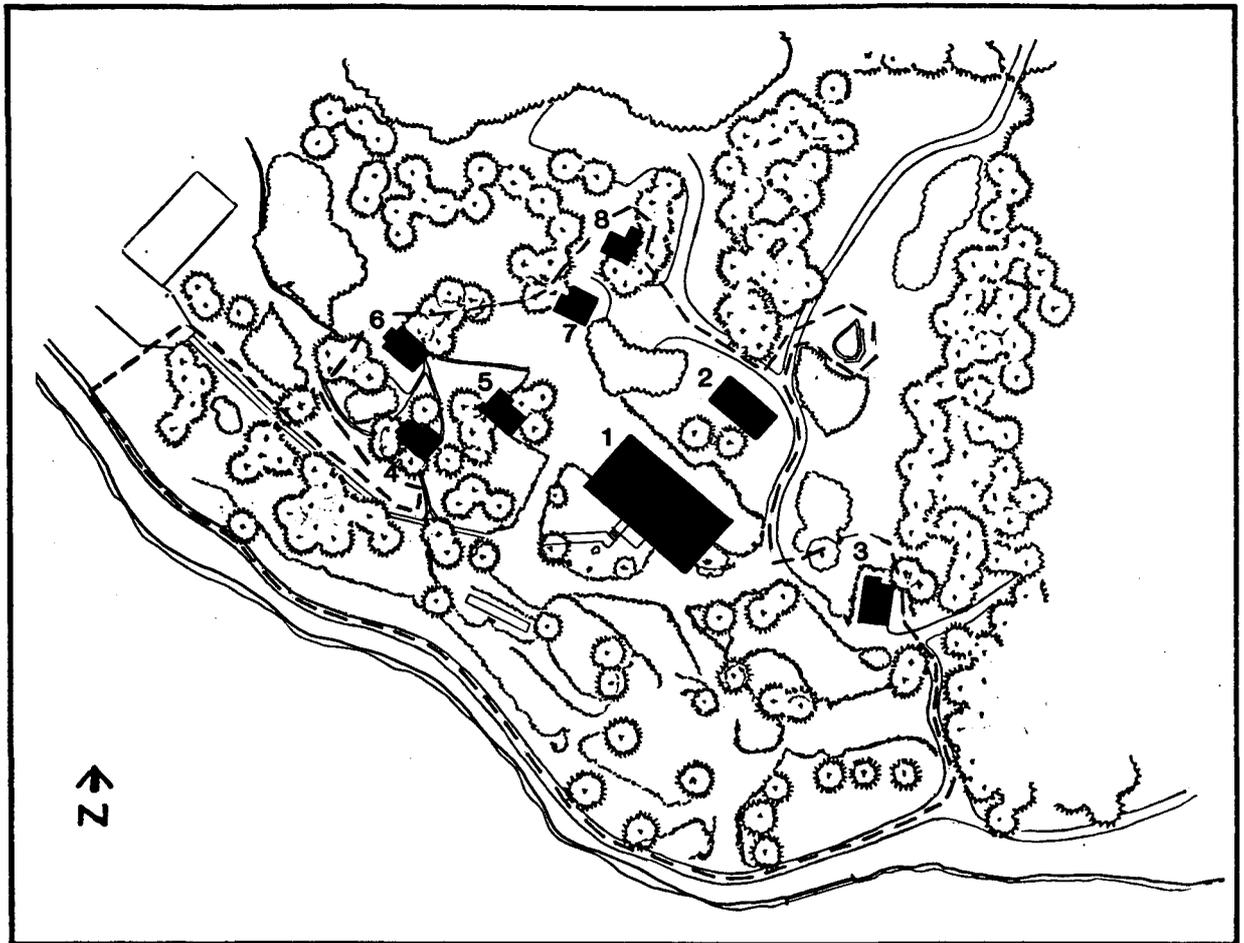
GOLDEN WEST LODGE HISTORIC DISTRICT

- 1. LODGE
- * 2. GARAGE
- 3. CABIN #11

- 4. CABIN # 15
- 5. CABIN # 14:
HOUSE THAT JACK BUILT

- 6. CABIN # 13
- 7. CABIN # 12
- 8. CABIN # 10

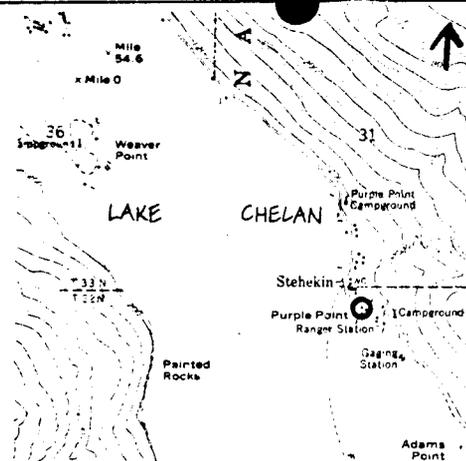
DESCRIPTION AND BACKGROUND HISTORY INCLUDING CONSTRUCTION DATE(S), PHYSICAL DIMENSIONS, MATERIALS, MAJOR ALTERATIONS, IMPORTANT BUILDERS, ARCHITECTS, ENGINEERS, ETC. <i>Garage. Wood frame set on squared sill log on rock foundation; rectangle (20' x 38'); 1 bay wide; 1-story; shiplap siding with board and batten beneath gable ends; metal-covered gable roof with exposed rafter ends; horizontal wood panel garage doors hung (sliding) on east; metal stovepipe on south slope. Exterior features include window opening (sash removed) on west; 5 boarded-up windows on south; hinged, vertical wood board door on south; wood panel door cut in half giving access to loft on west; plain fascia boards.</i> <i>This garage/workshop was built about 1927 or 1928 for the Golden West Lodge. Except for the metal roof and boarded-up windows it remains unchanged. The roof was installed pre-1968.</i>	CURRENT USE <i>Storage</i>	ORIGINAL USE <i>Garage/workshop</i>

SIGNIFICANCE
This building is one of the early buildings constructed in conjunction with the Golden West Lodge.

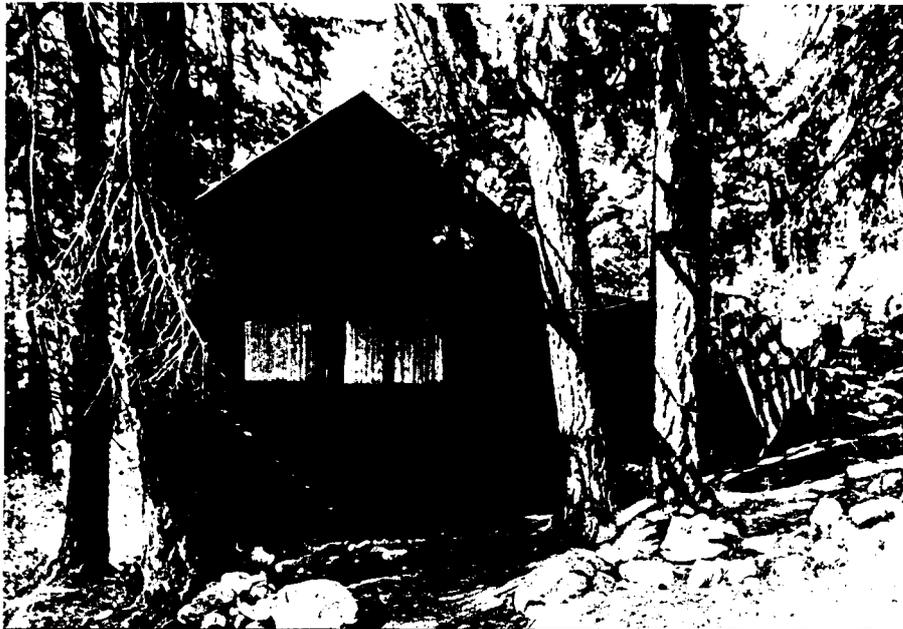
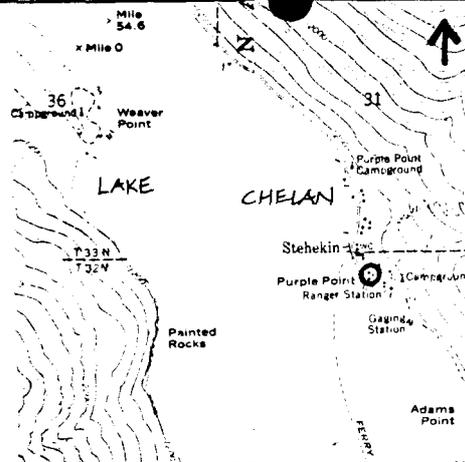
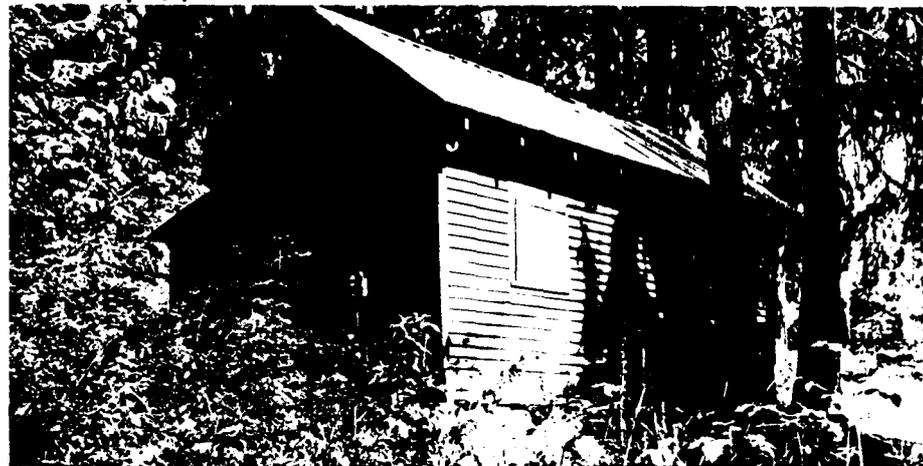
DESCRIPTION AND BACKGROUND HISTORY INCLUDING CONSTRUCTION DATE(S), PHYSICAL DIMENSIONS, MATERIALS, MAJOR ALTERATIONS, IMPORTANT BUILDERS, ARCHITECTS, ENGINEERS, ETC. <i>Cabin. Wood frame set on post and rock foundation; rectangle (17' x 20') with 7' x 9' shed-roofed, 1-story plywood addition on north; 1 bay wide; 1-story; clapboard siding with wood shingles above on gable ends; metal-covered gable roof with exposed rafter ends; recessed entrance with new wood door on east. Exterior features include three single-pane sliding sash with plain surrounds; single-pane hinged sash with plain surrounds (some sash altered); corner boards.</i> <i>This small cabin was originally built by Pete Miller, co-owner of Golden West Lodge between 1940-45. He built two other cabins at the same time he erected this one. Each cabin had its own cooking facilities for the guests to use. An addition to the cabin houses a bathroom. Today the cabin is used as summer housing for North Cascades Lodge employees.</i>	CURRENT USE <i>Seasonal housing</i>	ORIGINAL USE <i>Rental cabin</i>

SIGNIFICANCE
This building is an important component of the old Golden West Lodge complex.

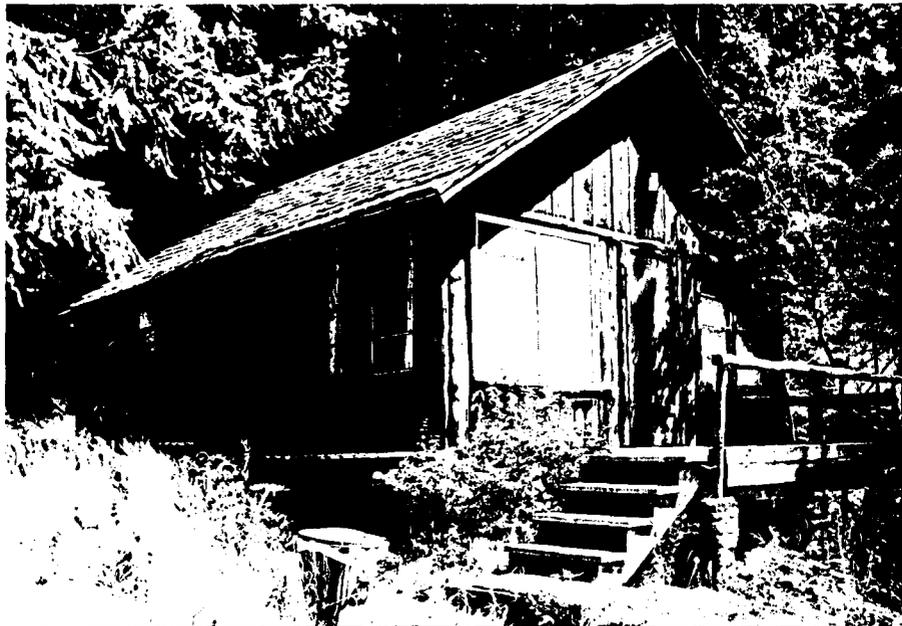
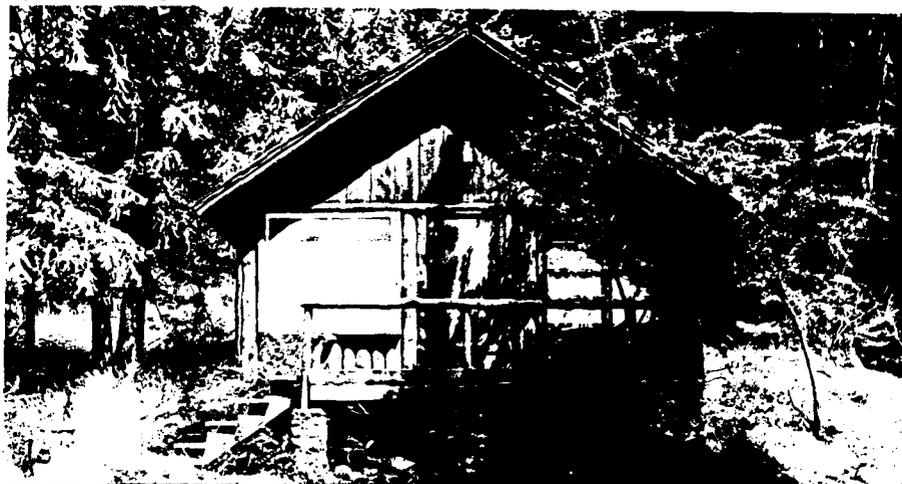
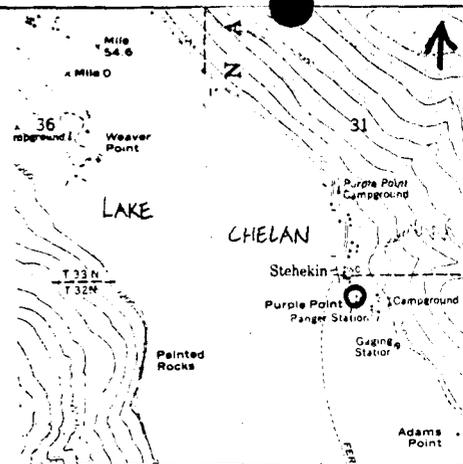
DESCRIPTION AND BACKGROUND HISTORY INCLUDING CONSTRUCTION DATE(S), PHYSICAL DIMENSIONS, MATERIALS, MAJOR ALTERATIONS, IMPORTANT BUILDERS, ARCHITECTS, ENGINEERS, ETC. <i>Cabin. Wood frame set on stone and mortar foundation (concrete partial); rectangle (18' x 21') with screened porch (8' x 5') on north; 3 bays wide; 1-story (with loft inside); vertical 1/2-round log construction with vertical boards on gable ends; wood-shaked gable roof with slightly extended eaves and exposed log rafters; center entrance on south with wood door and split log surrounds; metal stovepipe on east slope. Exterior features include horizontal 4-pane casement sash with split log surrounds; 1/1 double-hung sash with plain surround and split log surround; square, screened opening with interior wooden shutter on north; log fascia boards; raised entrance deck with log railings on south supported by rock and concrete piers; pedimented porch on north with vertical wood board siding with screens above and log posts.</i> <i>This rustic cabin was built by the Ashmead's in 1945-46 when they owned the Golden West Lodge property. It was built as a rental cabin. The addition of incompatible materials (clapboards) on the cabin's northeast corner is the only noticeable alteration.</i>	CURRENT USE <i>NPS housing</i>	ORIGINAL USE <i>Rental cabin</i>

SIGNIFICANCE
This building is an important and integral component of the Golden West Lodge complex. Although built later, this cabin's use of natural materials is consistent with the earlier structures' rustic appearance and thus contributes to the "wilderness-resort" atmosphere of the complex as a whole. It possesses integrity of design, materials, location, setting, workmanship, feeling, and association.

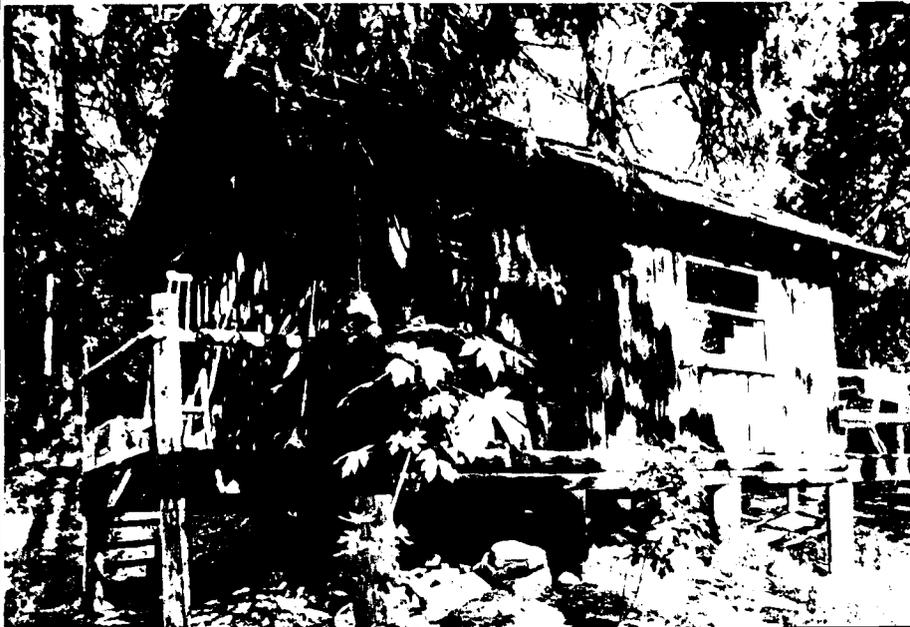
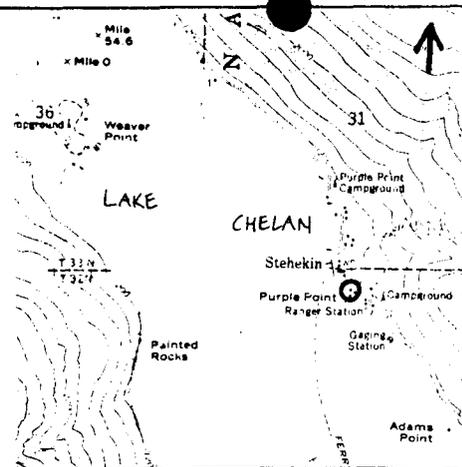
Cabin. Log construction set on rock and post foundation; L-shape (16' x 19'); 1 bay wide; 1-story; 1/2-round vertical log construction set on horizontal sill logs with vertical board siding at gable ends; wood-shaked gable roof with slightly extended eaves and exposed log rafters; off-center wood panel and glass door on west; center wood panel and glass door on east. Exterior features include 1/1 double-hung sash with small, 2-pane sidelight; 1/1 double-hung sash with split log surrounds; 2 square vents with split log surrounds; round log fascia boards; raised wooden decks on east and west with steps and round log railings.

This rustic cabin was built by Peter Miller, co-owner of the Golden West Lodge, in 1940. It is virtually a duplicate of another cabin on the property overlooking Lake Chelan (#12). Built as a rental cabin, it had its own cooking facilities. This cabin has been adaptively re-used and now houses an outdoor store. New front and back porches replaced similar ones that had deteriorated.

SIGNIFICANCE
This building is an important component of the old Golden West Lodge complex. The cabin's use of natural materials creates a rustic appearance which contributes to the "wilderness-resort" atmosphere of the complex.

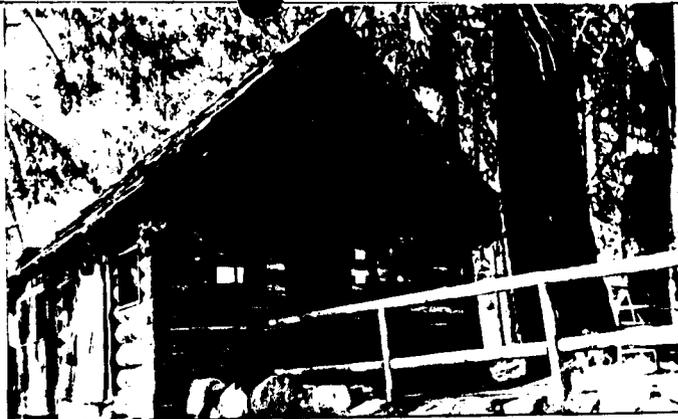
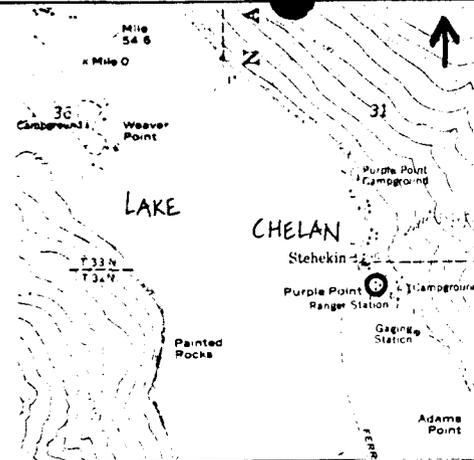
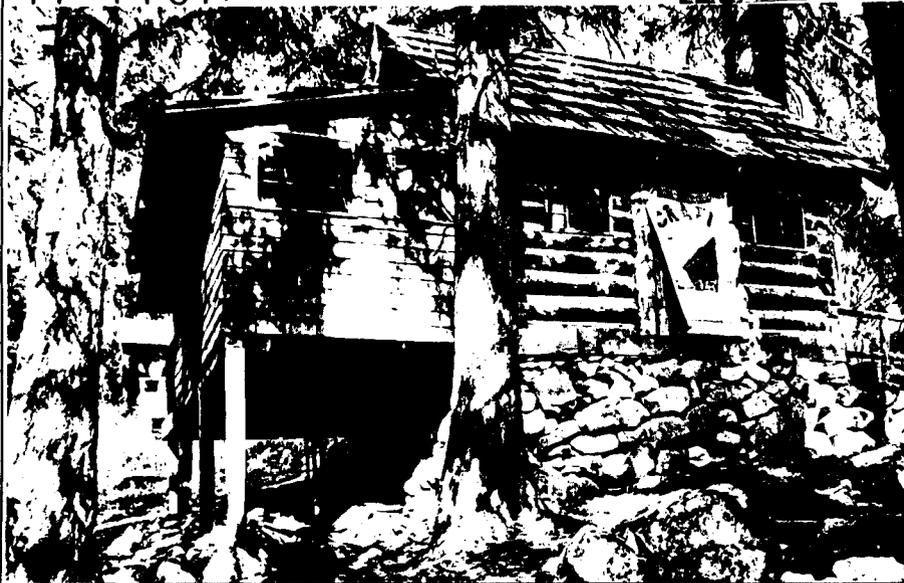
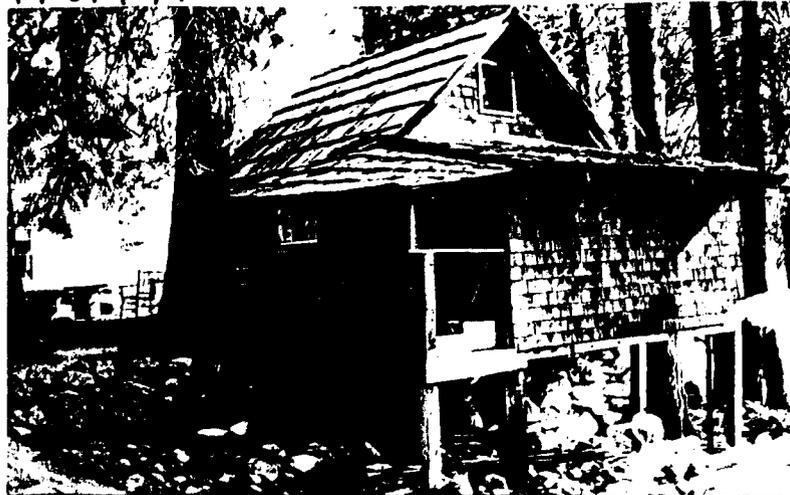
NAME(S) OF STRUCTURE/SITE *HOUSE THAT JACK BUILT/CRAFT SHOP*
(Building)

Cabin. Log construction set on rock foundation; square (14' x 14') with wood frame addition on east (9' x 14'); 3 bays wide; 1 1/2-stories; round logs with hewn planked ends and square-notched corners and wood shingle siding on gable ends; wood-shaked gable roof with extended eaves, exposed rafter ends, gable overhang on east; center entrance on east with wood-paneled door. Exterior features include 3, 6, and 9-pane hinged sash, some with plain surrounds; 6-pane sliding sash; 1-story, shed-roofed raised addition with wood shingle siding; shed-roofed porch on addition's north wall with wood-paneled door.

This cabin is believed to have been built by Jack Blankenship in the 1920s and moved to its present site c. 1926 from an undetermined location. The wood frame addition (once housing a kitchen and bathroom) may have been added in the 1940s when the lodge complex was expanding. A new roof was installed in 1982.
