**NATIONAL REGISTER OF HISTORIC PLACES
REGISTRATION FORM**

historic name: **N-Bar Ranch**

other name/site number: **24FR382**

N-Bar Ranch
 Grass Range vicinity
 Fergus County, Montana
 Sketch Map of ranch headquarters
 and National Register Boundaries

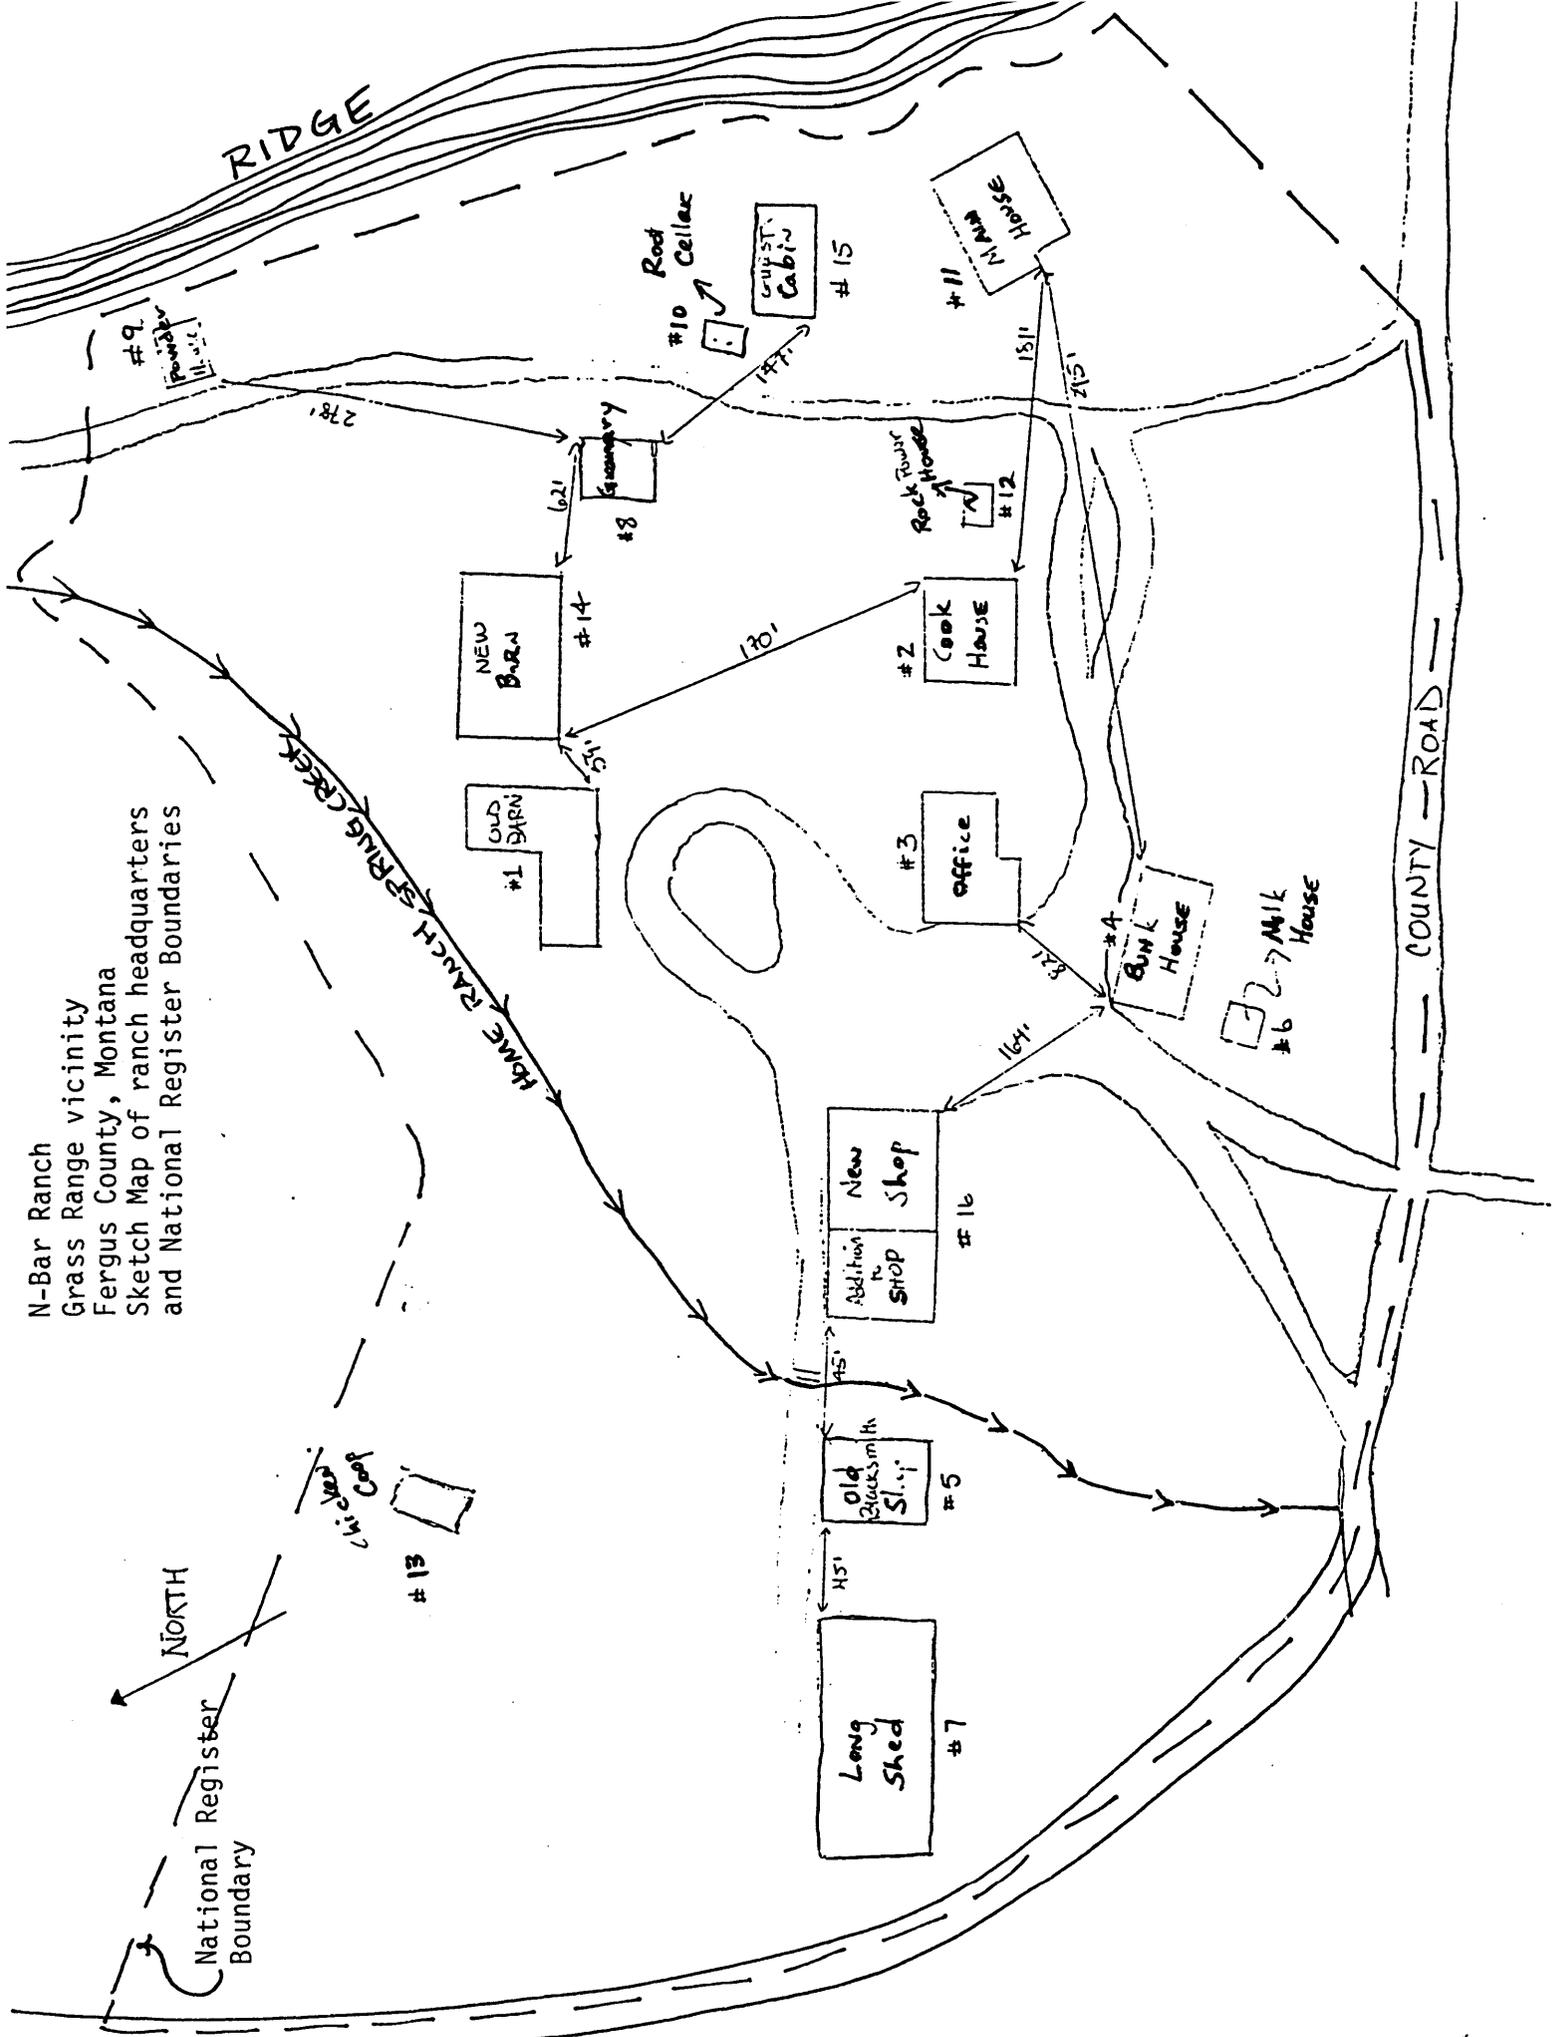
The boundary for this property has been drawn to encompass all the ranch headquarters' buildings, the heart of the ranch work area including such features as corrals, and the ranch lands surrounding these features bounded by higher topography, ridge lines, and a road which form the visual setting for this ranch headquarters.

From the southeast corner of section 28, proceed due west .25 mile to Flat Willow Creek Road, then .3 mile west along the Flat Willow Creek Road to the N-Bar Ranch Headquarters turnoff. This turnoff marks the point of beginning. From here, proceed northeast to the foot of the ridge behind the headquarters complex. Follow the 4320 foot topographic contour along the base of the ridge as it curves around to the north, west and south, to the point where it is north of the chicken coop. From here, proceed due west until meeting again with the Flat Willow Creek Road. Follow this road back to the southeast to the point of beginning.
