# NATIONAL REGISTER OF HISTORIC PLACES REGISTRATION FORM

historic name: Moon-Randolph Ranch  
other name/site #: Randolph Farm, Randolph Dairy, Moon Homestead, Moon-Randolph Homestead

street & number: 1515 Spurlock Road not for publication: N/A  
city/town: Missoula vicinity: N/A  
state: Montana code: MT county: Missoula code: 063 zip code: 59802

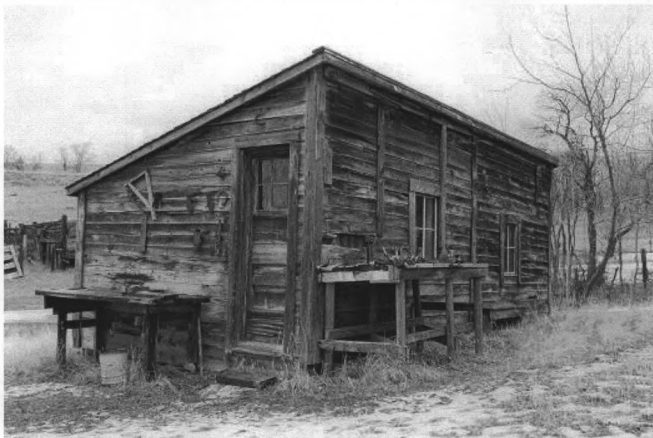
NR Photo #0004 – Moon Claim Cabin, view from southwest.

The Moon Claim cabin (24'5" x 12'7") is rectangular, east-west oriented, single-story building that stands just west of the access road, in the center of the ranch building complex. It has a shed roof and wood-frame walls supported by a poured concrete Sonotube foundation.<sup>6</sup> Cedar shakes cover the roof and planed 1" x 5" tongue-and-groove boards, like those on the interior floor, cover the walls. Vertical rough sawn 1" x 6" boards are attached at 4-foot intervals to the siding, apparently to cover joints. Fenestration is limited to two door openings and two window openings. The main door opening is at the south end of the west elevation, and is filled with a manufactured, four-light glazed-and-paneled door (26" x 79"). A second door opening on the north wall is the only feature on that wall, and is filled with a door (32" x 73") that was constructed on-site from the same 1"x 5" planed boards that were used as flooring and siding. Both window openings are on the south elevation, and are symmetrically placed—one in the each half of the wall—so that each window lights one of the two interior rooms. The window openings (26 ½" x 34") are filled with four-light, fixed-sash wood windows.

In 2003, the cabin was rehabilitated. The structure was given a new, concrete, Sonotube foundation (it originally had no foundation). The walls were dismantled, rebuilt using 2" x 4"s sheathed with plywood, and reclad with the original siding

on the exterior. The floors of the building were also replaced, and a new, cedar shingle roof was built. This roof mimicked the original roof pitch, shape and cladding, but was built with different, professional framing methods and with milled rough sawn lumber instead of the salvaged scraps originally used. During the remodel, carpenters identified what appeared to be a filled-in doorway on the west end of the south elevation. The location of the old doorway was marked by a rectangle, 36" wide by 73" tall, on which the siding ran vertically instead of horizontally.<sup>8</sup>

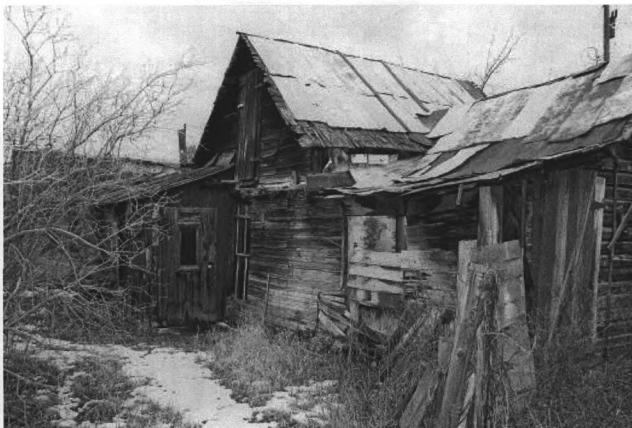
NR Photo #0005 – Main House view from southeast.

The Main House was constructed during the tenure of the Moon family. William and Emma Randolph inhabited the four-room farmhouse for almost 40 years, from 1907 until 1946. The west component was their kitchen, the pantry component their storage (wood shelves along the west wall are extant), and the central and eastern components were combined living/sleeping areas. Their son Bill may have lived in the house until 1956, at which point he moved into the 1946 residence after his parents died. By 2002, the farmhouse was in deplorable condition, due both to neglect and to its inadequate original construction. The west wall of the building was collapsing. The north wall of the kitchen was so far out of square that the exterior door wouldn't close properly. The pantry walls were crumbling and the interior shelving sagged. Floors throughout the house were uneven and rotting and walls weren't plumb. The windows were in poor condition. The roof leaked in places and some of the wall framing and siding was badly very deteriorated. Some initial salvage work began in July 2002 and in the spring of 2007, workers stabilized the west wall of the original component, repaired roof leaks, and braced unstable roof sections.

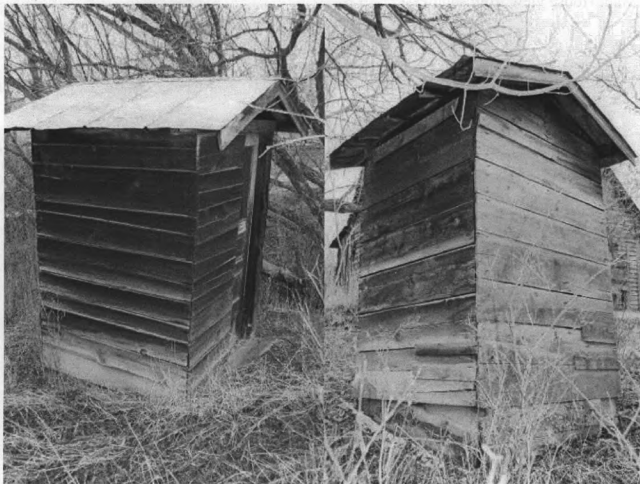
NR Photos #0008 and 0009 – Outhouse, view from southwest (0008) and northeast (0009).

The outhouse, located just north of the northeast corner of the Main House, is thought to have been constructed prior to the 1946 remodel of the western chicken coop and the subsequent abandonment of the Main House. It is 5' x 5', of typical wood-frame outhouse design, with a shallow-pitched front-gable roof. The roof is covered with tin sheeting, and the exterior walls are covered with wide, horizontally hung boards. There is no foundation under the building, though there is some stonework evident in the waste hole beneath the extant wood seat. The outhouse lacks windows. There only feature on the building is a door on the south elevation, facing the Main House. The doorway, at the east end of the elevation, is a manufactured one-light glazed-and-paneled wood door; plywood presently fills the light instead of glass.

The outhouse is in relatively good condition. The roof seems sound and the walls are fairly plumb, however, the door doesn't swing shut. The outhouse may originally have had two seats, located side by side on the south wall. One seat is extant.

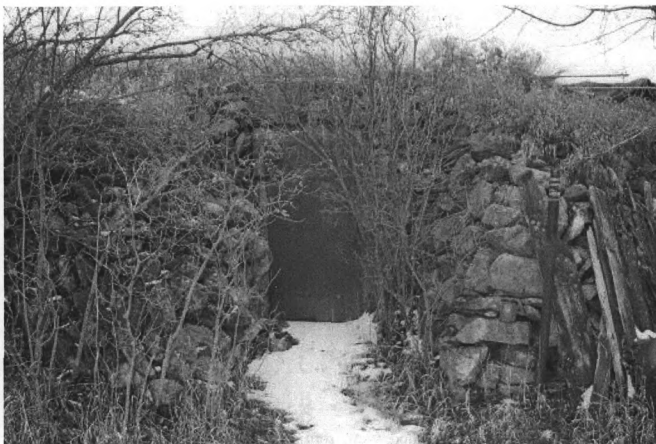
NR Photo #0010 – Root Cellar, view from east.

Randolph neighbors report that the root cellar was reinforced in 1975, when poured concrete was added to the interior walls to prevent erosion of the bank. The root cellar is in fair condition, but its integrity is threatened by a large hole in the roof structure of the north half. That hole has expanded rapidly in recent years, growing from 2' square to 6' square between 2002 and 2009 and is causing the roof to cave in.

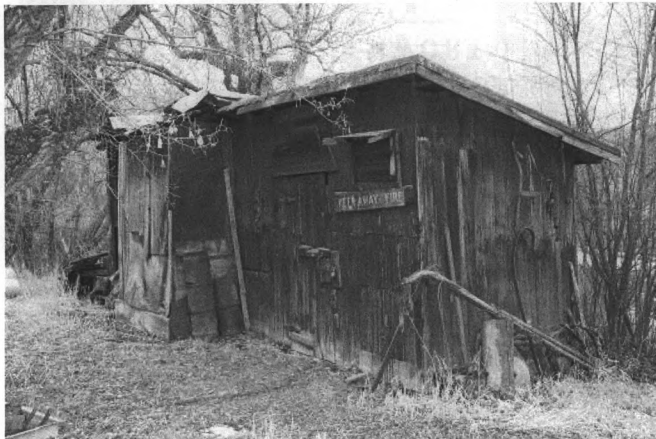
NR Photo #0011 – Tack Shed with attached wood shed, view from southeast.

The tack shed/wood shed is located east of the outhouse, roughly midway between the original Claim Cabin and the Main House. It is composed of two distinct, foundationless sections, both single-story wood-frame, that together form an east-west oriented rectangle. The tack shed was built first, and forms the east half of the building. It is 10' long and 7' wide, and has a shed-roof. Tin panels cover the roof and are wrapped around, and nailed to, the face of the fascia boards. It is sided with tongue-and-groove 1" x 6" boards salvaged from railroad box cars and installed vertically. Features on the tack shed are limited to a doorway, located in the center of the south wall and filled with a site-built door made of 1" x 6" pine boards butted together and nailed on to bevel-edged 1" x 4" boards running across the top and bottom, and a window opening located in the west wall (which now divides the tack shed from the wood shed) and filled with a six-light wood frame, fixed-sash window.

The tack shed appears to be in fine overall condition: the walls are plumb, the roof seems sound and the door swings freely. The period of intense draft horse use at the homestead extended from 1910-1950, and the tack shed is still protecting tack left over from the Randolph's tenure. The wood shed, although haphazardly constructed (even compared to the other buildings on the homestead), still functions well for its intended purpose – to house firewood.

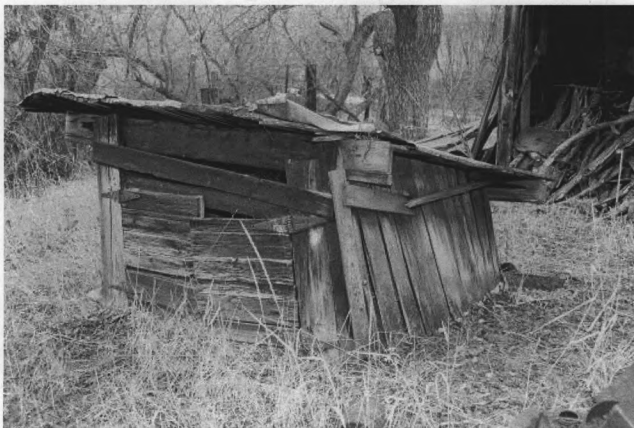
NR Photo #0013 – Domestic Hog Shed, view from southeast.

The hog shed has deteriorated since it was originally constructed: the walls are out of plumb, the structure is racked and leans slightly, roof material is loose, and the top boards of the doors are missing. It remains sound enough, however, to be able to serve its original purpose—sheltering hogs.

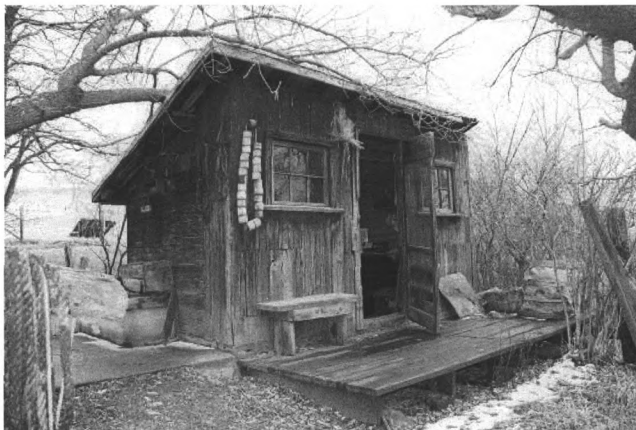
NR Photo #0014 – Milk House, view from northeast.

The east-west oriented, rectangular Milk House (10' x 12'8") is located at the southeast corner of the domestic building cluster, adjacent to the 1907 well (which was incorporated into the concrete pad poured off the east end of the Milk House in conjunction with its construction). It is a single-story, shed-roof, wood-frame building on a massive concrete foundation that appears to have been formed and poured directly onto the gently sloping ground. An uncovered porch, 5' deep, runs the length of the façade (north) elevation, and a concrete pad extends off the east elevation past the 1907 well. Within the boundaries of the concrete pad, the well is encircled by a one-foot high poured concrete wall, on which sits a wood cover. The concrete pad is inscribed with the date "1923" and Keith Randolph's initials. The pad also features a poured concrete box (5' x 2' x 2') located against the east exterior wall of the milk house. A wood-and-corrugated-tin lid covers the concrete box, which likely held milk cans or other items associated with dairying. The front (north) wall, and the upper parts of the side walls (beneath the roof), is sided with 1" x 6" tongue-and-groove boards salvaged from railroad boxcars. The rear wall, and the lower parts of the side walls, is covered with intact railroad boxcar doors, hung so their boards run horizontally. The roof is covered with sheets of corrugated tin. The tin is bent around and nailed to the face of the fascia boards as well as to the rafter boards. Fenestration on the building is limited to the façade (north) elevation, and includes two symmetrically-placed window openings flanking a central doorway. The window openings, unlike most on the ranch, are trimmed and have frames and sloped sills. They are filled with six-light, wood-frame windows. The centered doorway has only a screen door. The one-room interior of the Milk House has a heavy, smooth concrete floor that slopes to a drain in the southwest corner, which funnels drainage out of the back of the building through a clay-tile pipe set in the foundation. A scattering of bricks at the southeast corner of the building may be the remnants of a non-extant historic feature.

The milk shed is perhaps in better condition than any of the other homestead buildings: the foundation is solid, the walls are plumb, and the roof is fairly well built.

In 2002, the original porch (the deck of which consisted of various lengths and widths of mostly 2" thick lumber) was in shambles. It had no foundation and was supported by short pieces of 2" lumber, split pieces of firewood, or discarded pieces of iron. The porch was totally rebuilt in August 2002. The replacement porch was built to mimic the old: it has the same dimensions and features a deck built of random length and width recycled lumber intended to match the historic porch's appearance. Upgrades to the porch's foundation and framed structure are, for the most part, unobtrusive.

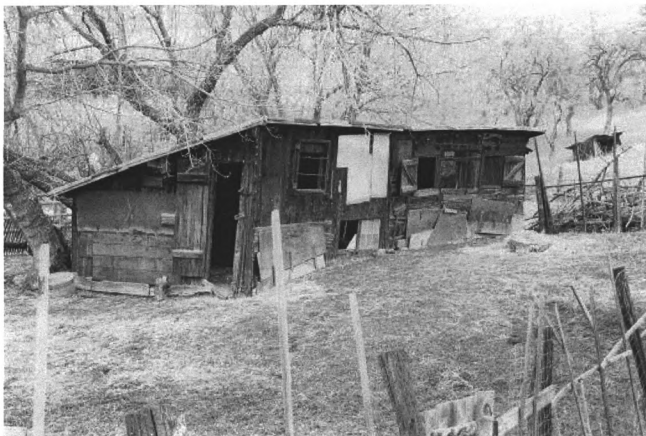
NR Photo #0018 – Chicken coop/Goat Shed, view from west.

The chicken coop/goat shed (30' long x 13' wide) is located east of the 1946 residence/chicken coop. Like its western counterpart, the chicken coop/goat shed, in its basic design, location, and orientation, is typical of chicken coops of the period. It is an east-west oriented, single-story building with a shed roof, south-facing façade, and rectangular footprint. It has no foundation. The roof is covered with corrugated tin. The front (south) is covered with vertically-installed tongue-and-groove 1" x 6" boards salvaged from railroad box car. The rear (north) and side walls are covered with 1" x 6" drop-lap siding hung horizontally. The chicken coop has two pedestrian doorways, one leading into each half of the building through the side (east and west) walls. The doorways are both filled with doors that appear to have been handmade with the same materials used to build the chicken coop. Additional fenestration is limited to the south (front) elevation, and includes three window openings, located high in the wall and paired with homemade wood shutters, as well as various boarded-over chicken doors at the ground level.

The chicken coop appears to be in serviceable condition: the walls are mostly plumb and the roof seems mostly sound. There is a built-up purlin in the west half that is rotting out and failing due to a long time leak in the roof. There is some amount of rot at the bottom of the walls due to moisture and direct contact with the ground. The rear wall bulges inward in two places due to two large trees growing too closely to the building.

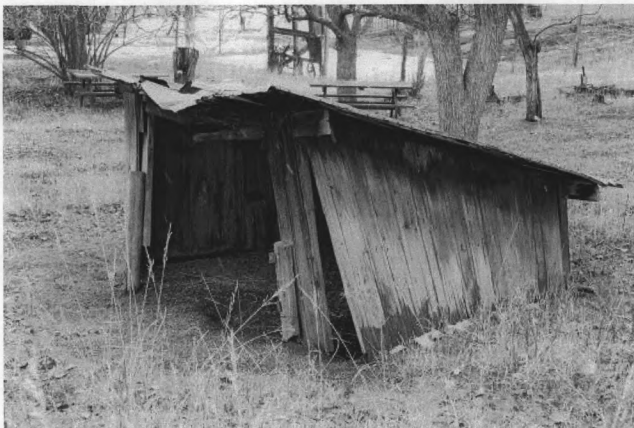
NR Photo #0020 – Orchard Hog shed, view from southeast.

The hog shed has deteriorated since it was originally constructed: the walls are out of plumb, the structure is racked and leans downhill to the west, the roof has a big dent above the front opening, the two rear corners of the roof have been bent, and the bottom plates and the lower part of most of the sheathing boards show signs of rot and deterioration.

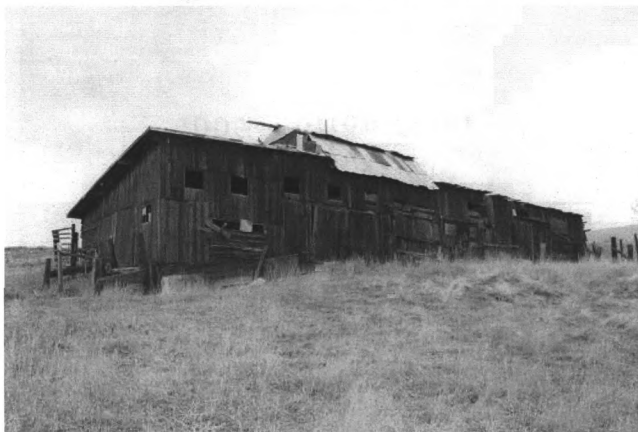
NR Photo #0024 – Barn – view from southwest.

The barn is in poor condition. Inadequately built to begin with, it is slowly shifting downhill, causing the front (south facing) walls of the barn to buckle and bow outwards. The north wall displays rotting due to continual contact with the dirt of the hillside into which the barn is built, and due to water damage from barn-roof and hillside run-off, both of which

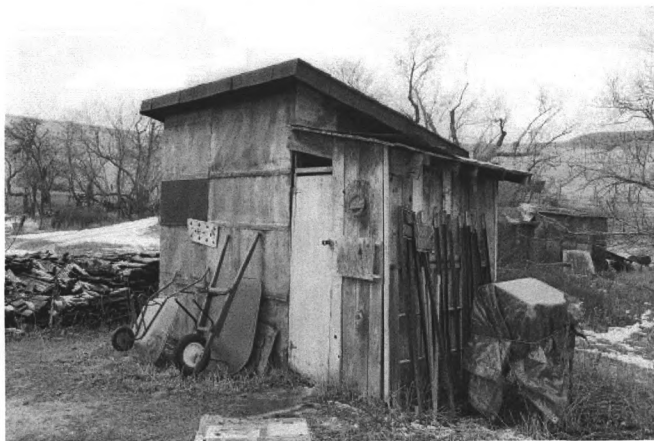
NR Photo #0027 – “Tin Shed” with attached outhouse, view from north.

Located south of the mine/winch shed area is a shed clad with tin and an attached outhouse. It is oriented southeast-northwest and has no foundation. It consists of two distinct components, a well-built shed-roof tin shed on the southeast end and a shed-roof two-seat outhouse added to the northwest elevation. The walls of the tin shed are sided with horizontal lapped boards covered with tar paper and the roof is covered with composition shingles. The walls of the outhouse are sided with unlapped vertical planks and the roof is covered with sheets of corrugated tin. Features on the building are limited to a single door accessing each component. The door to the tin shed is vertical wood plank door in the southeast elevation. A plywood door in the northeast wall elevation provides access to the outhouse.

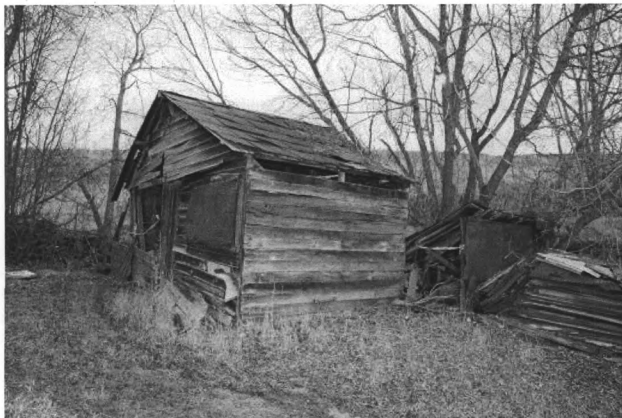
NR Photo #0029 – Winch Shed, view from south.

As befits its function, the winch shed stands in front (to the southwest) of the mine adit. It is a one-story, rectangular building (16' 6" across the front and 10" long on the sides) oriented southwest-northeast. The building has no foundation, and an historic addition on the back northeast wall has totally collapsed. The wood-frame walls are covered with tongue-and-groove 1" x 6"s and the front-gable roof is covered with pressed tin ceiling panels. Features on the winch shed are limited to the southwest-facing façade, and include an eight-light, fixed-sash, wood frame window (boarded over on the outside with a sheet of plywood) and an unfilled door opening. The winch remains in place inside the shed.

The winch shed is in very poor condition and, without intervention, will collapse entirely in the coming years. The walls and roof structures were poorly and inadequately built. Some of the framing members used are severely weathered or completely missing. Wall and roof sheathing boards are missing or badly weathered. The rear addition has completely collapsed. A couple of years ago, volunteers used several 2" x 4"s and 2" x 6"s to stabilize the building.
