National Register of Historic Places  
Registration Form

historic name METHODIST EPISCOPAL SOCIETY OF TYRINGHAM

other names/site number Union Church and parsonage (preferred)

street & number 128-130 Main Road not for publication

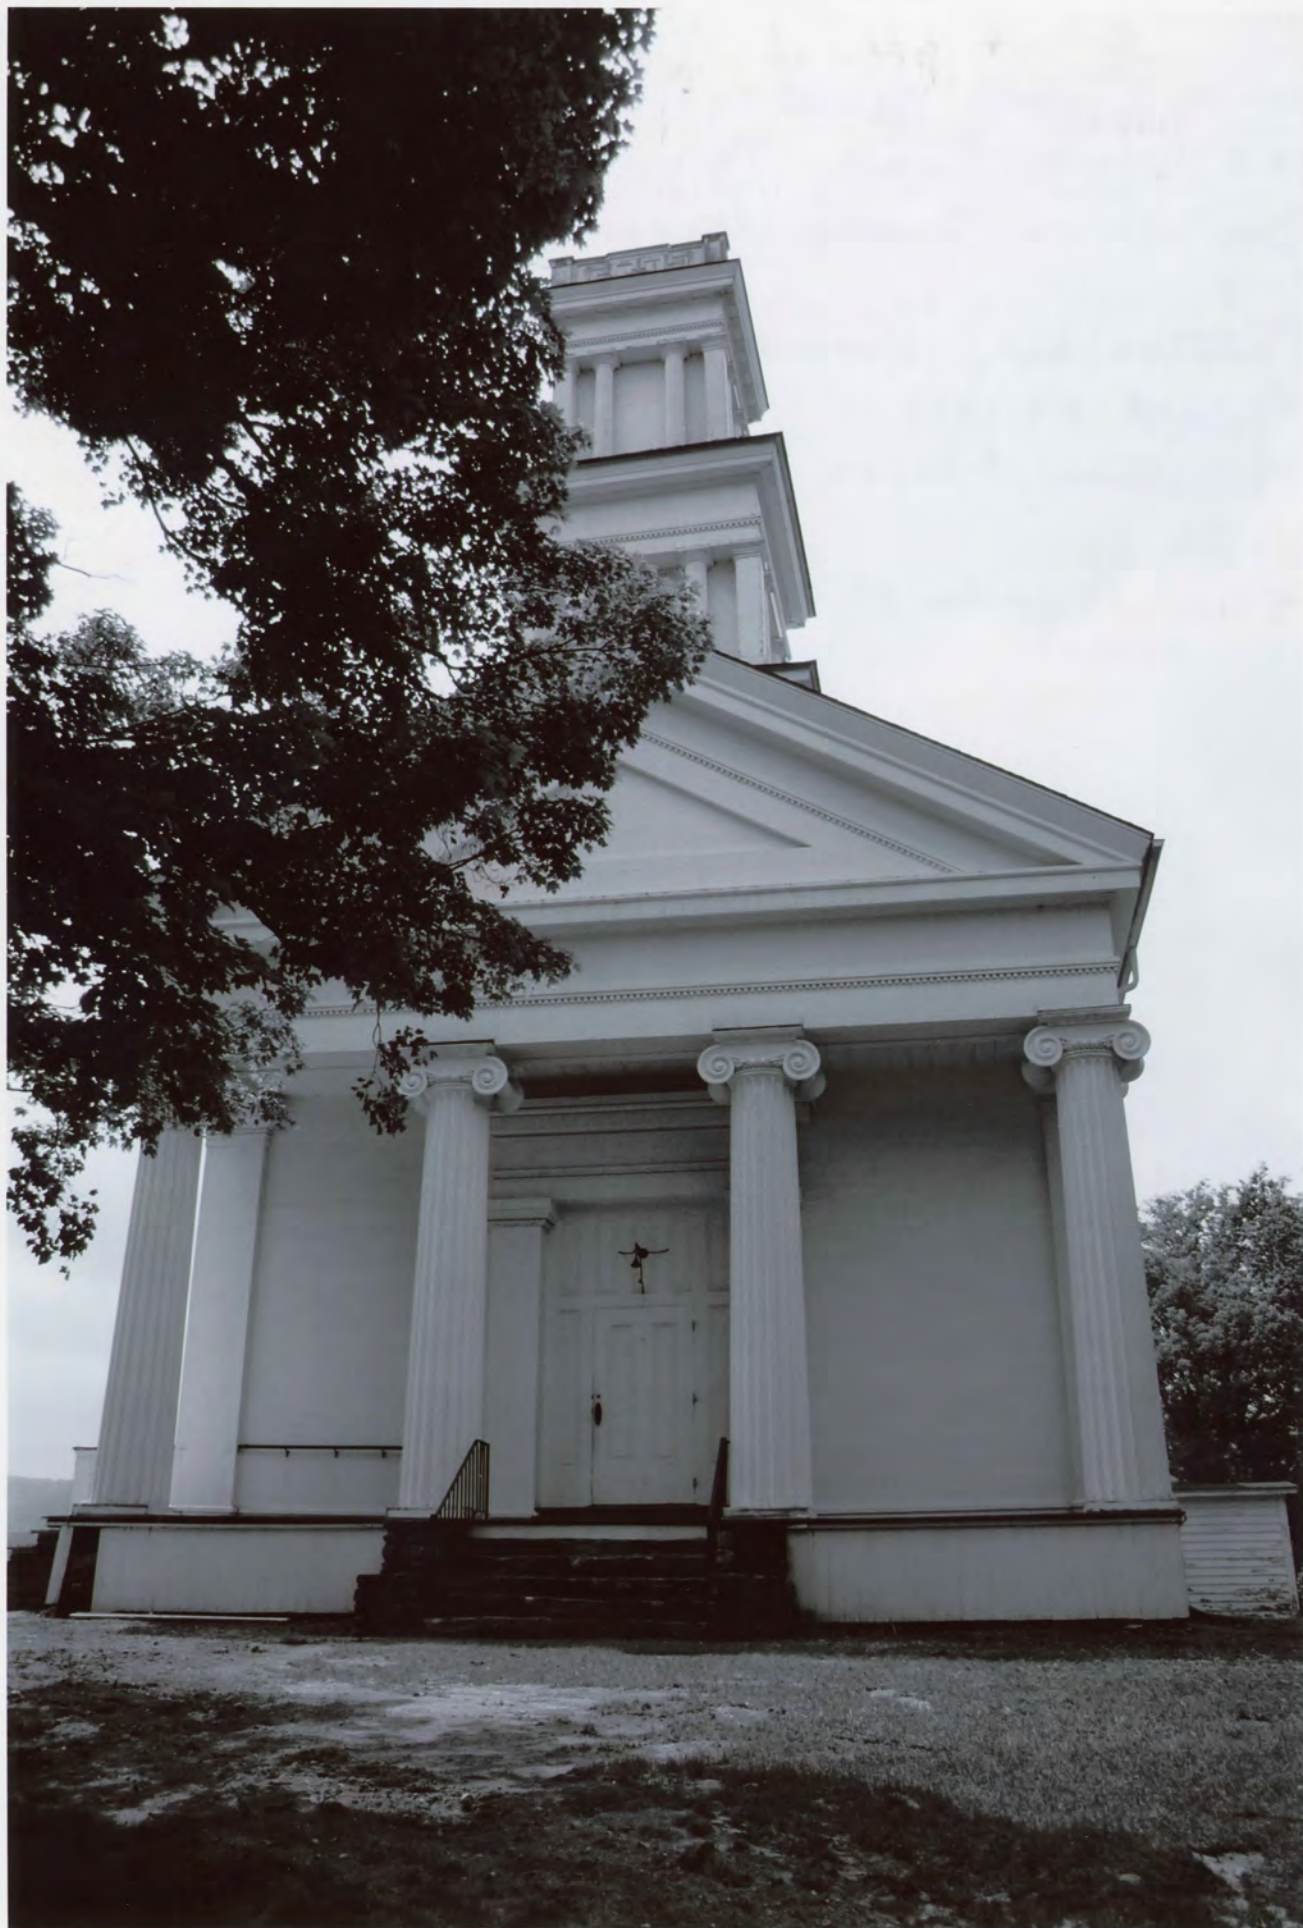
Photo #1

Front facade of church from front lawn. Facing  
Southwest.

The front northeast facade is clad with flush flat boards inside a four columned Ionic portico (Photo #1). This portico is approached by side steps of granite from Church Road which were rebuilt in 1999 replacing rough granite steps in 1968, and by another set of granite steps from the front lawn, also installed in 1968 as replacements of the original front steps. The wide central doorway is framed by massive ante or pilasters and a huge entablature decorated with bands of egg and dart molding. The broad four-foot wide front door has three vertical panels set within a larger frontispiece composed of ten panels in two tiers. This, in turn, is framed by two antes and an entablature. On all sides of the building, the deep entablature is decorated with a band of dentils (Photo #5). At the corners are broad ante. The front and rear pediments repeat the detailing and proportions of the dentilled entablature. The three sides, other than the front facade, are clad in weatherboard. On the lateral sides of the building are four huge double-hung windows with 25 over 25 clear glass lights (Photo #8). The square tower is in two stages with a pair of Doric columns in antis on each facade. Louvered panels are located between the columns at the lower level. Atop the tower a low parapet is decorated with fretwork. The original acroteria atop the tower are mostly missing, but are stored for future reinstallation.

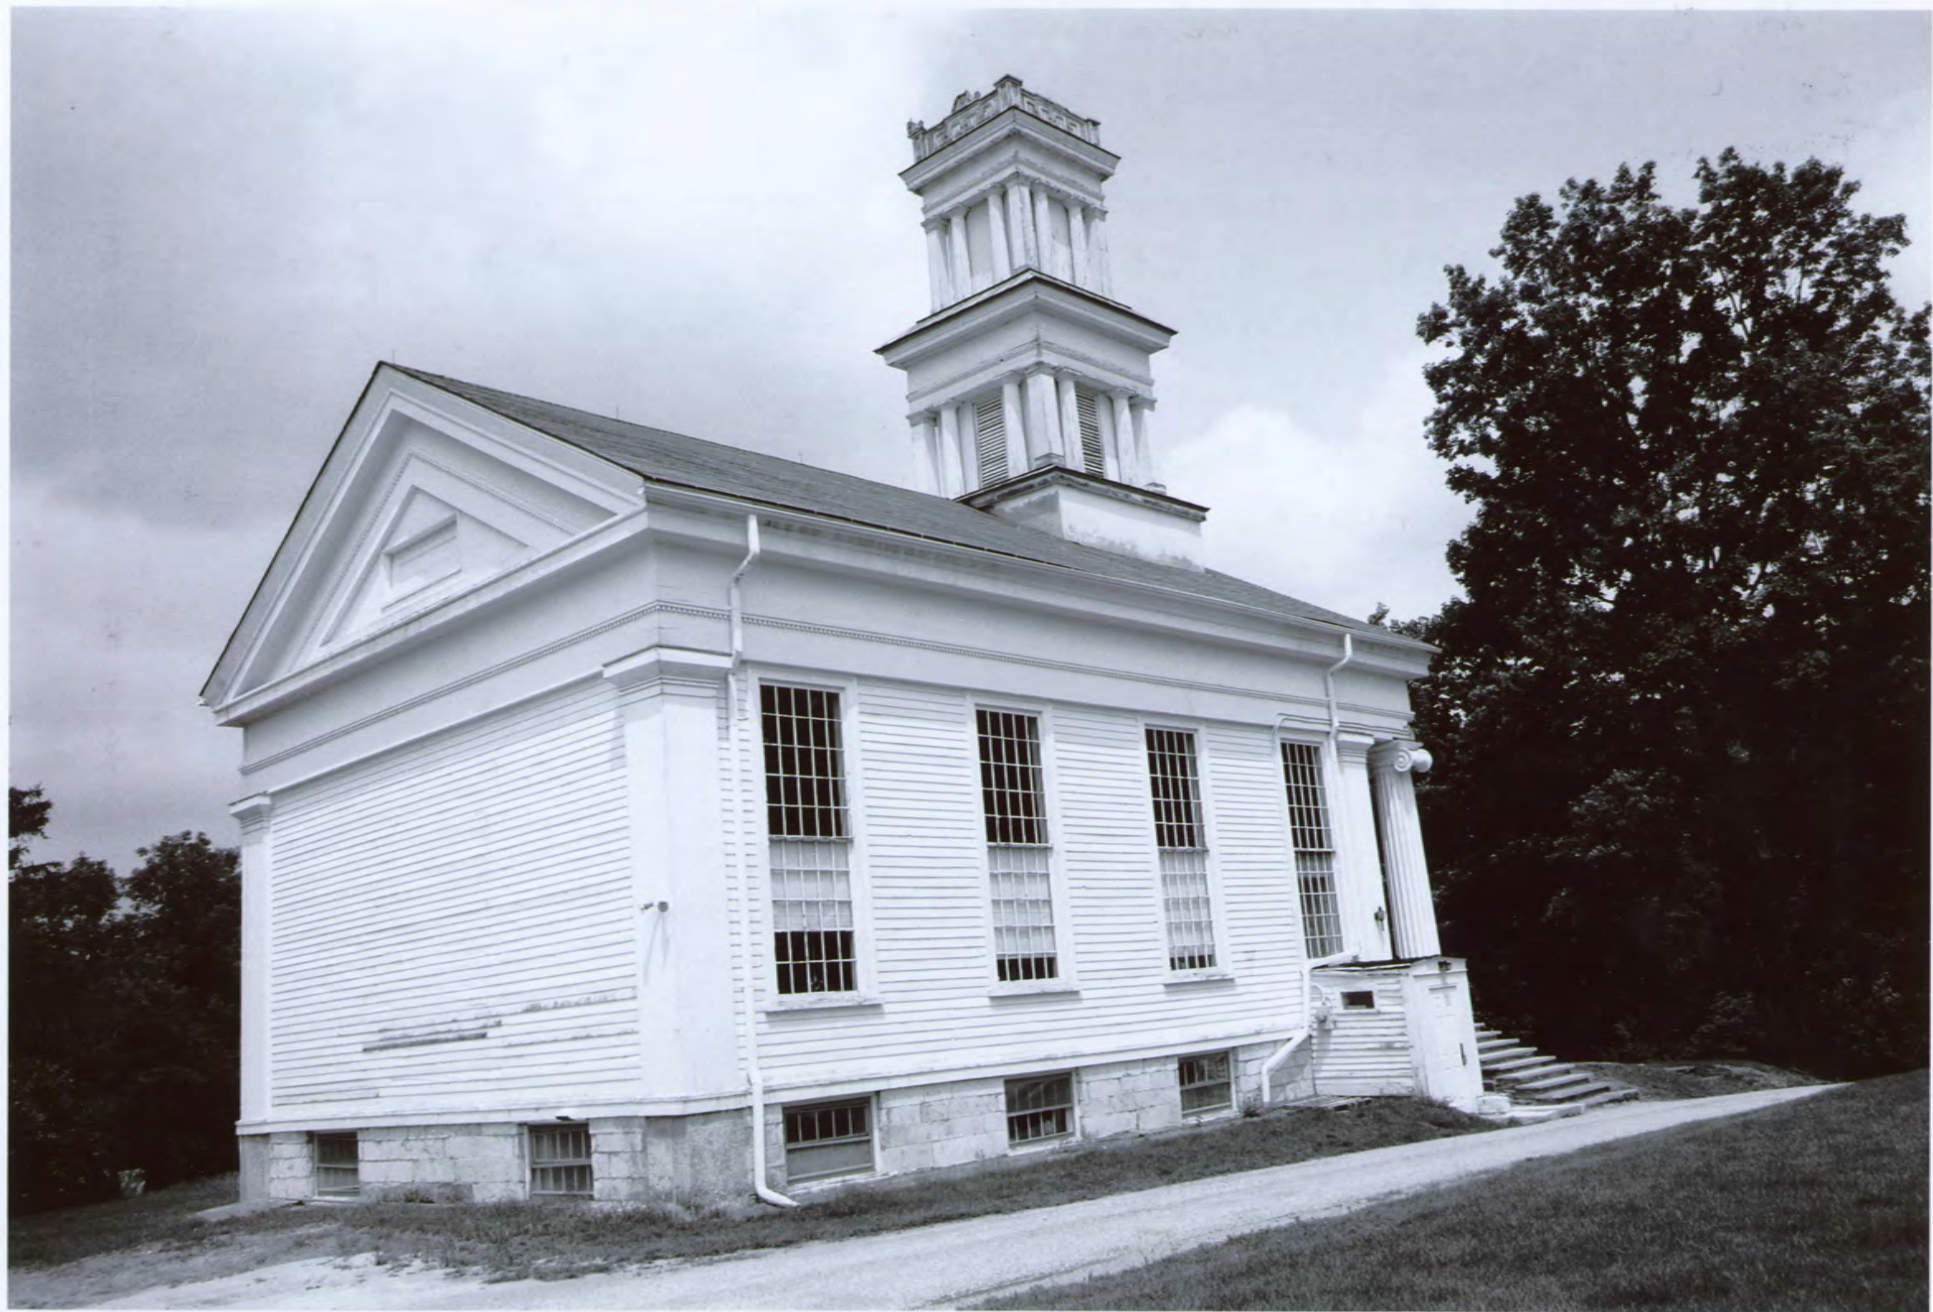
Photo #2

SE(right) + SW rear sides, looking north.

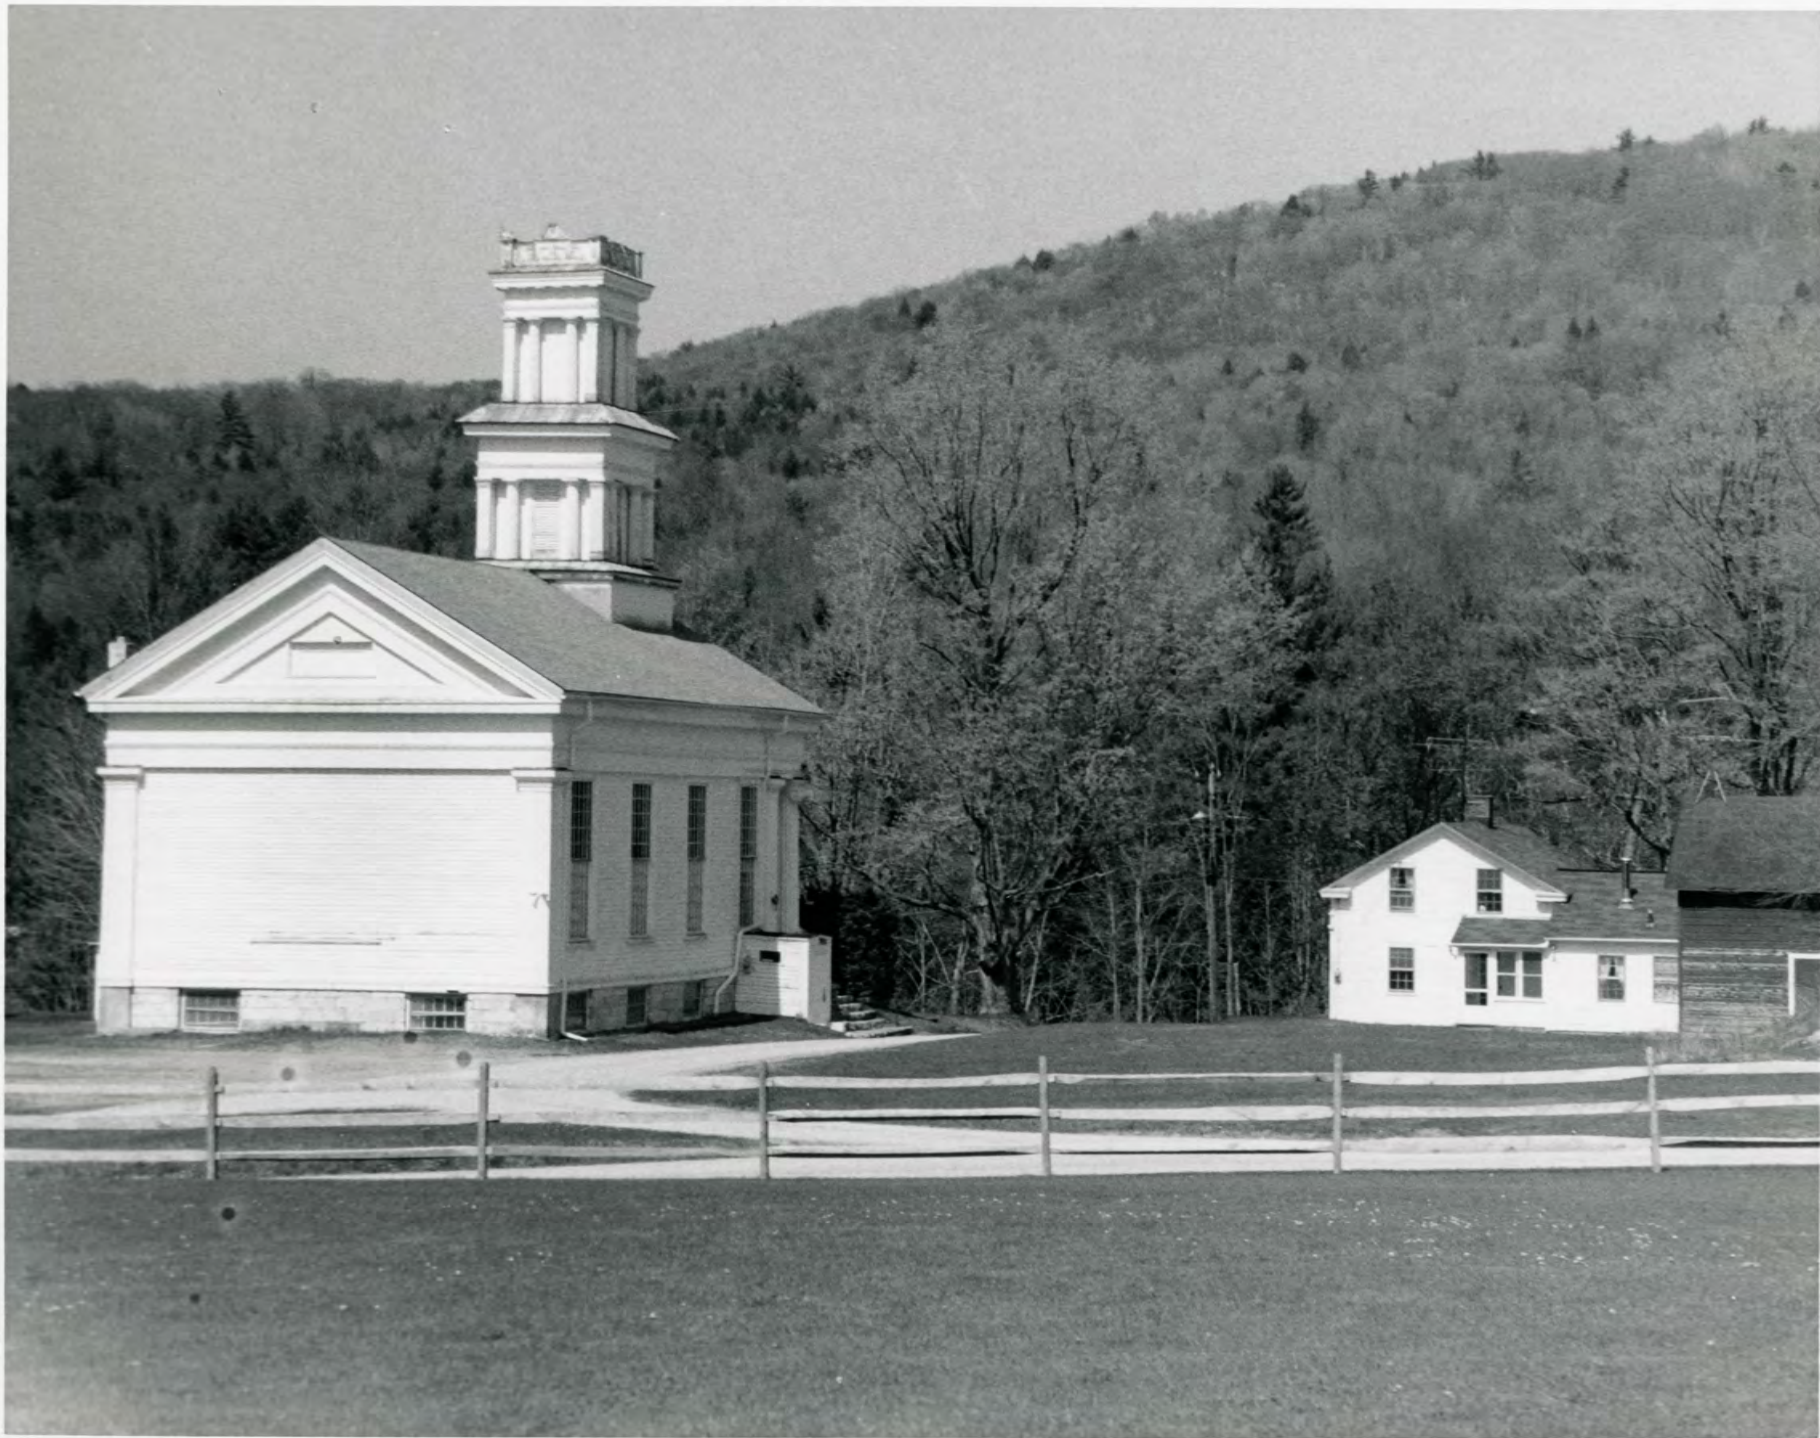
Photo #3

View of rear of church and parsonage and barn

Looking NE.

The property is located on a hill west of Main Road, just south of the center of Tyringham, a small community in southern Berkshire county. It consists of legal parcels, the church property and the parsonage property to the southeast (Photo #3). The church faces northeast over a maple shaded lawn which slopes down to the Main Road (Photo #1). Church Road runs close to the southeast side of the building (Photo #2). The parsonage lies southeast of the church. Between the two is Church Road which turns to the south behind the church and parallels Main Road to the east a short distance to the crossroads of Main Road and Jerusalem Road which joins Main Road from the southwest less than a quarter mile to the northeast of the church. Both the front facades of the church and parsonage face northeast on Main Road. The church is set back from the road on a rise approximately 130 feet while the parsonage, much closer to the road, is set back approximately 40 feet. The front yard of the church contains two old sugar maple trees to the southeast of the front yard and two younger sugar maple trees to the northeast of the front yard closer to the road. The church sign is located west of the younger sugar maples off-set to the northeast of the front of the church building (Photo #7). The church is close to the adjacent residential property at 3 Church Road and is visually separated by bushes and a garage which faces southwest on Church Road. Between the church and parsonage is a dirt portion of Church Road. The area between the two buildings is devoid of plantings. Behind the church is a gravel parking area assessable to Church Road. Behind the parsonage is the carriage barn. The southeast boundary of the parsonage property has some high untrimmed bushes. The front yard of the parsonage is narrow and the current road cut sites the parsonage considerably above the road. There are three sugar maples in the front yard, so that a face-on view of the front façade of the parsonage is impossible to see, except as one walks up to the front door. To the southwest behind both properties is Church Road, across which lie open fields and a view of mountains and hills west beyond Tyringham valley. This area immediately behind the parcels is open and treeless. A split rail fence on the west side of Church Road surrounds a meadow which was recently purchased as an addition and future expansion of the town cemetery (Photo # 3), which

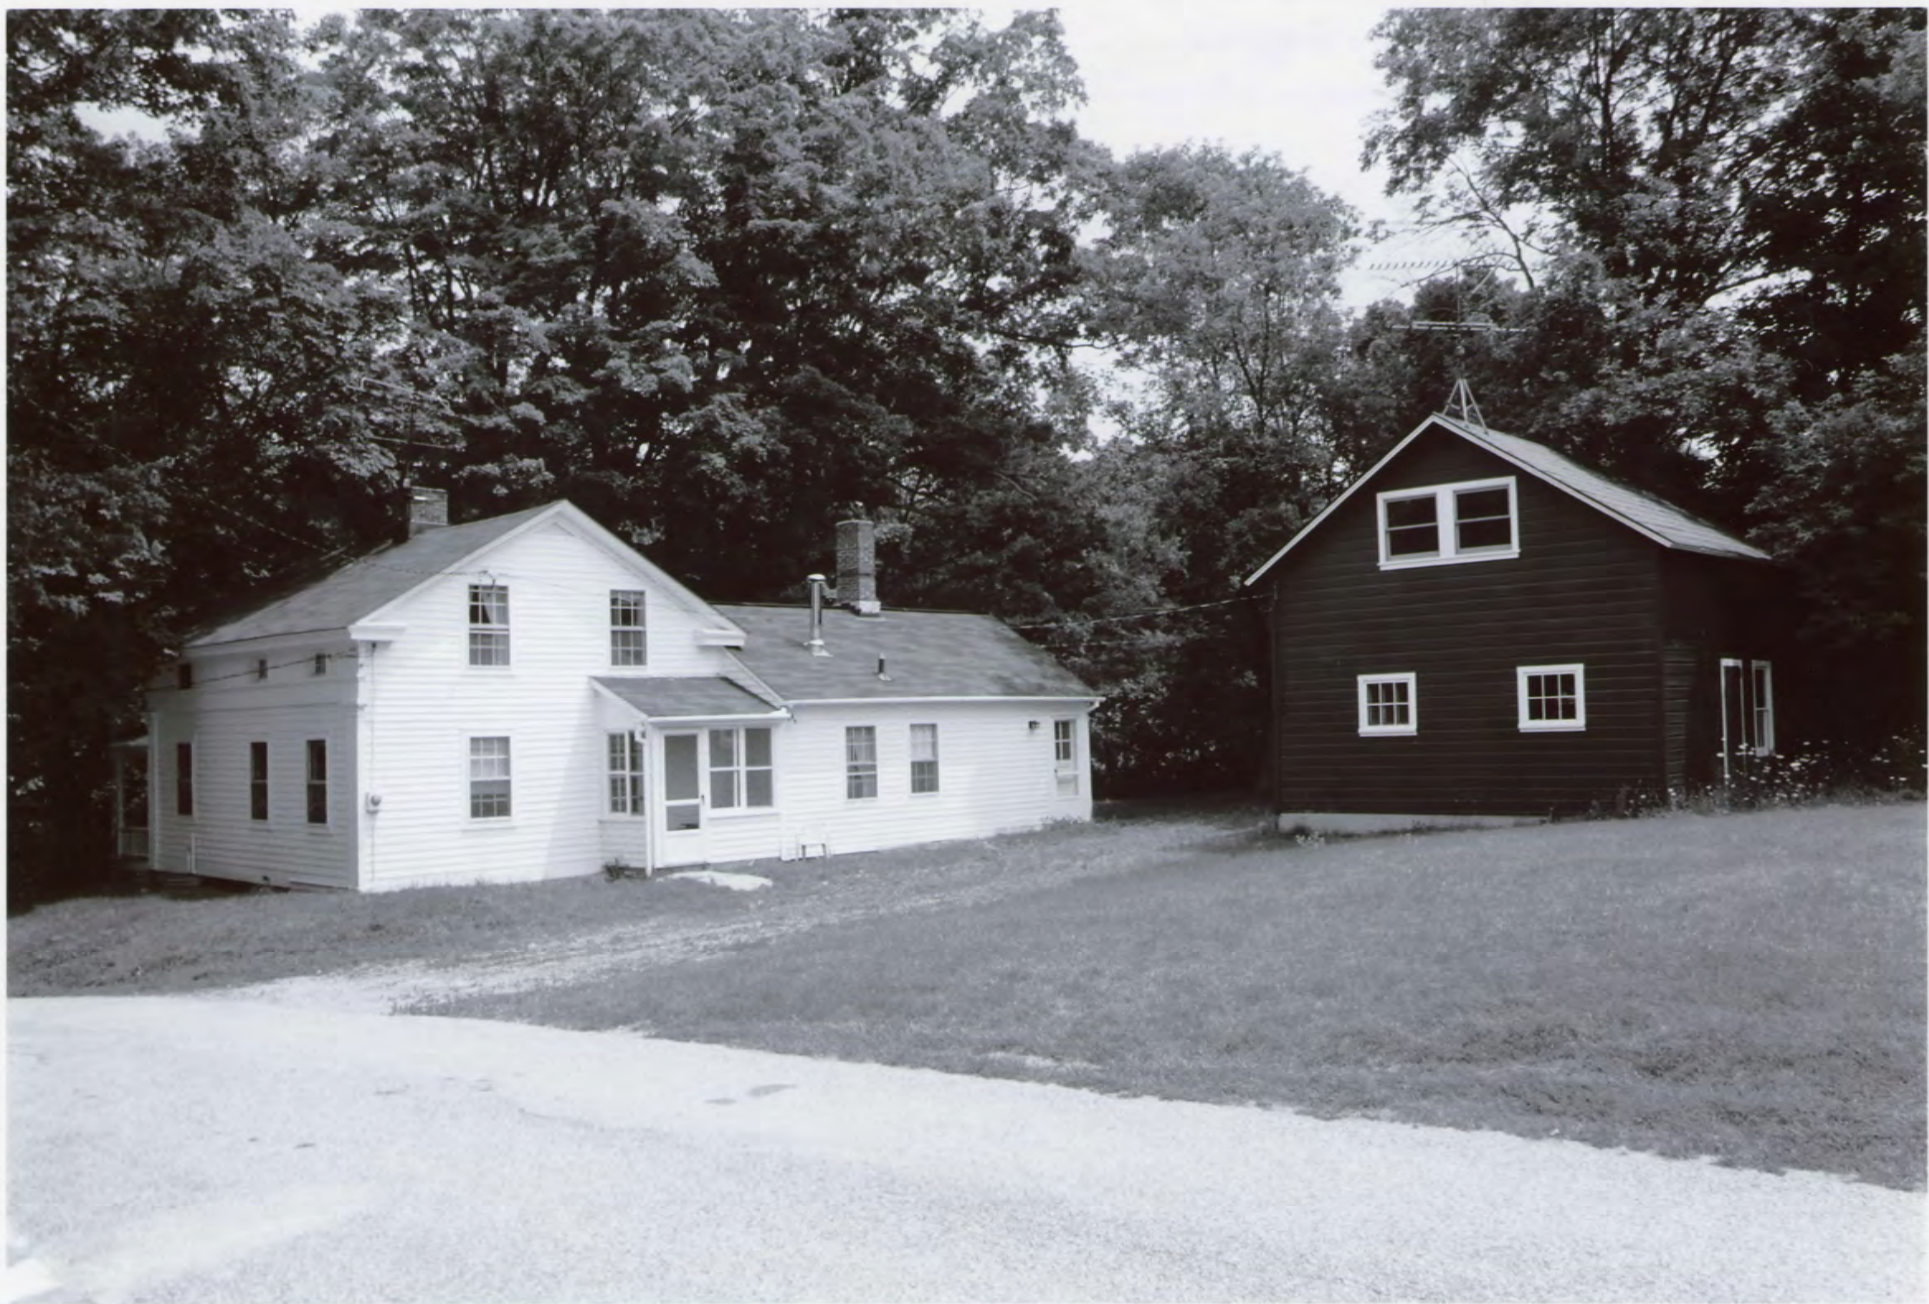
Photo #4

Parsonage + barn, facing SE. Church Road in foreground.

Southeast of the church building across Church Road stands the parsonage perched above the Main Road, which it faces. Built ca. 1842-1844 for a private citizen, this one-and-a-half story weatherboard dwelling is built in Greek Revival style, now somewhat obscured by a later bracketed porch added after 1893, according to a historic photograph in *Picturesque Berkshire*. The house is front gabled. The front facade consists of three bays with an off-center tripartite doorway flanked by sidelights and fluted pilasters. Wide plain pilasters delineate the corners of the front façade. On the lateral sides of the house under the eaves are three rectangular triple-light windows to a side which punctuate the wide plain wooden frieze. In the fully-pedimented front gable of the house above the porch roof is a horizontal attic light decorated with a rectilinear pattern of muntins, typical of many attic windows in the town. A one story side-gabled kitchen

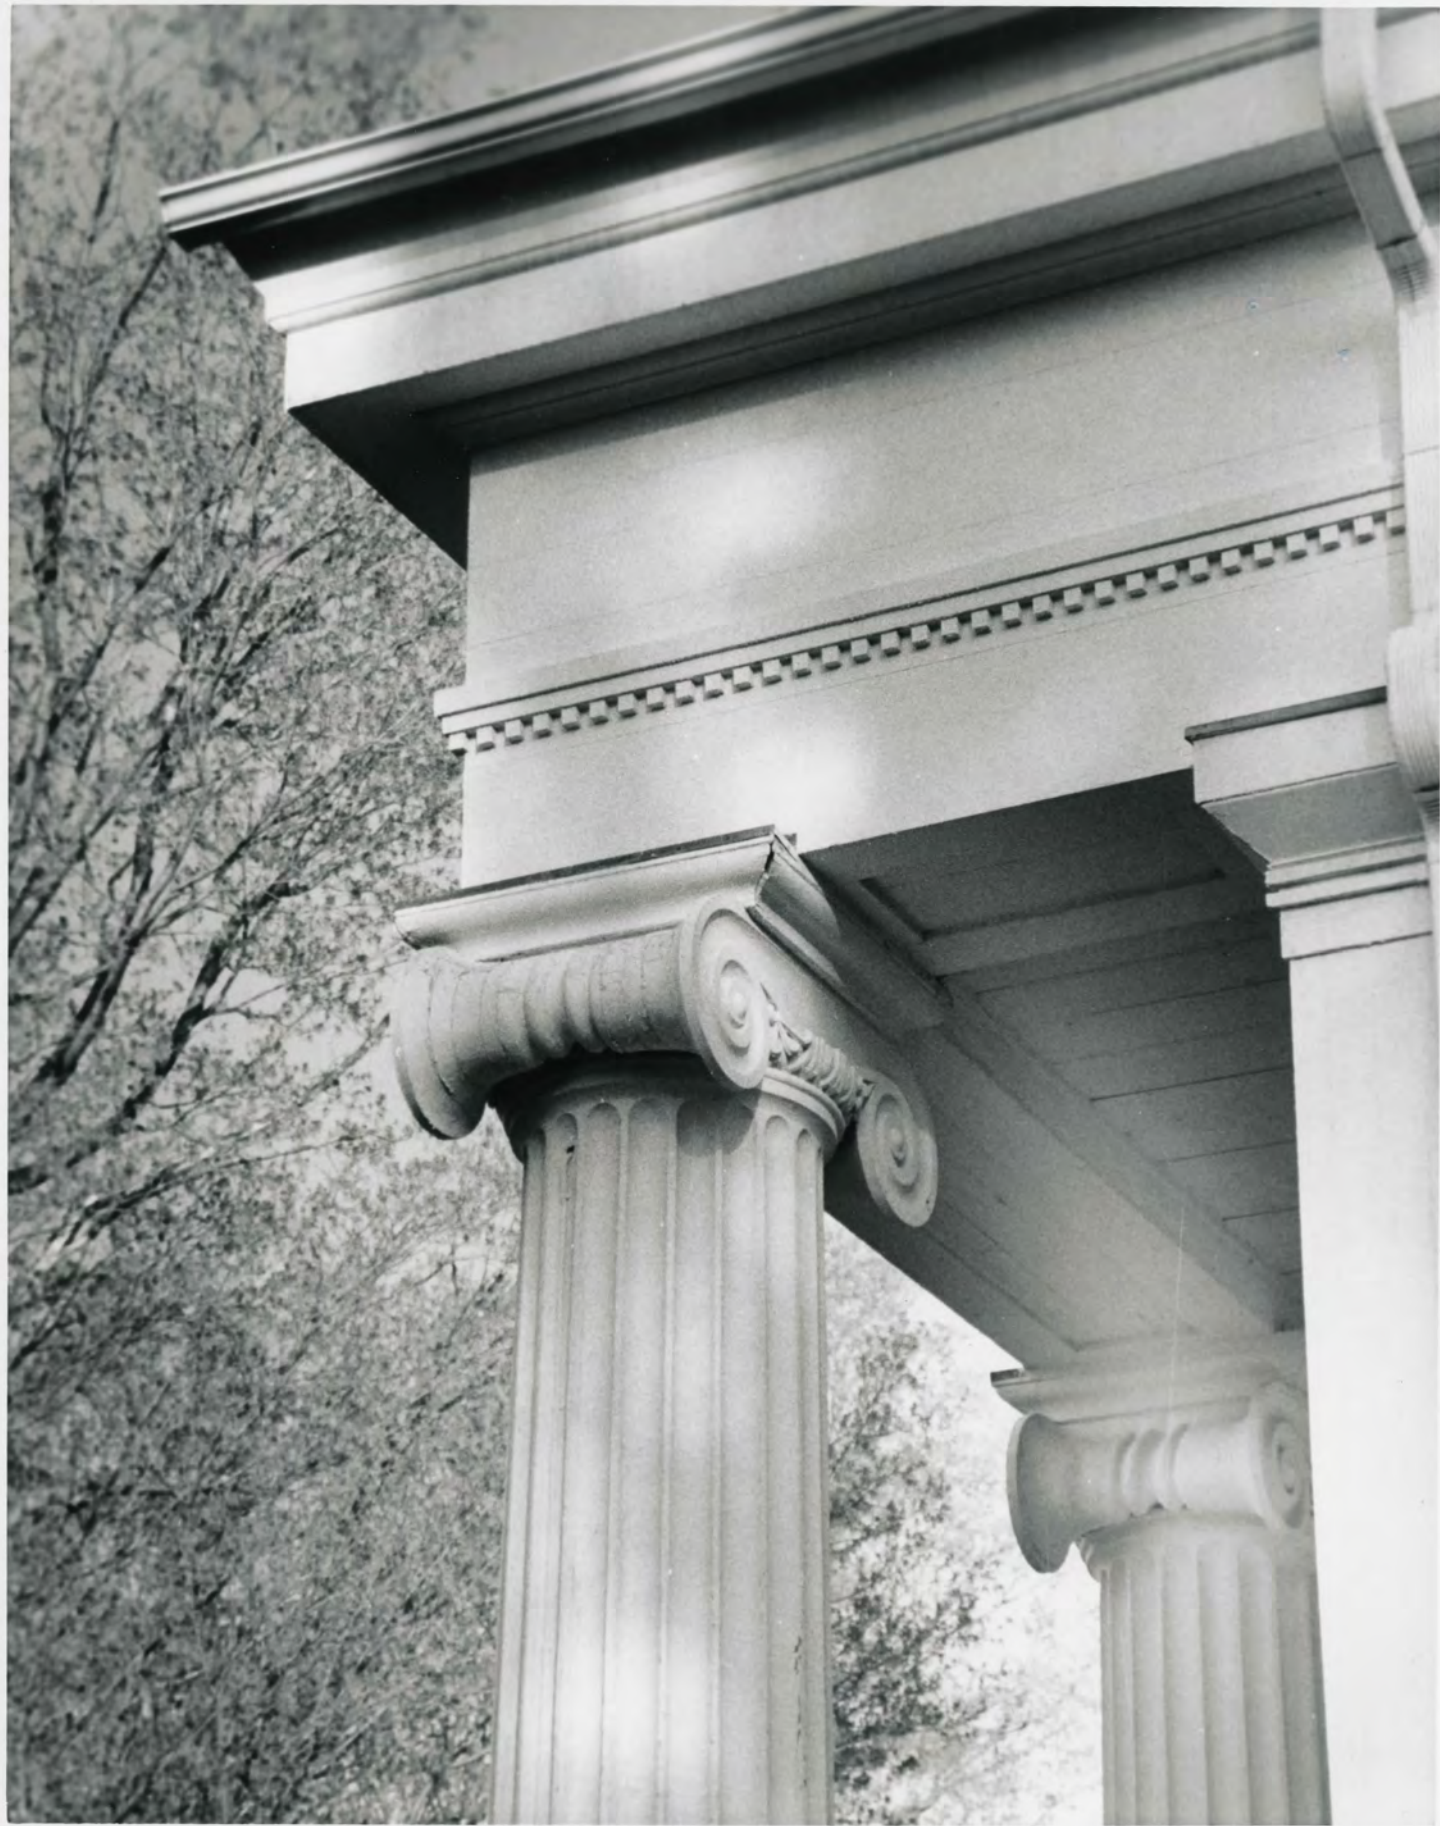
Photo #5

detail of column and entablature on front portico

View looking EAST

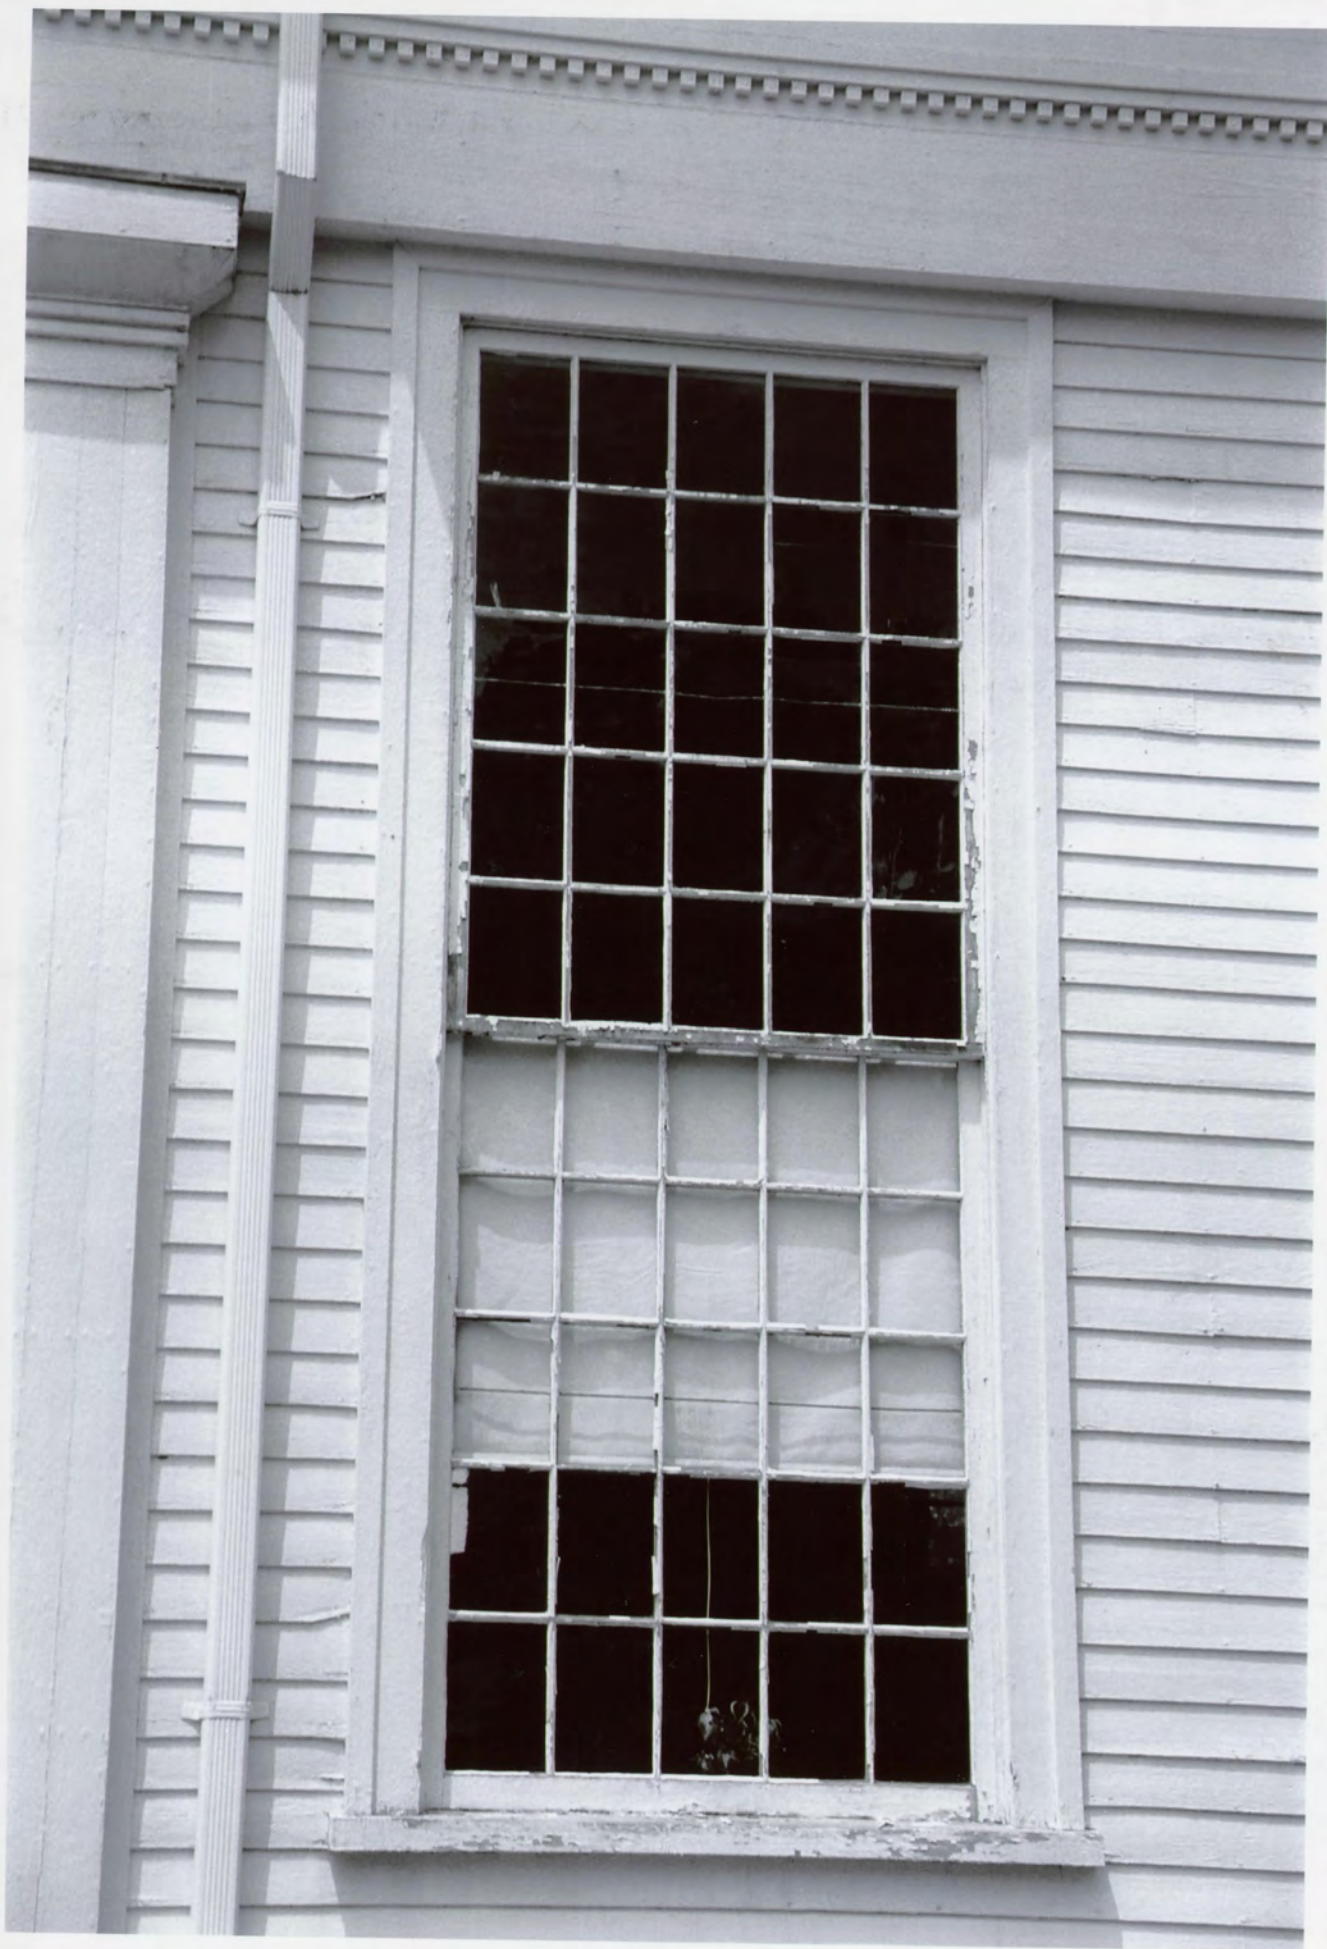
Photo #8

Detail of southernmost window of SE side of bldg.  
Facing NW

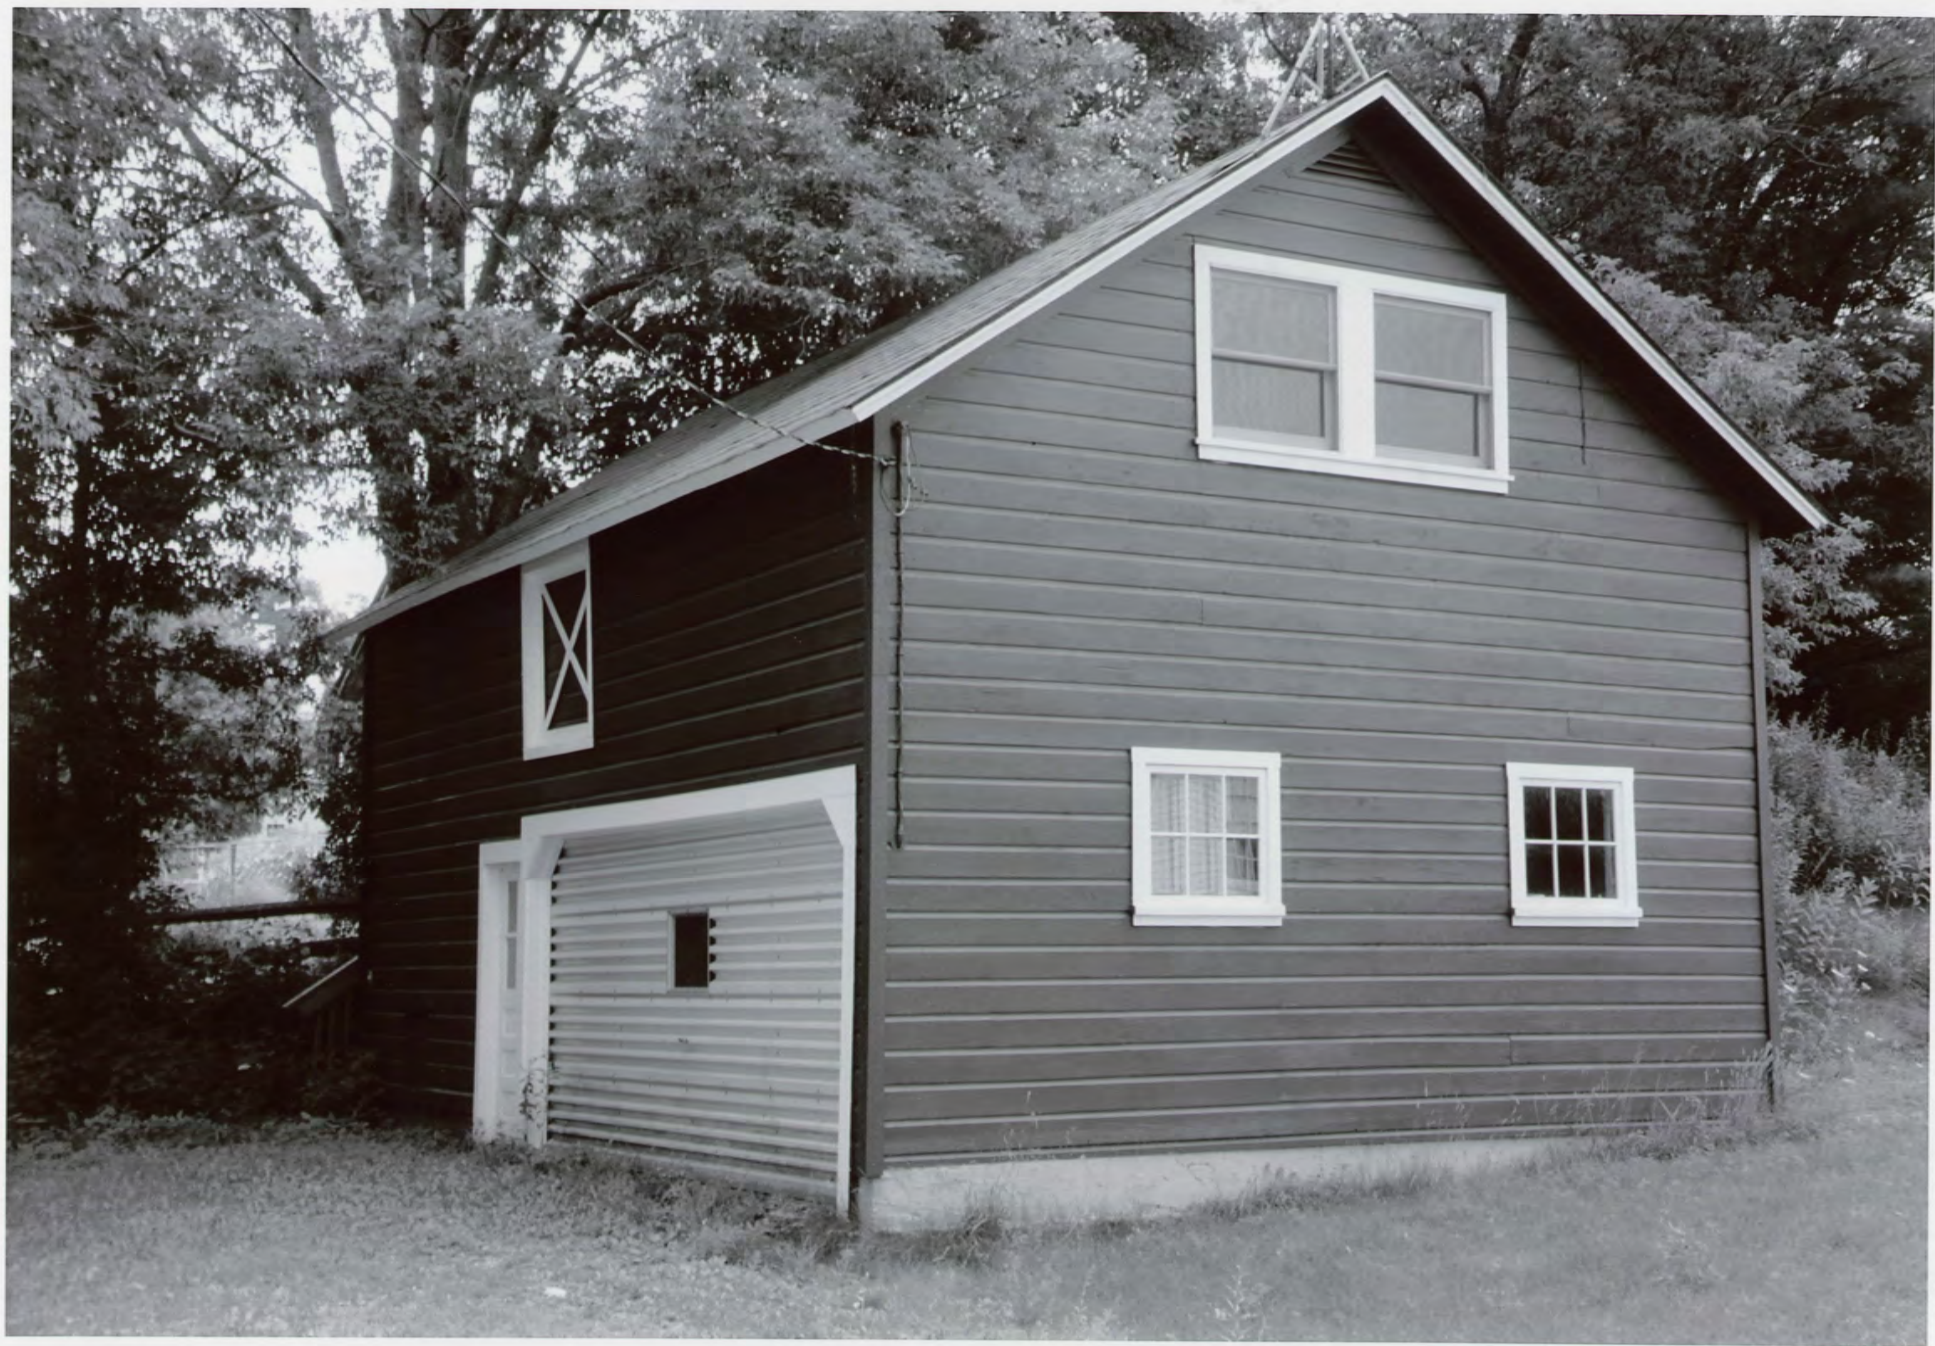
Photo #9

View: facing south behind parsonage

Behind the parsonage to the west stands a one and a half story frame barn. It is non-contributing in this nomination because it has lost most of its historic fabric (Photo #9). While this building is in excellent condition, very little of the historic architectural fabric remains. This barn is shown vaguely in an 1893 photograph in the book *Picturesque Berkshire*. The photograph is difficult to make out, but this barn might have been approximately a third larger with a sloping roof toward the parsonage, which does not exist today. This barn is today a small carriage barn with new shiplap siding, new windows and doors, and new garage doors punched through the wall on the northeast side facing the parsonage. Today, this barn has been fitted out with new overhead plastic corrugated white garage doors on the northeast side of the barn which face the rear of the parsonage. On the interior, the attic with knee-walls have been sheet rocked upstairs and made into a room with an exterior pressure-treated wooden stairway on the southeast side of the barn leading to an upstairs door. The interior of the ground floor of barn is post and beam with replacement posts, suggesting that only some 50% of the original framing of the original barn remains. All of these alterations were made to the barn in 1978. The arrangement of the ground level indicates that this barn at one time accommodated stalls for two horses, hay storage, and probably a carriage. This outbuilding is indicated on a 1904 map, as well as in the 1893 photograph.
