National Register of Historic Places
Registration Form

Historic name Deerfield Texaco Service Station
Other name/site number _____

Deerfield Texaco Service Station
Deerfield, Kearny County, Kansas

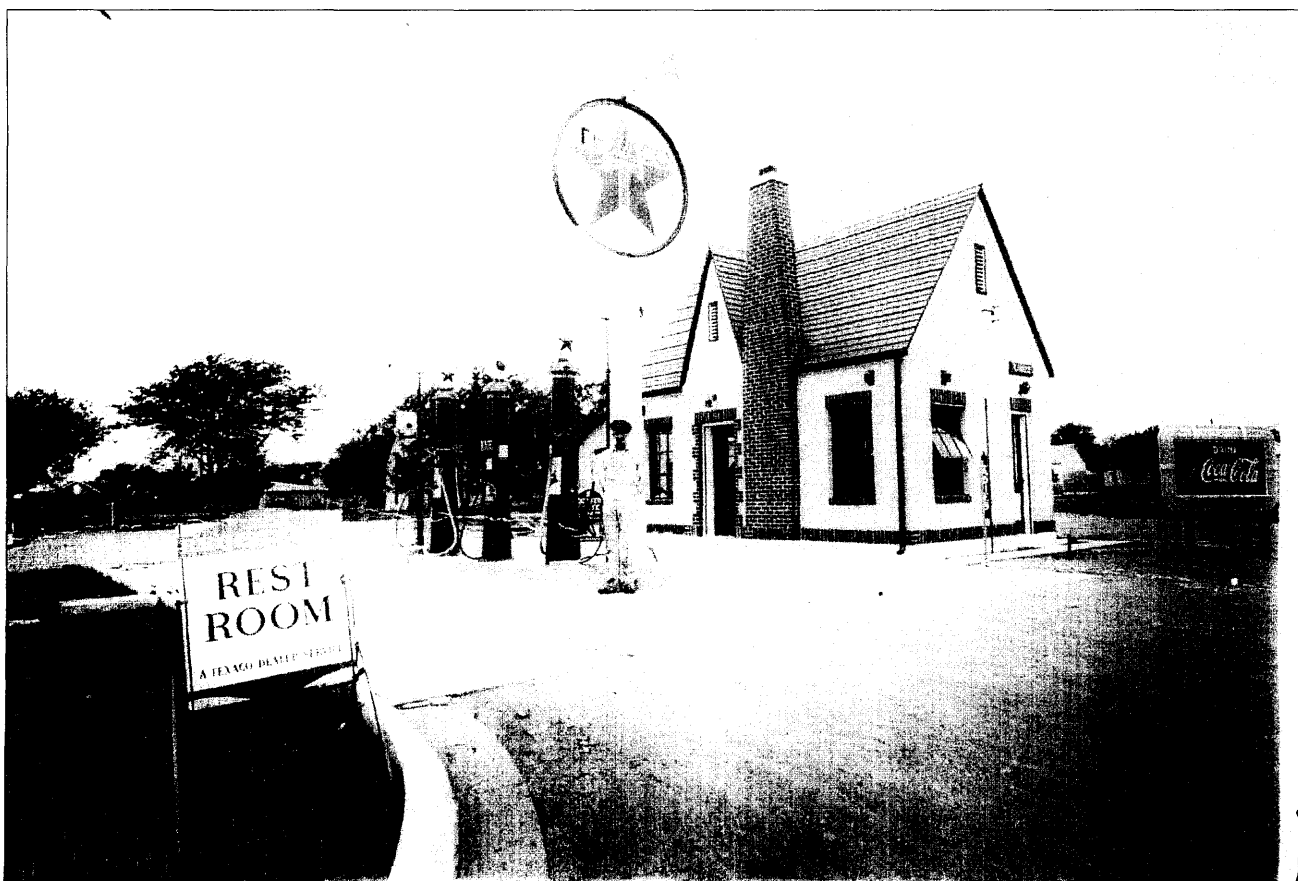
Deerfield Texaco Service Station, 1930s – Photo courtesy of Kearny County Historical Society

With its “Registered Restroom” sign prominently displayed along the roadside and a sign on the east side of the station noting the presence of the “Ladies” room, Spellman’s description depicts the Deerfield station perfectly. The Registered Restroom program was voluntary and designed to improve Texaco’s image and increase sales. The program continued until 1959.

A historic photo of the Deerfield Texaco Service Station shows the location of the exterior pump island that is no longer extant. Judging from the symbols in the picture and the style of pump the photograph appears to be dated from the mid 1930s. The evidence in the photos shows a Banjo-Style Texaco Logo that was introduced in 1936. And the gasoline pumps are serving the Fire-Chief gasoline. According to some of the Texaco records, Fire-Chief Gasoline was distributed by Texaco from 1932 till 1938.¹⁰ The pumps themselves are Wayne-type 515 or 615 pumps. These types of Wayne pumps were first used in the early 1920s until the early 1930s. You can see the ten-gallon glass gasoline holder at the top of the pumps.¹¹ The Ford Model T, 1908-1927 as well as the Ford Model A, 1927-1929, had a 10-gallon tank. At that time, gas mileage was 20-25 miles per gallon.

The photo also provides evidence that the Deerfield station was a "Texaco Registered Restroom." Texaco introduced the Registered Restroom program in 1938. According to author Susan Spellman:
