# National Register of Historic Places Registration Form

historic name Fish Lake Guard Station  
other names/site number Fish Lake Remount Station

street & number Willamette National Forest, 57600 McKenzie Highway  not for publication  
city or town McKenzie Bridge  vicinity  
state Oregon code OR county Linn code 043 zip code 97413

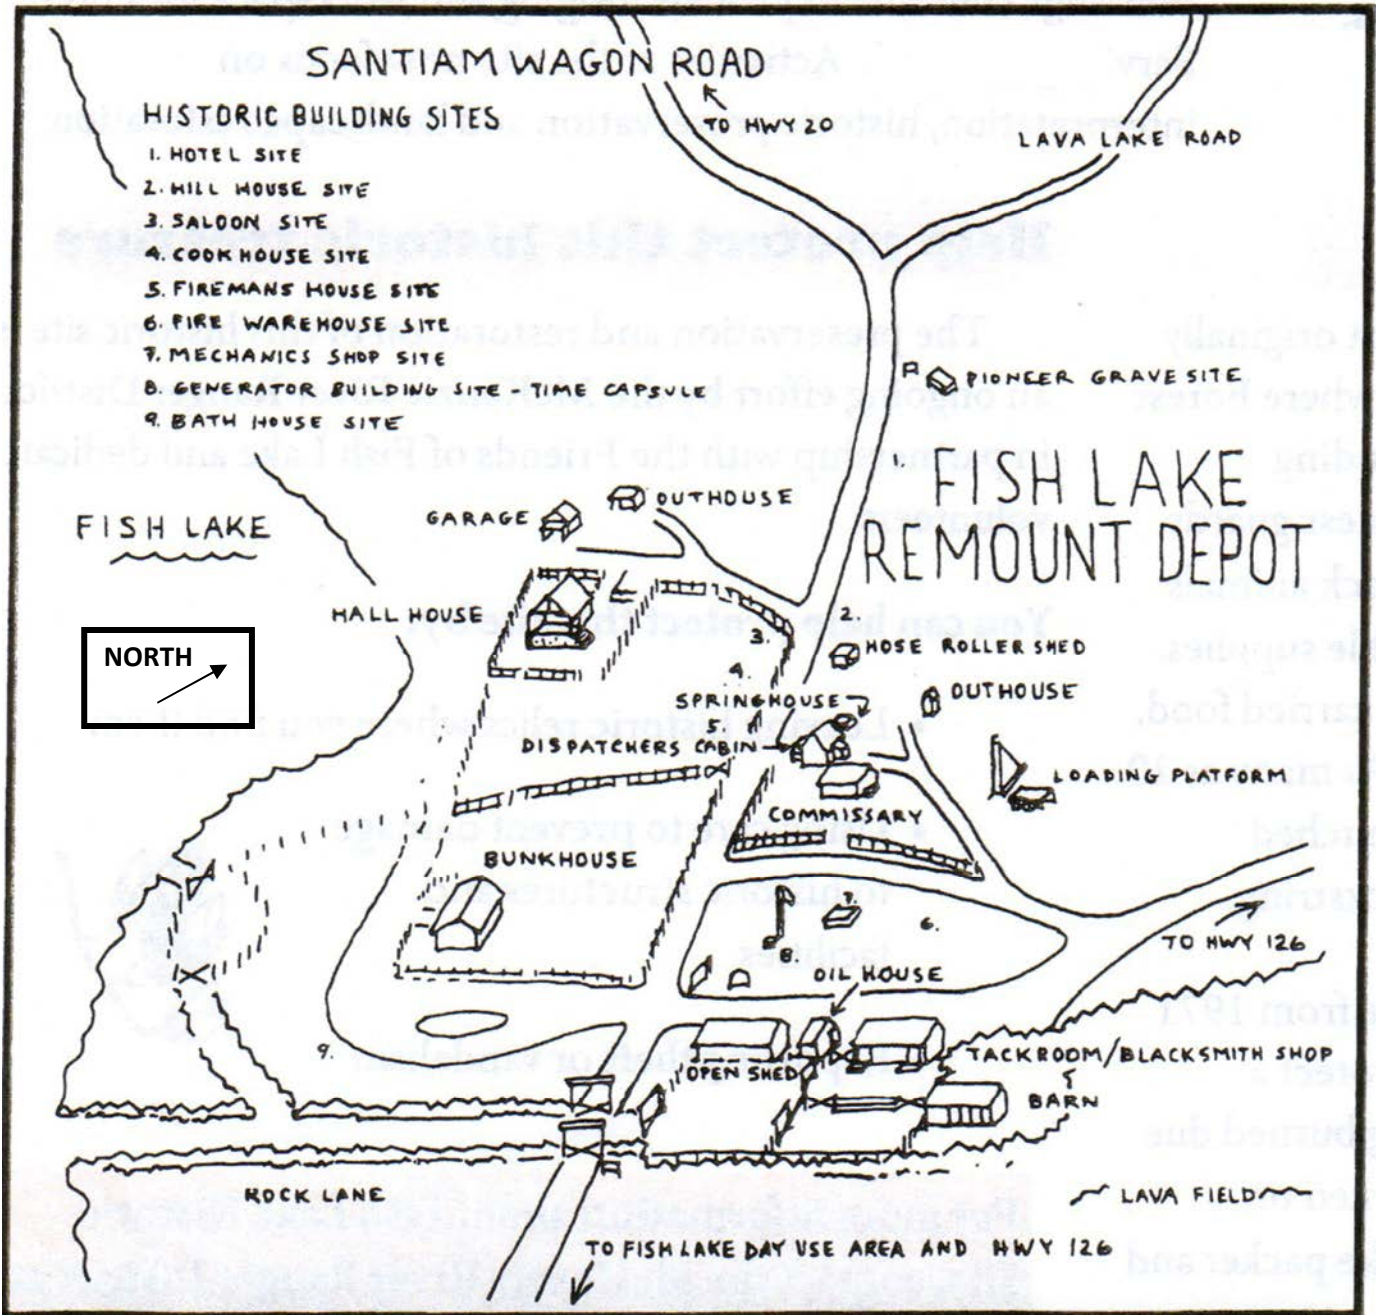
Figure 4: Site Sketch Map.

Artist's rendition of the site. Dam not included due to scale. Numbers 1-5, 8-9 refer to no longer extant buildings or sites. Drawn by Jim Denny.
