National Register of Historic Places Registration Form

Historic Name: Cotulla Downtown Historic District

City or town: Cotulla

State: Texas

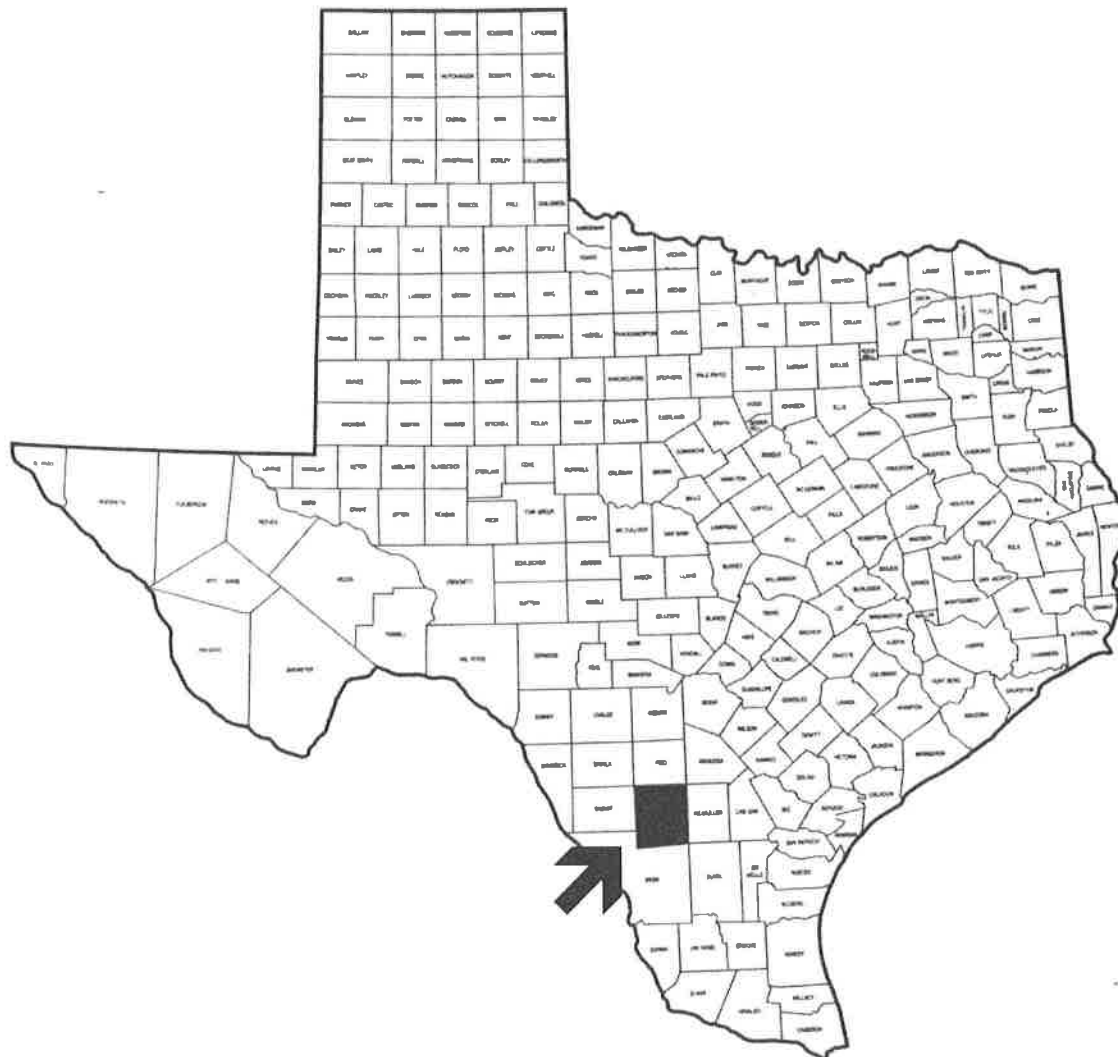
Cotulla Downtown Historic District, Cotulla, La Salle County, Texas

MAP OF THE TOWN OF COTULLA,

At Twining Station, in La Salle County, Texas, on the line of the International & Great Northern Railroad.

Cotulla was founded in 1881 as a railroad town, when the International-Great Northern Railroad came through La Salle County. Because of this, the location of the railroad tracks dictated the city's organization and street layout. The railroad enters southern Cotulla at a northeasterly angle, bends north-northwest as it passes through town, and then resumes its northeasterly course. West of the railroad, Cotulla's streets mirror the railroad's north-northwest angle, so that the street grid is slightly skewed off true north. The tracks and their adjacent commercial buildings constitute the eastern edge of the street grid, and later development spread westward and today terminates at Interstate 35. The courthouse sits at Center Street, three blocks west of the railroad tracks. North of Center Street, street names have a "North" directional designation, and south of Center Street, streets are designated "South." Front Street runs parallel to and immediately west of the tracks. East of the tracks, the street grid differs—the southwest-northeast angled streets here were platted as the town of La Salle, an 1881 town that was eventually absorbed into Cotulla.

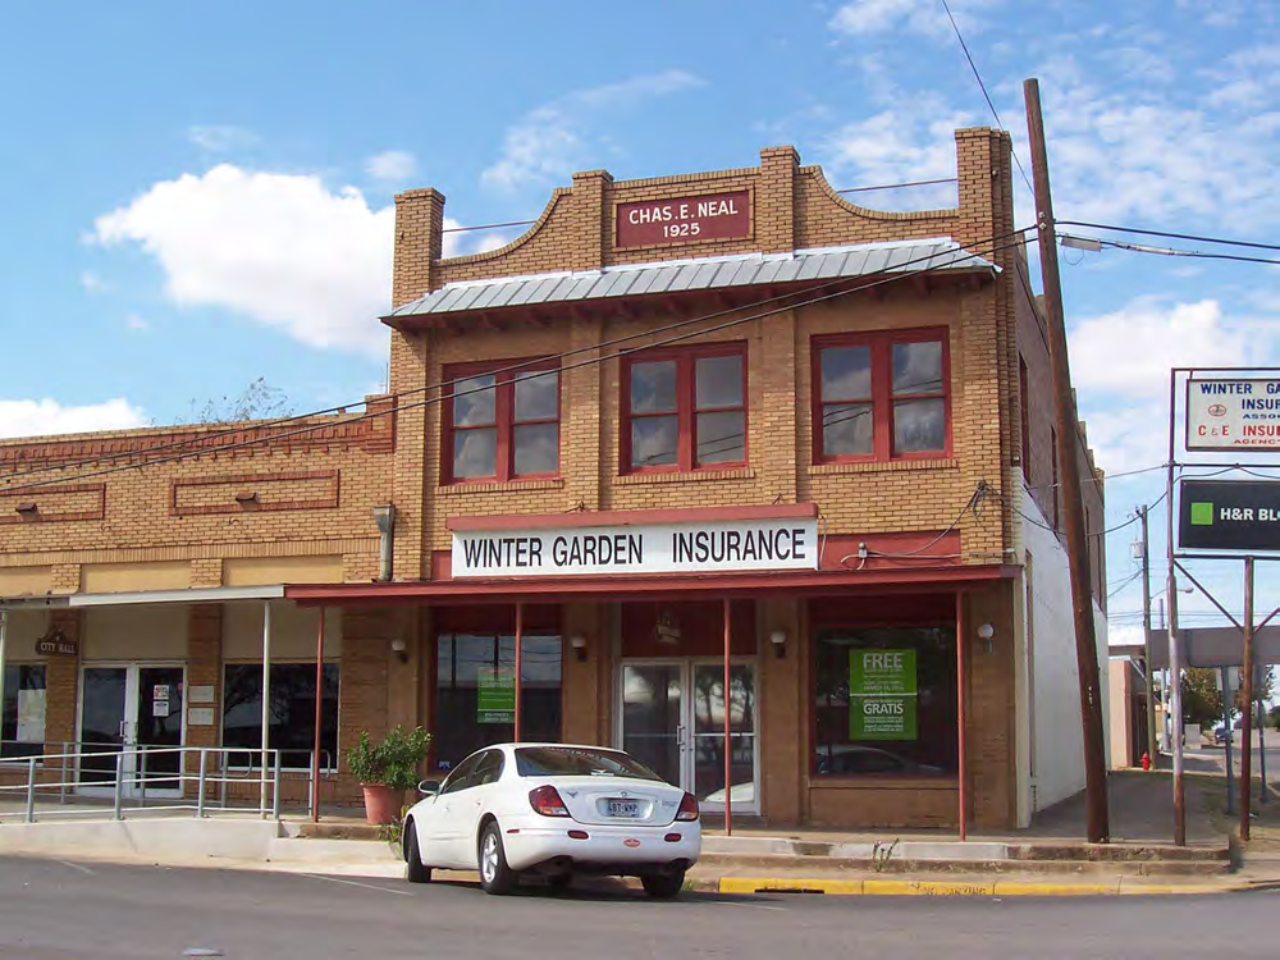
CHAS. E. NEAL
1925

The Chas. E. Neal Building at 119 N. Front Street is a two-part commercial building at the southwest corner of Front Street and Tilden Street. The building is clad in bricks of a dark buff color. The front façade, which faces east toward Front Street, has a symmetrical three-bay arrangement with storefronts on the ground floor and offices or apartments above. On the first floor, the central bay contains a double entry door with transom. The two flanking bays each contain one large storefront window, each with transom. The entry doors and storefront windows are nonhistoric replacements, and the transoms over the entry and storefronts have been blocked in. A nonhistoric wood and metal awning spans the façade just over the storefronts. On the second floor, each bay contains one set of paired double-hung windows. The wood windows sash and trim are original and are in good condition. At the façade corners and between each of the bays is a shallow brick pilaster. The pilasters continue vertically to the parapet level and are incorporated into the parapet’s symmetrical design, which features brick parapet walls and a central plaque reading “CHAS. E. NEAL 1925.” The building’s north façade faces Tilden Street. The lower level has been stuccoed and a door opening bricked-in. A secondary storefront located at the rear of the façade has its door and window openings blocked in with plywood. The north façade’s second floor is in good condition, with its brick cladding and regularly-spaced double-hung windows intact.
