National Register of Historic Places Registration Form

historic name Blandwood
other names/site number Keeley Institute

street & number 447 West Washington Street not for publication
city, town Greensboro vicinity
state North Carolina code _____ county Guilford code _____ zip code 27403

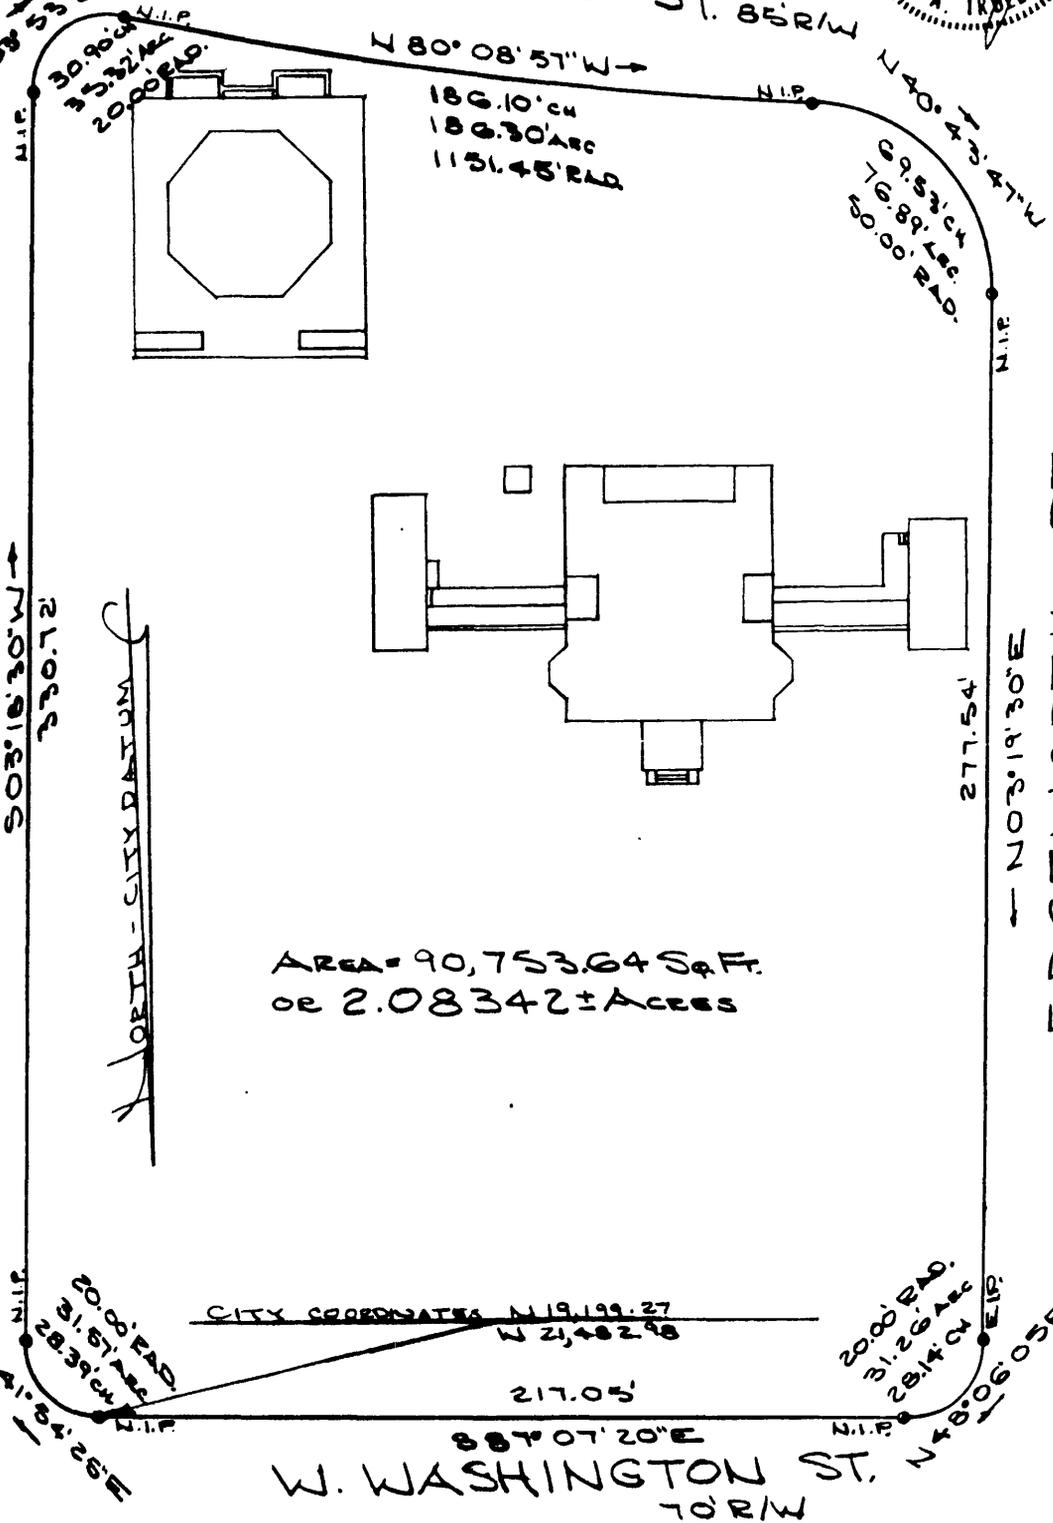
The two and a half acres represented on the survey map are the remaining acreage from the original 50 acre estate of Governor John Motley Morehead. In 1844 Blandwood was on the outskirts of the small village of Greensboro. Today the house stands near the center of a thriving city.

Survey For:
 John Motley Morehead Memorial Commission
 447 West Washington St.
 Morehead Township, Guilford Co.
 Greensboro, N.C. Deed Book 2421 Pg. 780 & 781
 Tax Map #20-8-1
