# Klinar Engineering Structural Consulting

## Photographs:

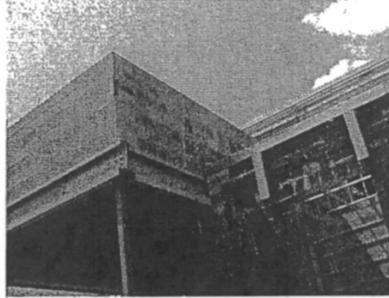
Figure 5 Low roof over  
entrance and vestibule – See  
items 1, 2, 4

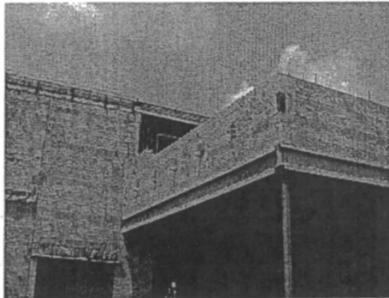
Figure 6 Low roof over  
entrance and vestibule – See  
items 1, 2, 4

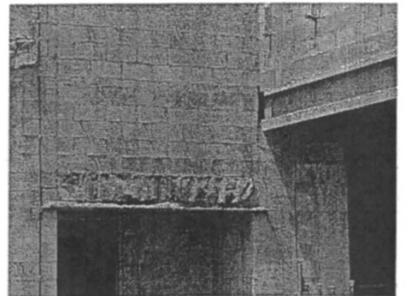
Figure 10 Lintel installed over  
door 123B

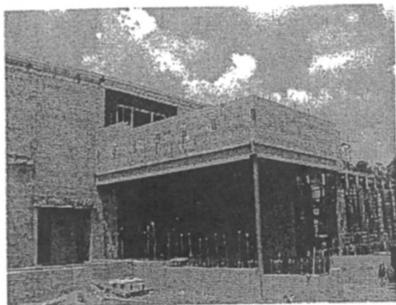
Figure 11 Low roof over entrance and vestibule – See items 1, 2, 4

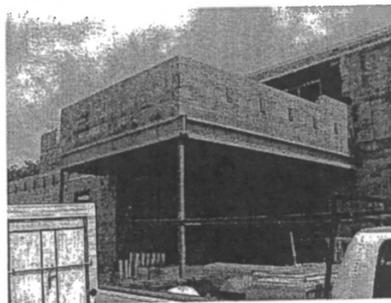
Figure 17 Low roof over terrace – See items 1, 3, 4.

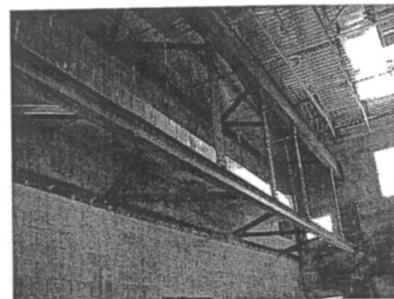
Figure 20 Horizontal truss framing in lobby – See item 6

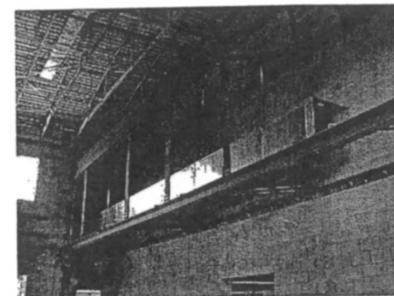
Figure 21 Horizontal truss framing in lobby – See item 6

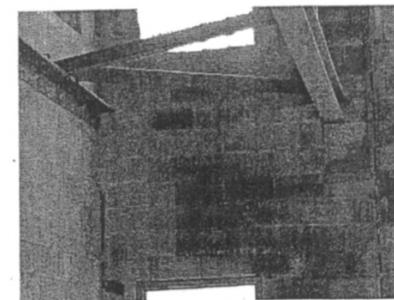
Figure 22 Horizontal truss in lobby – See item 6

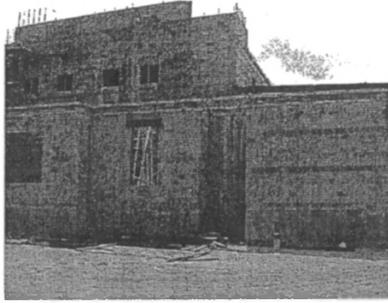
Figure 27 Back corner of building = verify lintel height

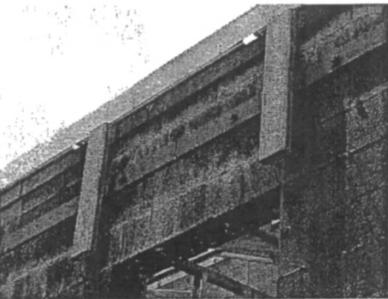
Figure 30 Exterior wall at low roof and precast supports – See item 8

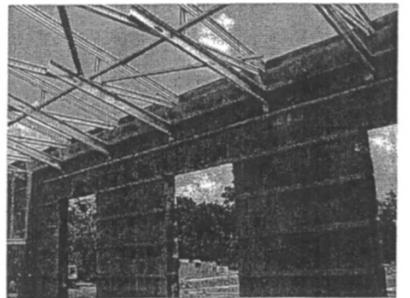
Figure 34 See item 8

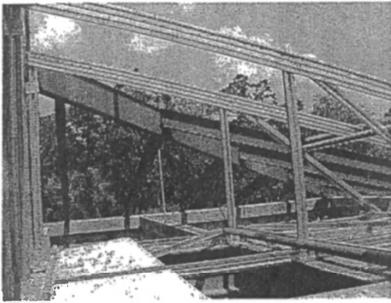
Figure 35 Low roof steel hip framing – see items 10, 16, 17, 18

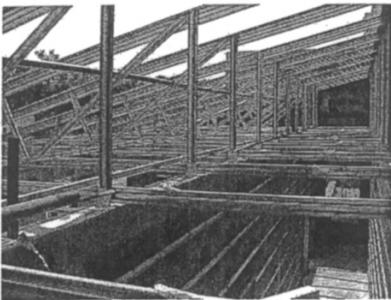
Figure 36 Intermediate bearing at low roof trusses – See items 11, 15

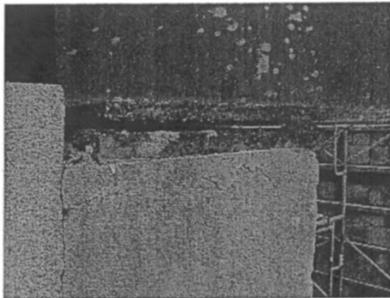
Figure 39 Bearing plate at W16 – See item 12

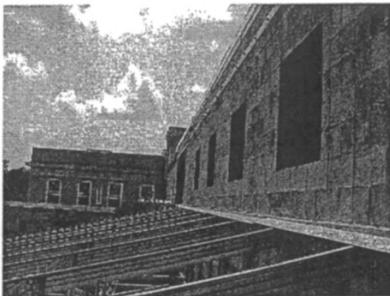
Figure 40 Interior supporting wall at low roof trusses

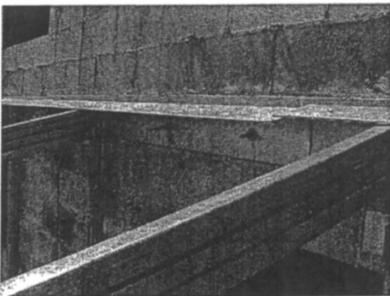
Figure 41 Bent plate roof connection at low roof

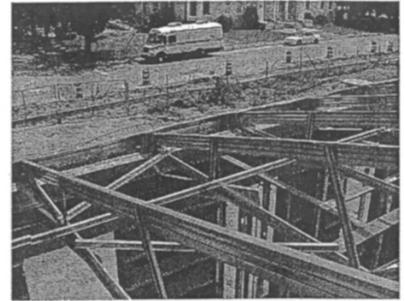
Figure 42 Exterior wall supporting low roof trusses – See item 13

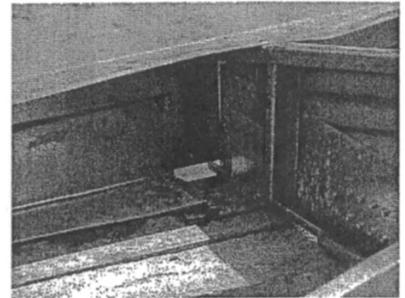
Figure 43 Exterior wall supporting low roof trusses – See item 13

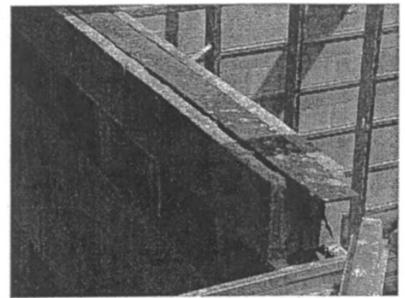
Figure 44 Typical embed plate at interior wall at low roof. Void between grout and plate – See item 15

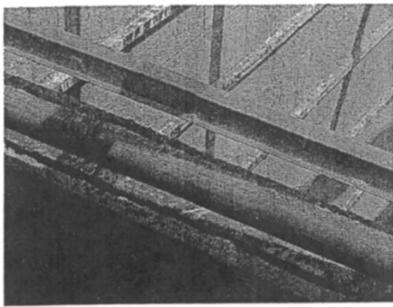
Figure 45 Typical embed plate at interior wall at low roof. Void between grout and plate – See item 15

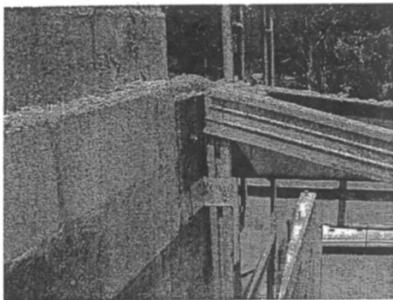
Figure 46 End plate for hip girder – See item 17

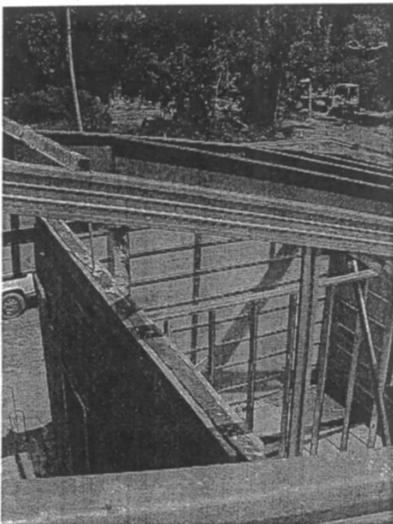
Figure 47 Low roof steel hip framing – see items 10, 16, 17, 18

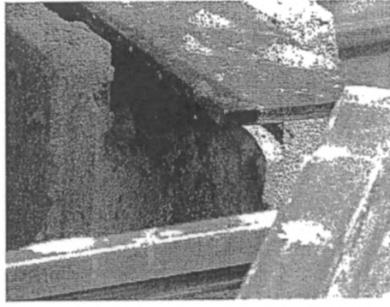
Figure 48 Typical embed plate at interior wall at low roof. Void between grout and plate – See item 15

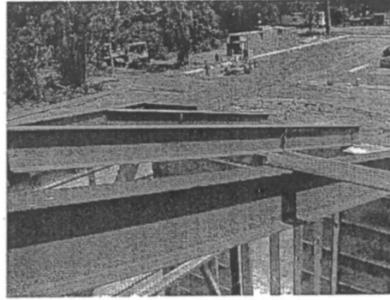
Figure 49 Low roof steel hip framing – See items 10, 16, 18

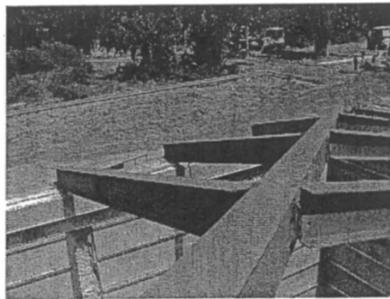
Figure 50 Low roof steel hip framing – See items 10, 16, 18

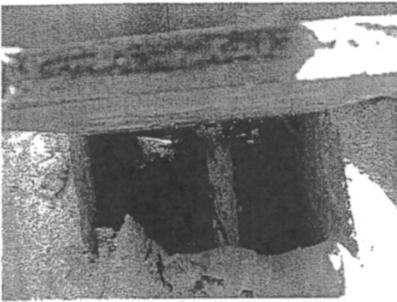
Figure 54 Typical embed plate at interior wall at low roof. Void between grout and plate - See item 15

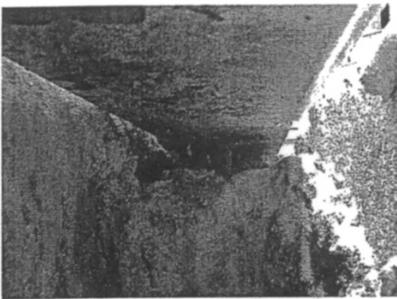
Figure 55 Typical embed plate at interior wall at low roof. Void between grout and plate - See item 15

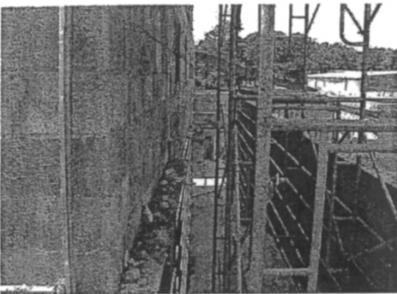
Figure 56 Angle support and low roof framing not installed at back wall at judges chambers

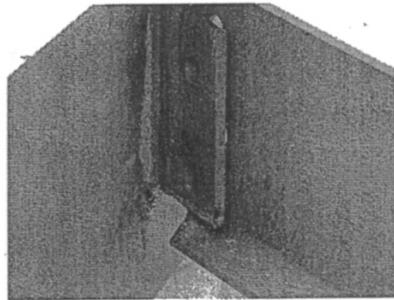
Figure 57 Field-modified tab plate connection at steel hip framing - See item 10

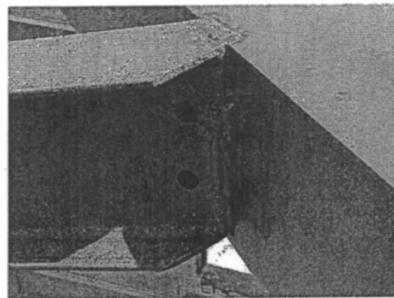
Figure 58 Field-modified tab plate connection at steel hip framing - See item 10

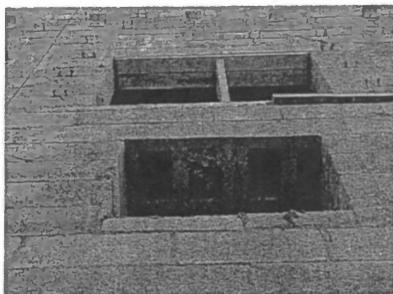
Figure 68 UngROUTED lintel over louver opening – See item 24

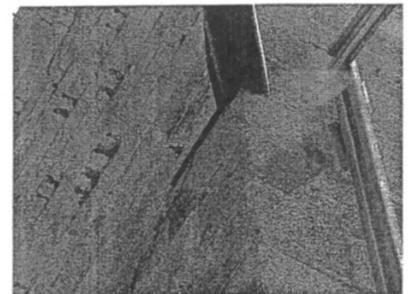
Figure 71 End plate for hip girder – See item 17

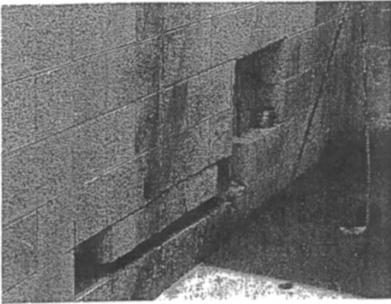
**Figure 72** Trenched wall in room 129A

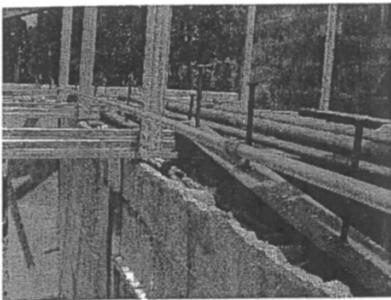
**Figure 73** Intermediate CMU support wall for low roof framing. Bond beam is partially grouted without embed plate. Steel trusses already installed – See item 20

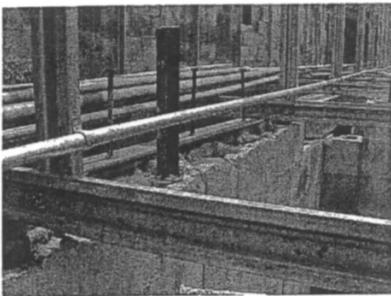
**Figure 74** Intermediate CMU support wall for low roof framing. Bond beam is partially grouted without embed plate. Steel trusses already installed – See item 20

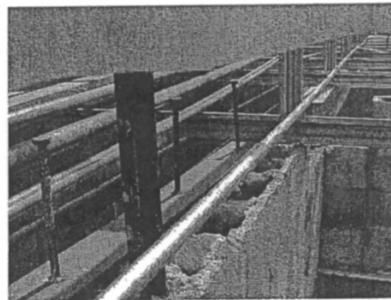
**Figure 76** Intermediate CMU support wall for low roof framing. Bond beam is partially grouted without embed plate. Steel trusses already installed – See item 20

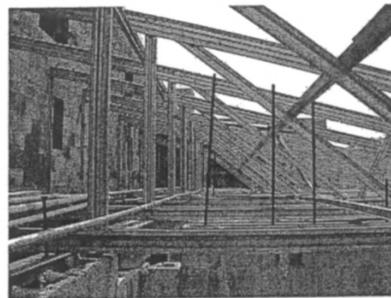
**Figure 77** Intermediate CMU support wall for low roof framing. Bond beam is partially grouted without embed plate. Steel trusses already installed – See item 20

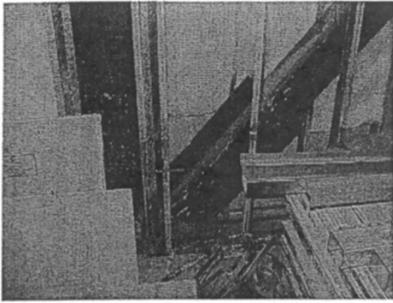
Figure 92 Braced frames in existing building – See item A

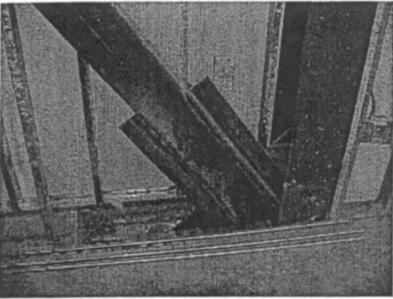
Figure 93 Braced frames in existing building – See item A

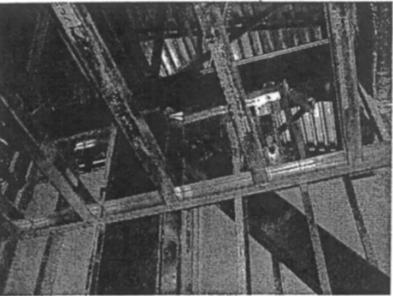
Figure 94 Braced frames in existing building – See item A

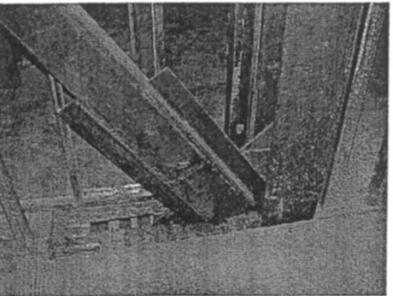
Figure 95 Braced frames in existing building – See item A

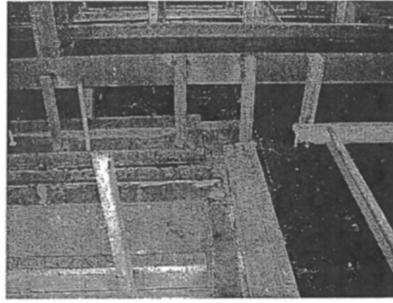
Figure 96 Lintel L17 over second floor opening in existing wall at connector

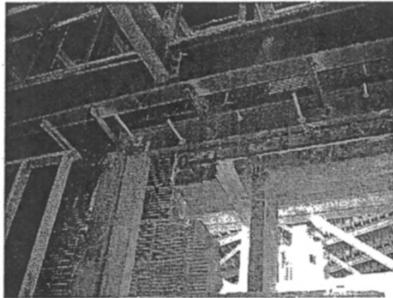
Figure 97 Lintel L17 over second floor opening in existing wall at connector

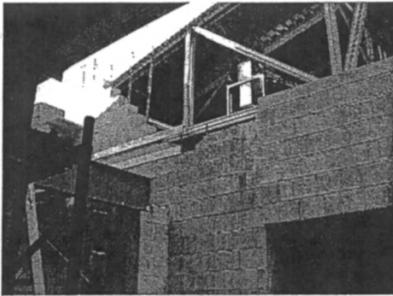
Figure 98 Lintel L16 over second floor opening in new wall at addition – See item 27

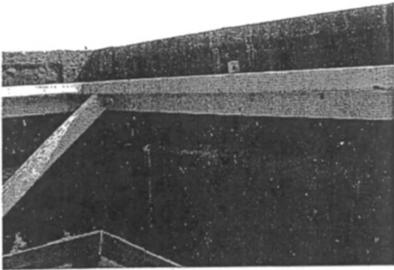
Figure 102 Parapet wall connection at portico roof – See item D

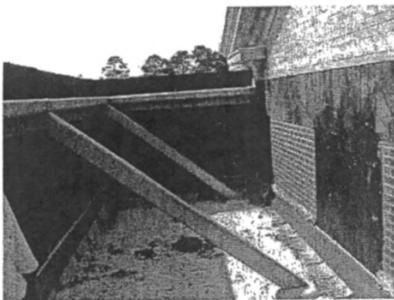
Figure 103 Parapet braces at portico roof – See item C

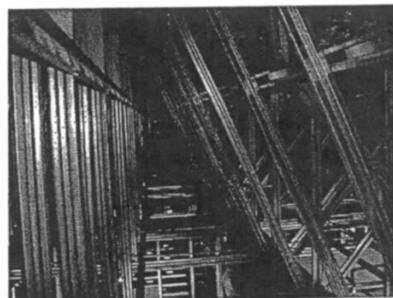
Figure 106 Roof framing at existing building

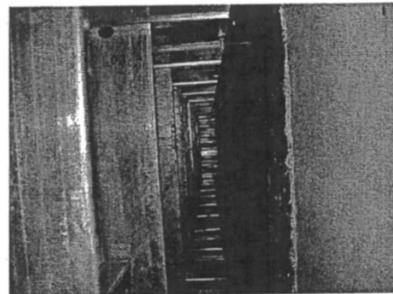
Figure 107 Miscellaneous steel connection material at masonry gable end wall – See item F

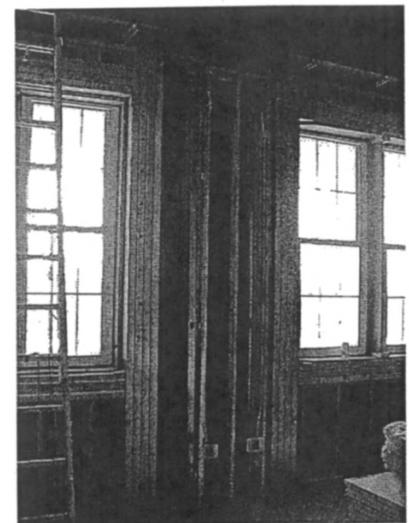
Figure 109 Second floor window reinforcing

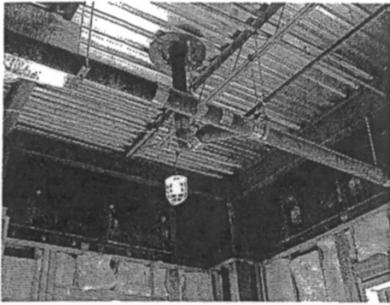
**Figure 110** Low roof parapet bracing extending under roof deck and fastened to limestone water table on inside face at existing building

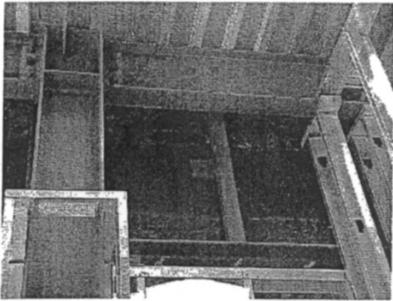
**Figure 111** Low roof parapet bracing extending under roof

deck and fastened to limestone water table on inside face at existing building

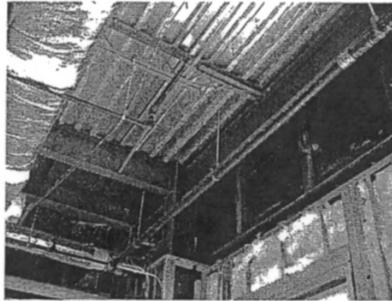
**Figure 112** Low roof parapet bracing extending under roof deck and fastened to limestone water table on inside face at existing building

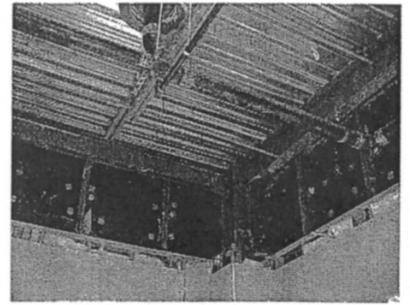
**Figure 113** Low roof parapet bracing extending under roof deck and fastened to limestone water table on inside face at existing building
